ADDRESS: 1632 POPLAR ST

Proposal: Remove gable roof and stone veneer; construct rooftop addition; replace windows

Review: Final Review
Owner: Poplar Lofts LLC

Applicant: Chwen-ping Wang, Ping Architects LLC

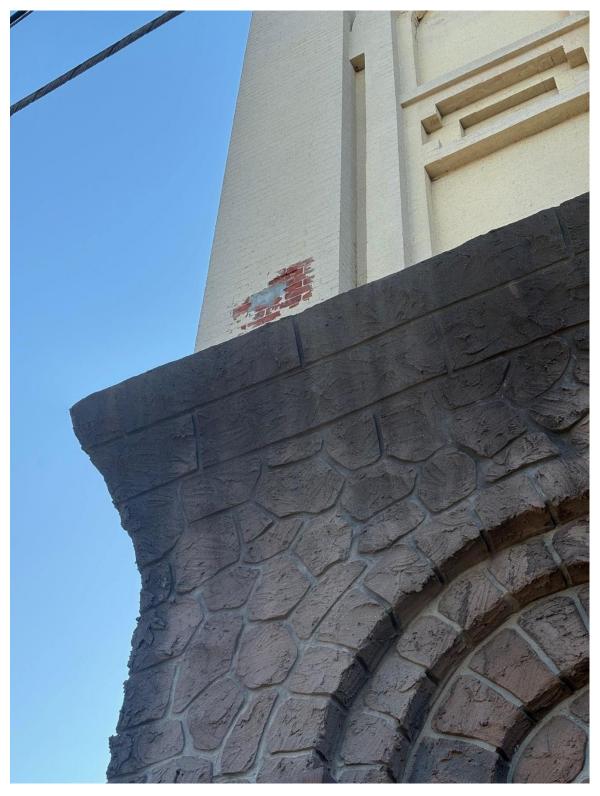
Image 7: The original brick is visible on the second and third elevations of the building. The original red brick is currently painted yellow. The first floor is currently clad in stone veneer.

- The applicant will work with the staff on the future removal of the stone veneer and the condition of the masonry material underneath it in order to meet Standard 9. Once the removal is complete, the applicant can work with the staff to determine an approvable preservation approach to rehabilitating the masonry façade.

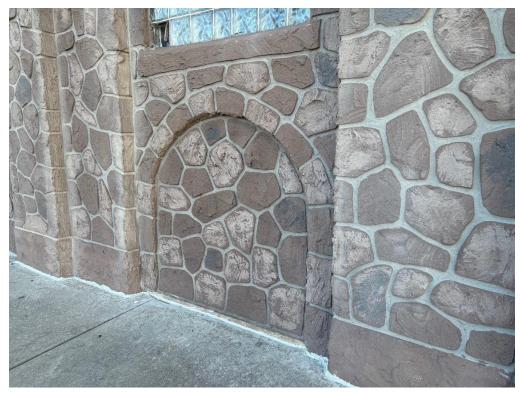
Image 9: Close up view of stone veneer along N. 17th Street.

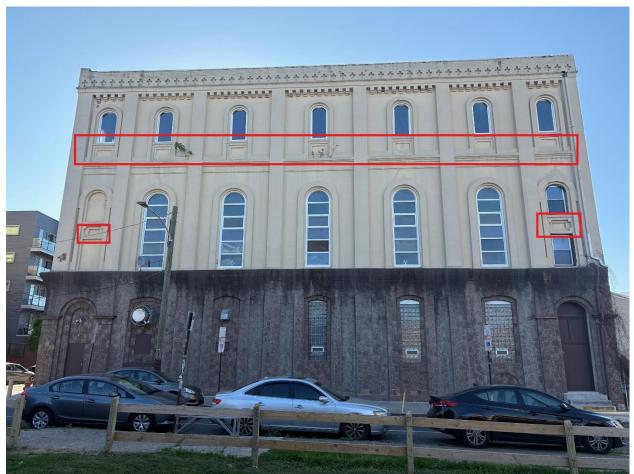
Image 10: Elevation along N. 17th Street. The red boxes show areas of historic brick detailing that dates to original construction. The third floor recessed panels are also extant on the Poplar Street front façade.

- O Photographs provided of the third-floor interior indicate that the existing window openings have not been altered. The exterior brick recessed panels below the third-story windows are character-defining features and should remain in place. A similar element is extant on the second-story elevation along N. 17th Street, and this too should be retained. Removal of these historic brick details does not meet Standard 2.

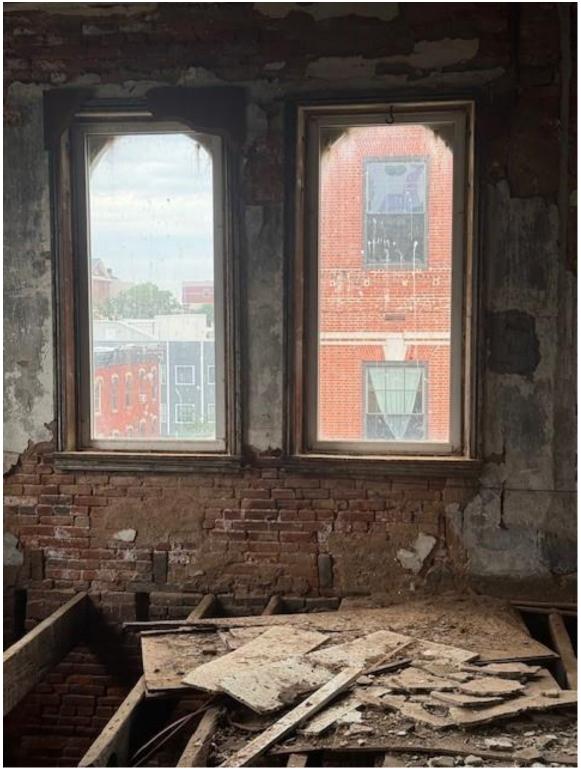
Image 11: Interior view of windows on third floor. Plaster was removed to expose original brick. There is no indication that these windows were reduced in height since the 1859 construction. The lack of alterations in this area confirms that the brick panel detailing on the exterior was included in the original design and construction.

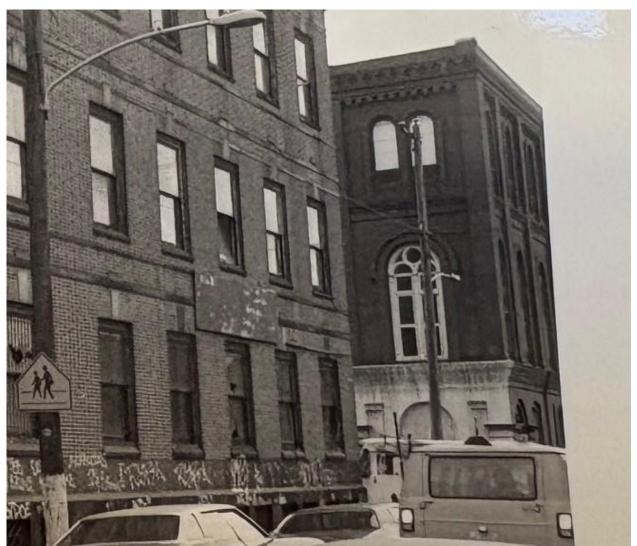
Image 12: 1632 Poplar Street in early 1980s. Photograph shows building corner at Poplar and N. 17th Streets. Unpainted brick is visible on the second and third levels. The first floor appears to have stucco applied to the façade and window/door openings are filled in. An original window is still visible on the second-floor façade. The architectural design of Philadelphia public markets constructed during the mid-18th century consistently showcased heavy ornamented brick and large arched windows with detailed tracery. The original window shown in this photo is similar to other public markets constructed in this era (see Images 13-16).

- The identified historic window configuration should be incorporated into the two first-floor windows and central entrance along Poplar Street (see historic photographs and precedents—Images 12-16) to meet Standard 9. For the majority of the windows, the installation of two-over-two double-hung windows would be appropriate to the original construction period and satisfy Standard 9.

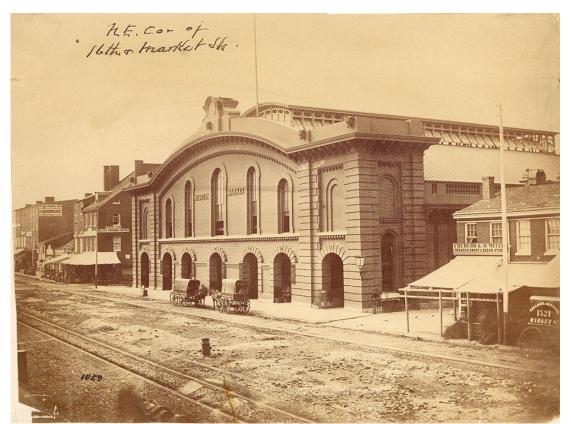
Image 13: Western Market (demolished). Located at Market Street and 16th Street. Constructed 1859.

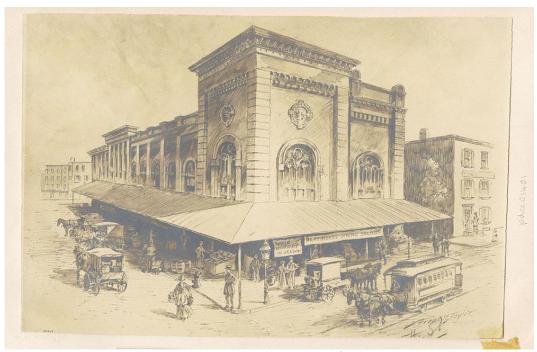
Image 14: Eastern Market (demolished). Located near 4th Street and Chestnut Street. Constructed 1859.

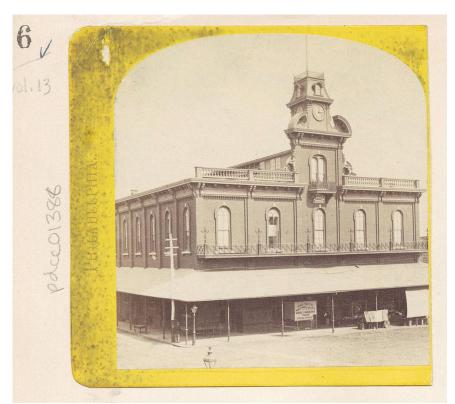
Image 15: Lincoln Market (demolished). Located at Broad Street and Fairmount Avenue. Constructed 1871.

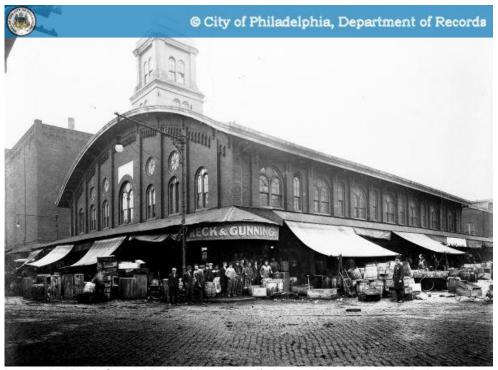
Image 16: Dock Street Market (demolished). Located in proximity to Delaware Avenue and Dock Street. Constructed circa 1870.

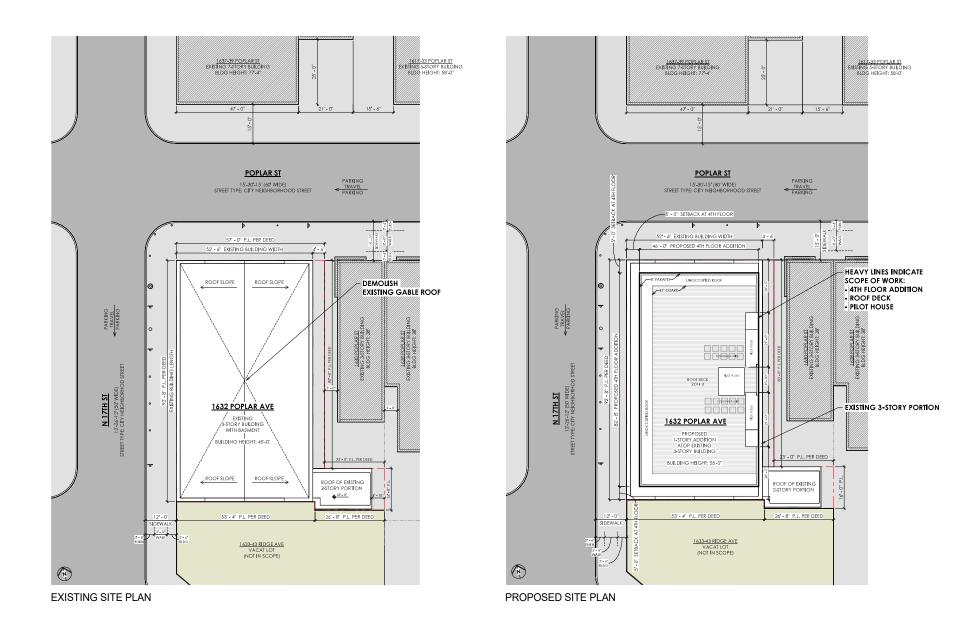
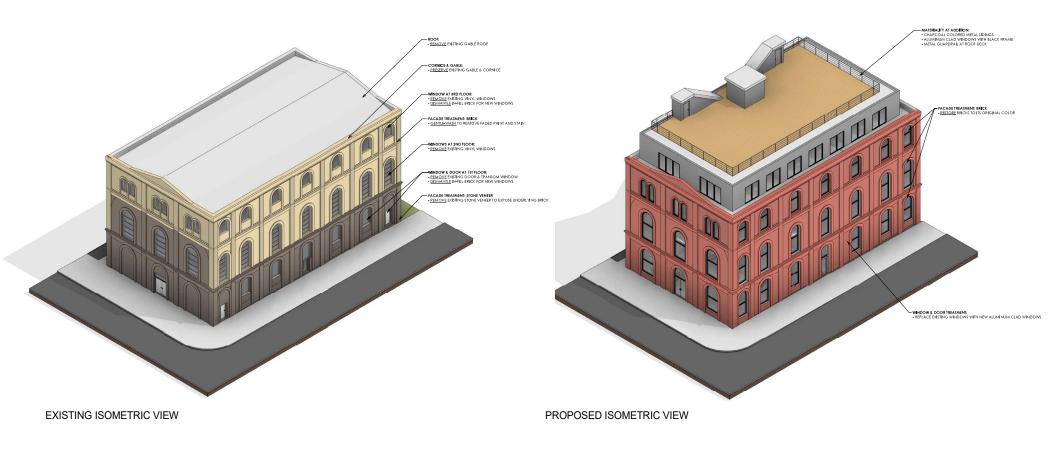
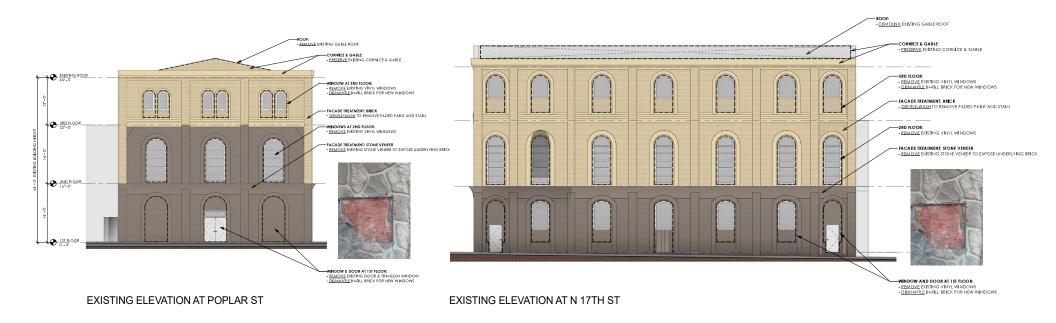
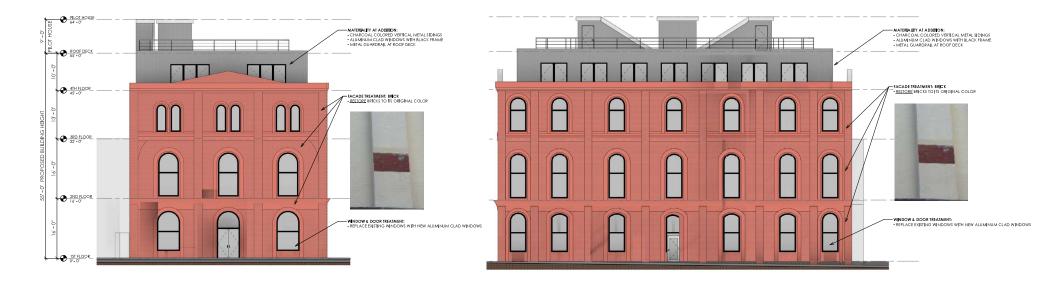
PROPOSED ELEVATION AT POPLAR ST

PROPOSED ELEVATION AT N 17TH ST
