**ADDRESS: 413 S 3RD ST**

Proposal: Demolish rear one-story addition; construct two-story addition

413 S 3rd Street

Historical Commission Conceptual Review

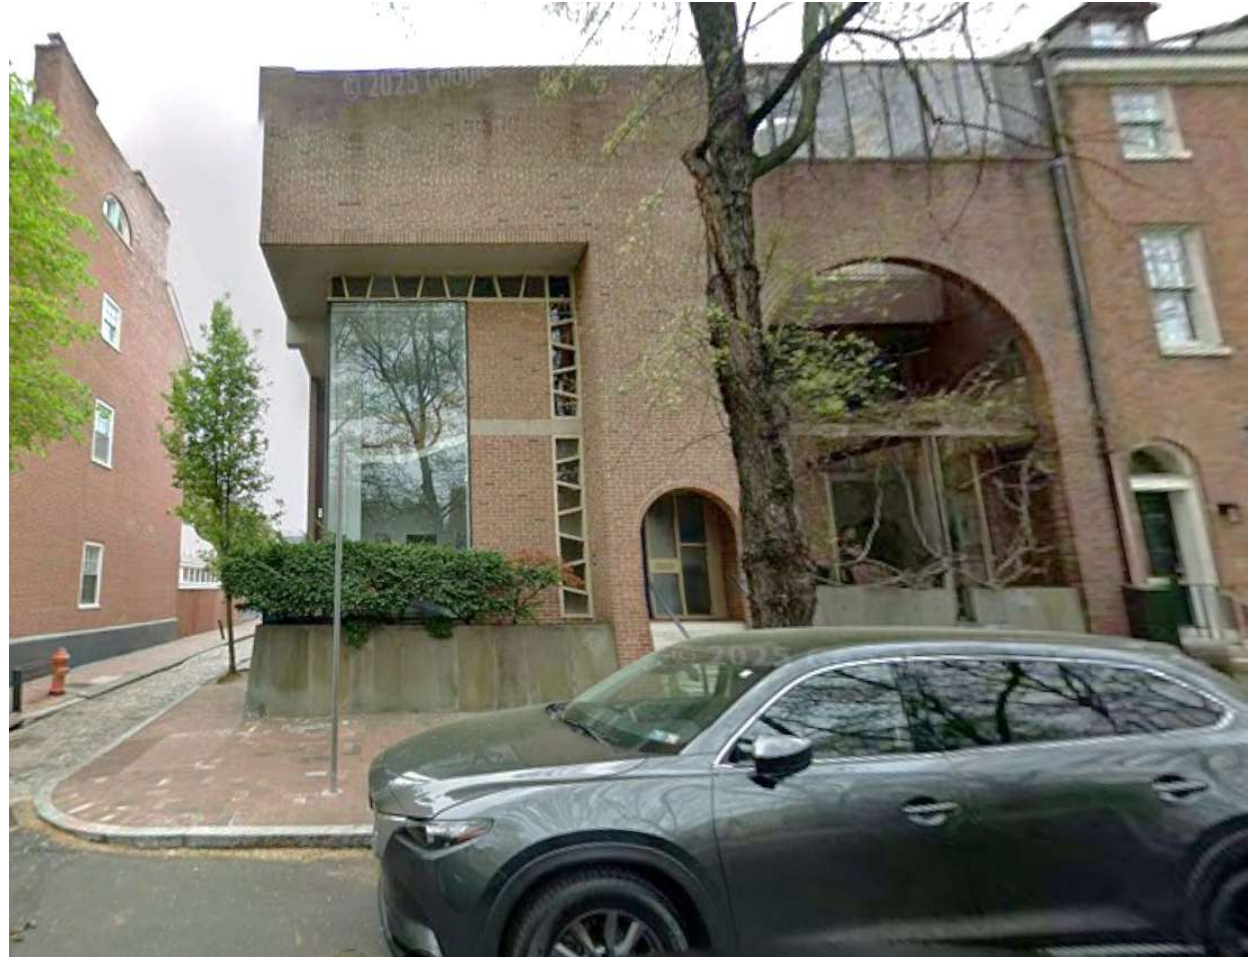
## 415-17 S 3<sup>rd</sup> St

- Extensive Glazing
- Brick Recesses
- Façade Layering

## 234-230 Lombard St Homes

- Brick Patterning
- Large Fenestration / Casement Windows

## 304 Lombard St

- Brick + Standing Seam Metal Façade Cladding
- Brick Patterning
- Large Casement Windows

## 439 S 2<sup>nd</sup> St

- Double Height Window Walls
- Sculptural Brick Massing
- Repetitive Architectural Elements
- Massing Setbacks / Façade depth

## 4<sup>th</sup> and Locust

- Full Height Glazing
- Brick Façade with Black Metal & Minimal Mullions
- Reinterpretation of Historic Massing

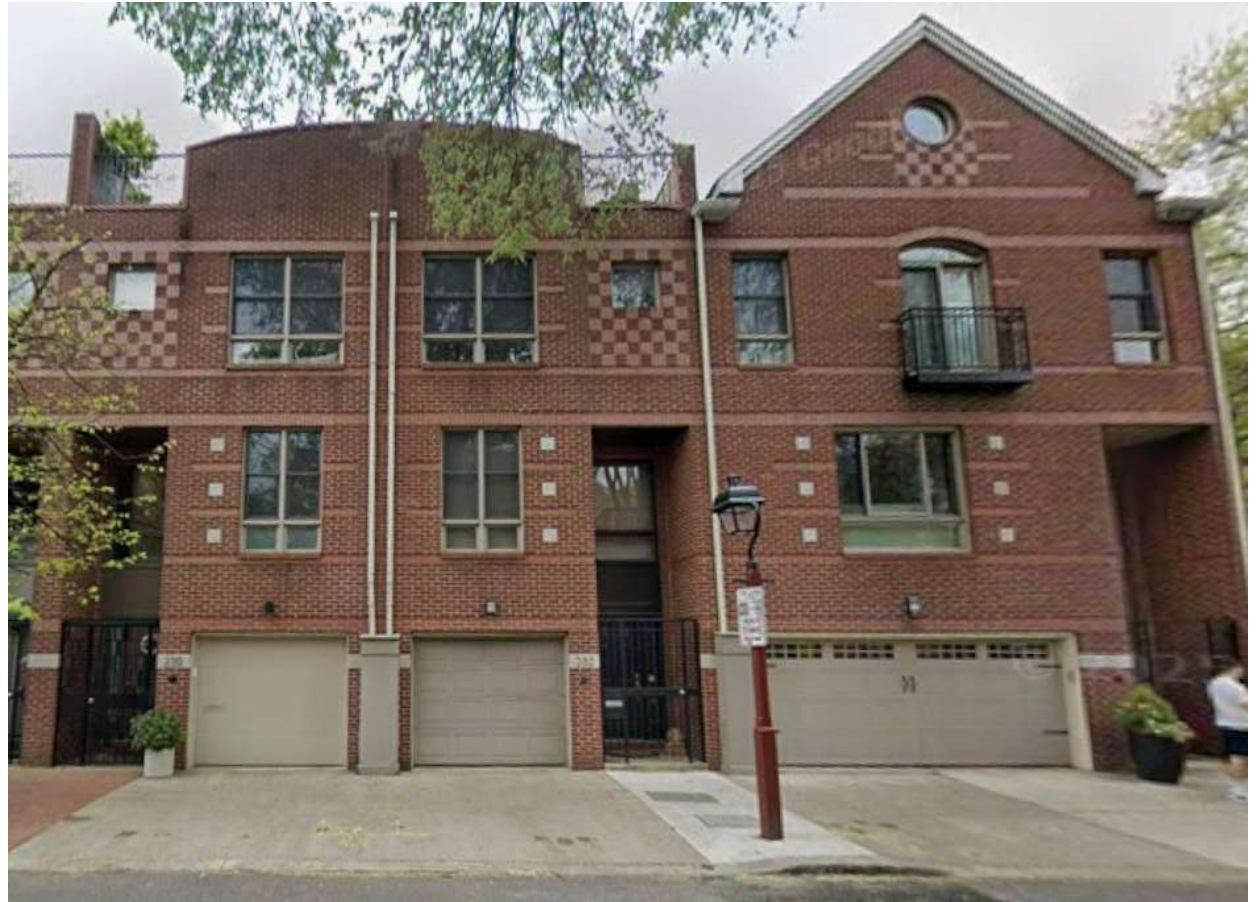
## 415-17 S 3<sup>rd</sup> St

- Extensive Glazing
- Brick Recesses
- Façade Layering

## 234-230 Lombard St Homes

- Brick Patterning
- Large Fenestration / Casement Windows

## 304 Lombard St

- Brick + Standing Seam Metal Façade Cladding
- Brick Patterning
- Large Casement Windows

## 439 S 2<sup>nd</sup> St

- Double Height Window Walls
- Sculptural Brick Massing
- Repetitive Architectural Elements
- Massing Setbacks / Façade depth

## 4<sup>th</sup> and Locust

- Full Height Glazing
- Brick Façade with Black Metal & Minimal Mullions
- Reinterpretation of Historic Massing

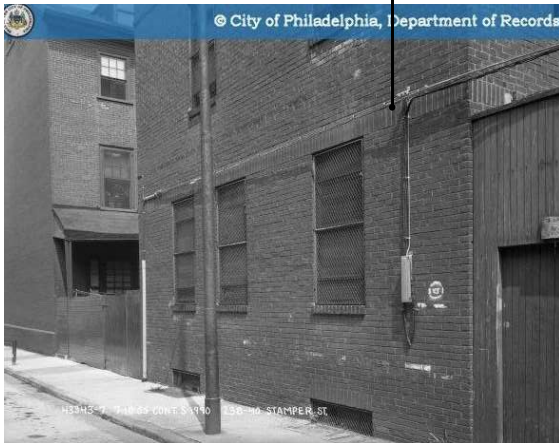
PHOTOGRAPH FROM 1955

Two-story rear structure, adjusted between 1958 to 1980s

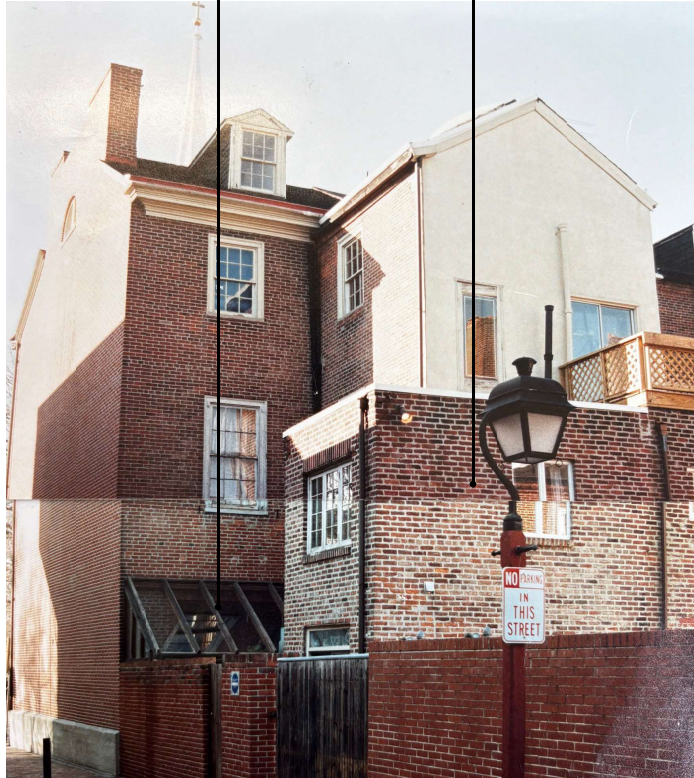
PHOTOGRAPH FROM 1980S

Glass and wood lean-to structure at rear

Two-story rear structure demolished between 1980s to 1999

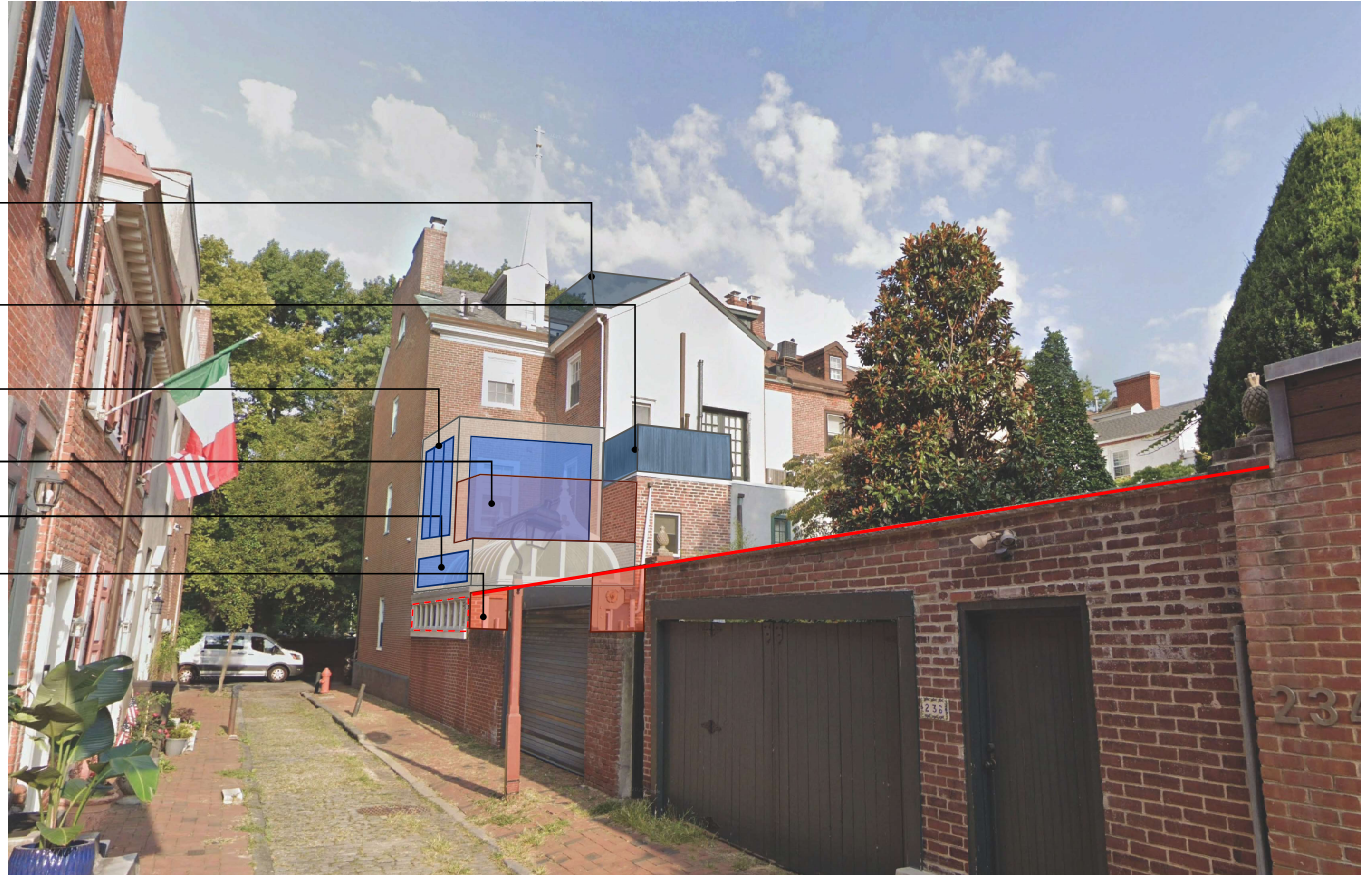
- Guardrail for existing rooftop deck
- Proposed metal guardrail to replace non-historic guardrail
- Addition and deck @ level 2 with windows on south and east elevations
- Perforated brick 42" guardrail
- Move up & enlarge transom windows
- Rebuild brick wall to align with adjacent neighbor wall, approx. 9' H

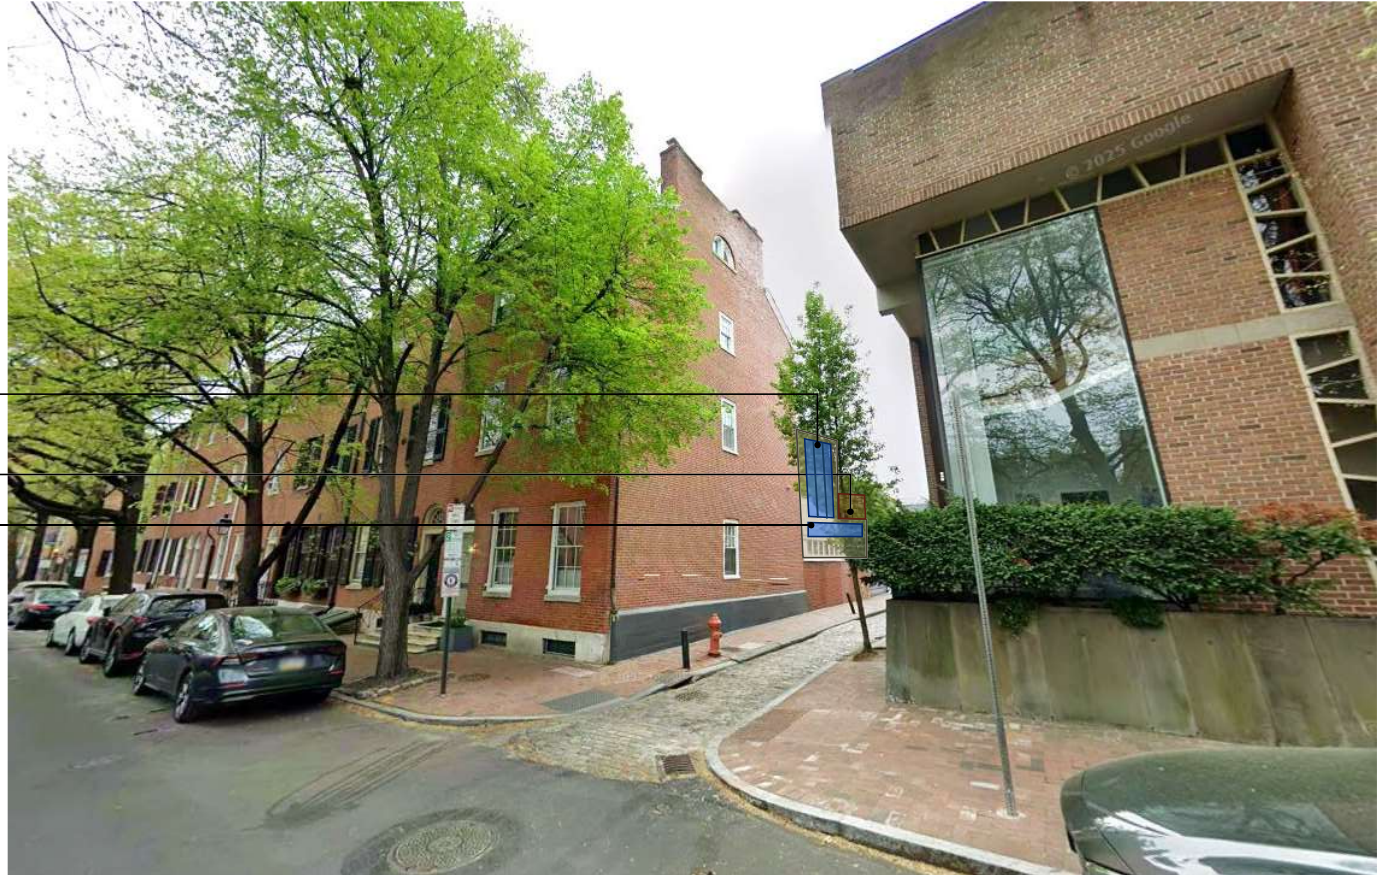
Addition on level 2 with outdoor deck over existing level 1 footprint. New south and east facing windows

Perforated brick screen 42" guardrail

Move up & enlarge transom windows
