## **COMMENT ON NATIONAL REGISTER NOMINATION**

**ADDRESS: 1801 E Huntingdon Street, Textile National Bank**

**1. Name of Property**Historic name: **Textile National Bank**

Name of related multiple property listing: **Industrial and Commercial Buildings Related to the Textile Industry in the Kensington Neighborhood of Philadelphia**

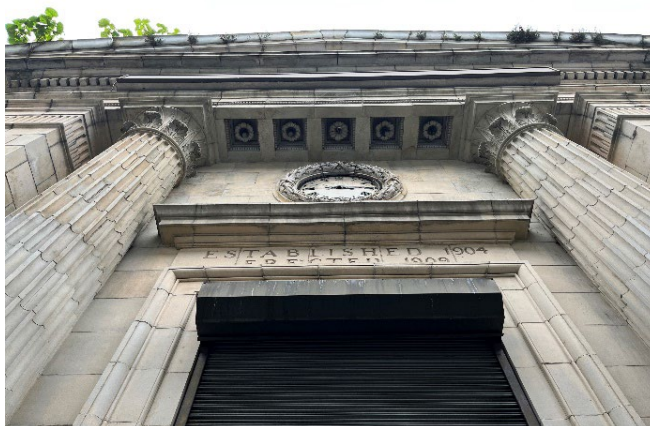
**Photo 3:** Looking up (toward the east) at the entablature, clock, and pediment above the main entrance on the west elevation, facing Kensington Avenue.

The wall space just above the entrance, but below the pediment, features an original clock with an ornately carved terra cotta frame ([Photos 3, 4](#)). In the entablature just below the pediment, the frieze is partially covered by a circa 1970s or 80s metal box sign ([Photo 2](#)). In historic images, the name of the bank appears in this location, possibly incised into the terra cotta, but it is not known if it remains behind the sign. The cornice of the pediment is denticulated. Within the tympanum, there is a Classical-style, high-relief sculptural panel depicting two recumbent female figures on either side of a shield ([Photo 5](#)). Above and slightly recessed from the face of the

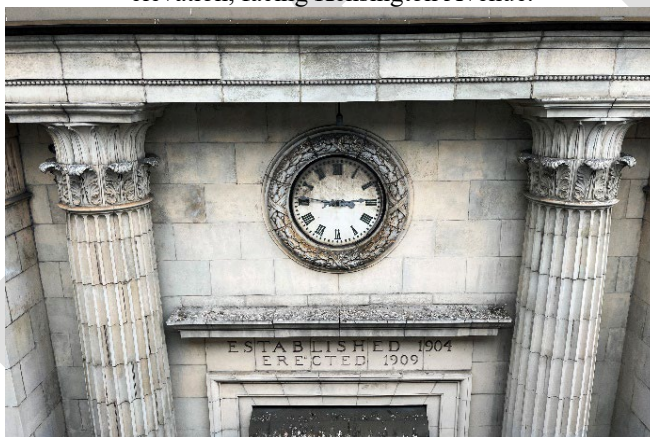
**Photo 4:** The clock above the main entrance, looking east from the northbound platform at Huntingdon Station on the Market-Frankford Elevated Line.

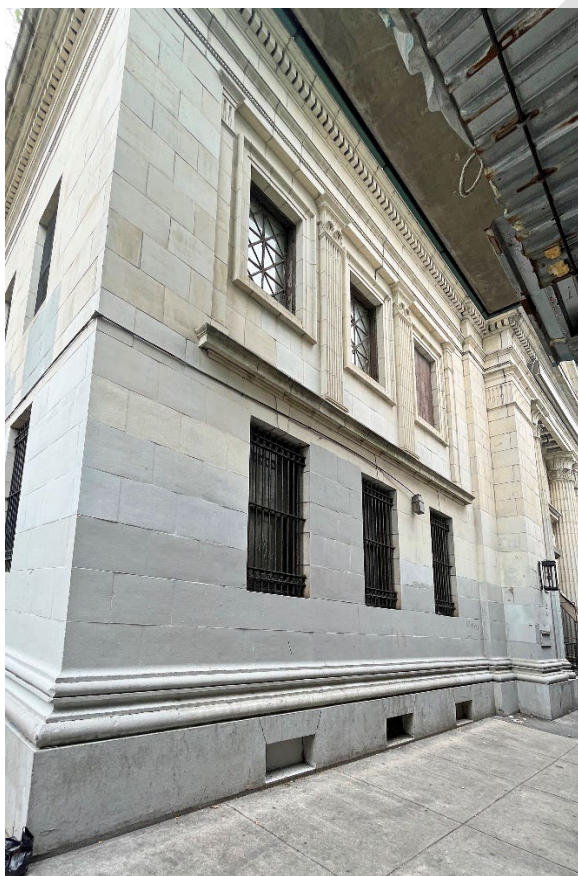
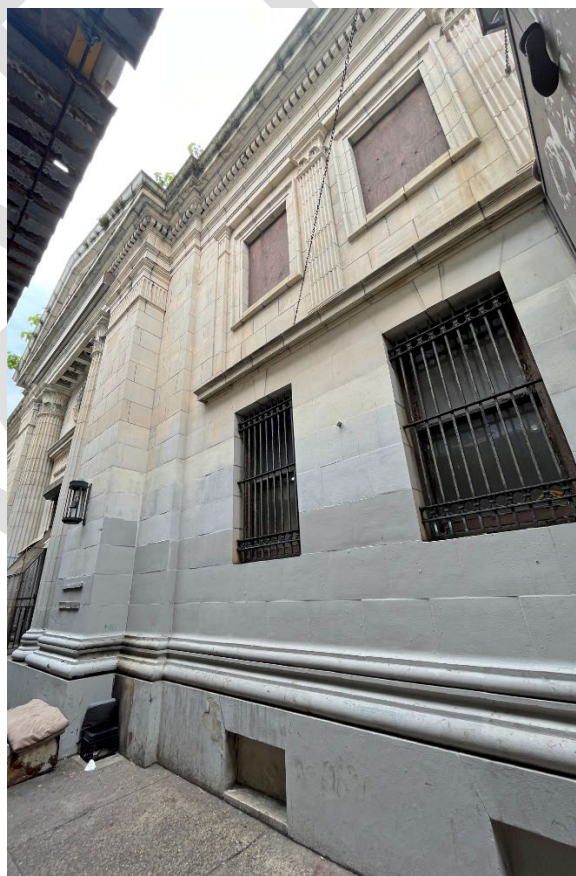
**Photo 6** (left): West elevation, facing Kensington Avenue, north of the central bay.

**Photo 7** (right): The clock above the main entrance, looking east from the northbound platform at Huntingdon Station on the Market-Frankford Elevated Line.

The wings on either side of the central bay are each three-bays wide and are identical in treatment (Photos 6 and 7). On the first story, there are three original, one-over-one, double-hung wood windows with original iron security grates on each side. The windows are set into punched openings that have no articulated sills or surrounds but do have keystones at the top of each window that project out slightly from the wall surface. The second story also features three windows on each side, which are of similar size and align with those below, but are more decorative, consisting of original Roman lattice-style wood casements with architrave surrounds. Many of the second-story windows are currently covered by painted plywood panels but remain visible on the interior side. Corinthian order pilasters, which rise from a small, slightly projecting entablature above the first-story windows, separate and frame the second-story window bays. Above the second-story windows, the entablature with denticulated cornice found in the pedimented central bay continues to the north and south elevations. The parapet also continues, but in this case the parapet has three punched, balustraded openings on each side, aligning with the first- and second-story windows below.

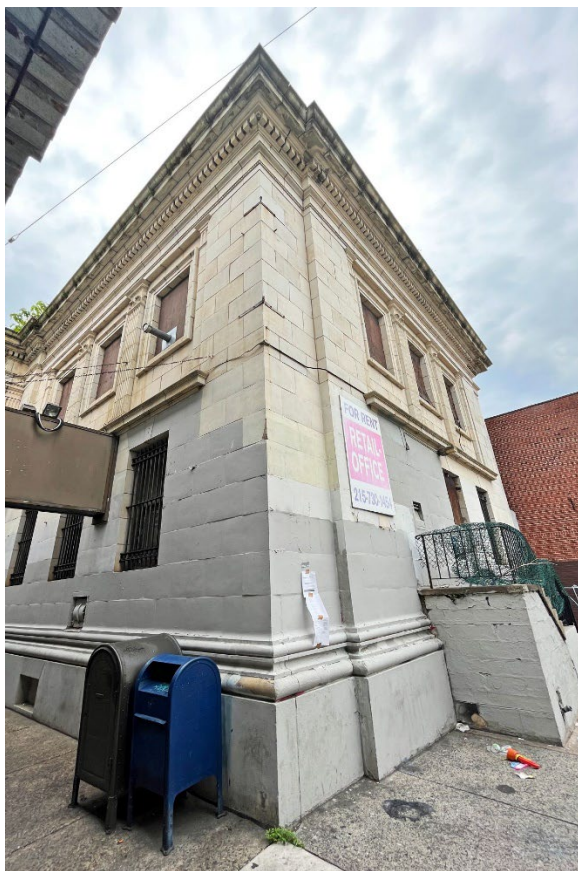
**Photo 8** (left): West and south elevations, looking northeast.

**Photo 9** (right): South elevation, looking north.

The south elevation, which is three-bays wide and faces East Huntingdon Street, is similar in treatment to the side wings of the west elevation. On the first story, situated parallel to the building, is a concrete stair with a metal picket railing and two landings that appears to date to

the mid- to late-20<sup>th</sup> century. At the top landing, the original opening in the westernmost of the three bays (far left in [Photo 9](#)), is infilled with concrete block, which is painted. The center bay extends down through the top of the water table to the first landing and has a painted hollow metal door, above which the remainder of the opening is covered with plywood. The easternmost bay (at far right) matches those on the west elevation, containing a punched opening with an original one-over-one, double-hung wood window and original iron security grate. All three openings have keystones at the top. The three windows on the second story are all covered with plywood, but again remain visible on the interior. The architrave surrounds, the pilasters that frame the bays, and the cornice from which the pilasters rise all remain intact. Above the second-story windows, the entablature, cornice, and parapet treatment matches the west elevation, except that there are two rather than three balustraded openings in the parapet (the center one consists of a solid panel).

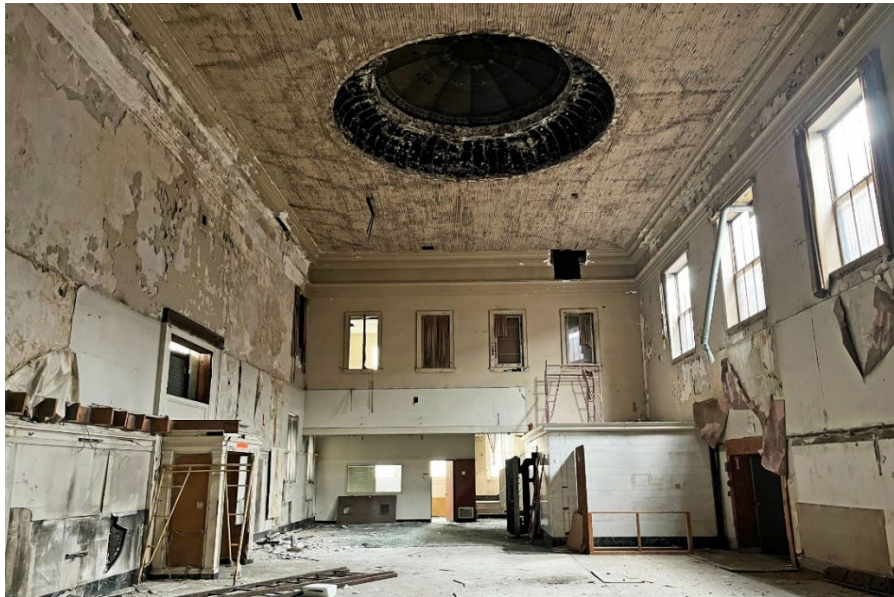
**Photo 11:** Banking hall, looking north. At right, there is a rectangular opening into the adjacent industrial building. The opening was inserted following the closure of the last banking tenant in 1992.

The primary feature of the ceiling is a large, leaded glass dome, which is centered above the banking hall (Photos 11, 13). The dome is largely intact – only a few areas of glass are damaged – but the historic plaster cove under the dome is missing its plaster finish. Currently, the dome is extremely dirty and no longer transmits natural light because it is covered by a later roof.

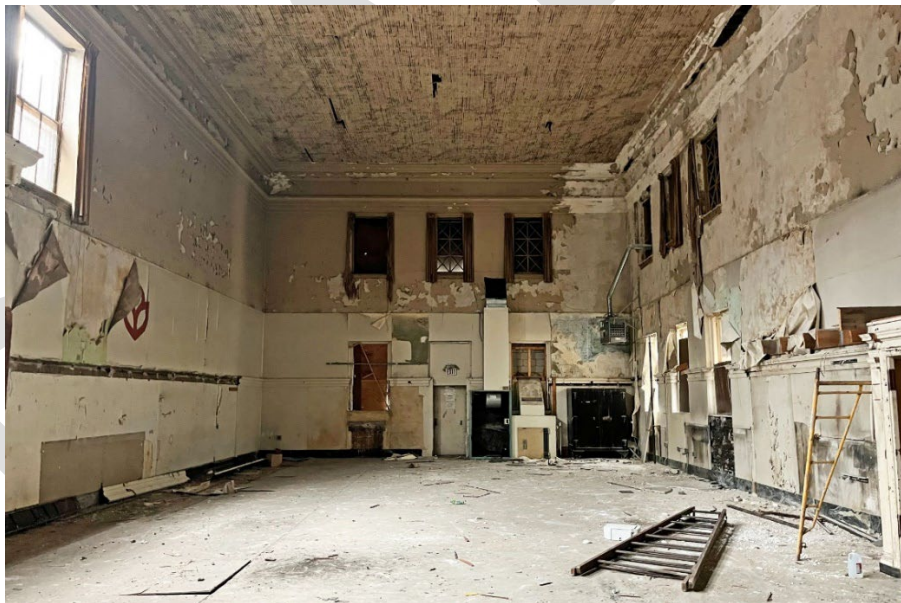
**Photo 12:** Banking hall, looking south.

*Interior:* The interior of the building consists almost entirely of a large, double-height banking hall, which is rectangular in plan ([Photos 11, 12](#)). The floors are currently covered with plywood, and investigations have so far not revealed the existence of a historic floor finish. The walls, however, are clad in original white marble panels, which rise to a height of about seven feet, are painted in many areas, and sit atop a green marble base. The marble paneling is topped by original painted wood molding. Above the marble paneling, the walls consist simply of painted flat plaster. The ceilings are also flat and historically had a plaster finish, but the plaster has detached in most locations, revealing the underlying wood lath. Around the perimeter of the ceiling, there is plaster crown molding, which is largely intact. On the east wall, there is a rectangular opening into the adjacent industrial building ([Photo 11](#)). This opening was made sometime after 1992, when the last banking tenant departed the building. Historically, the two buildings were not connected internally.

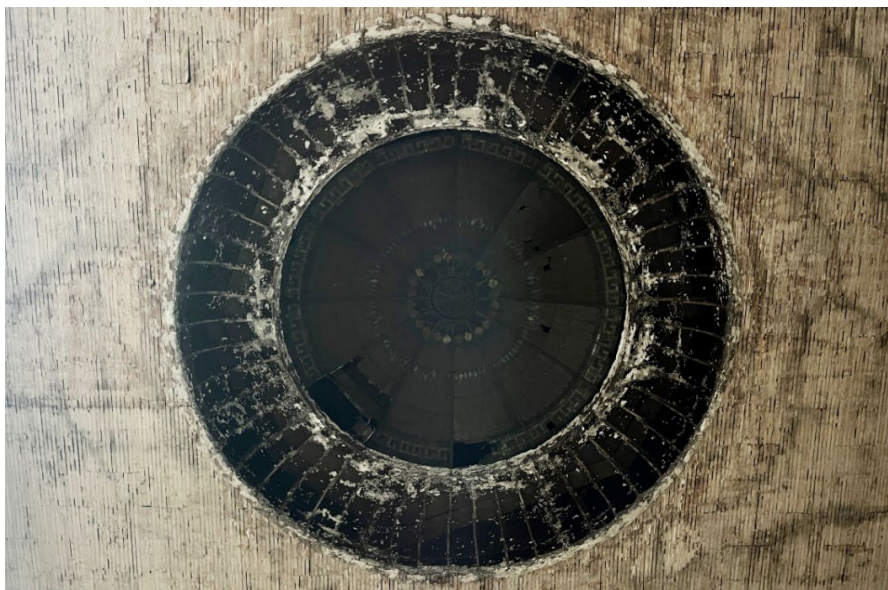
**Photo 13:** Leaded-glass dome at the center of the banking hall ceiling. The glasswork is largely intact, but the plaster finish on the cove below it (the wide ring surrounding the glass) is largely missing.

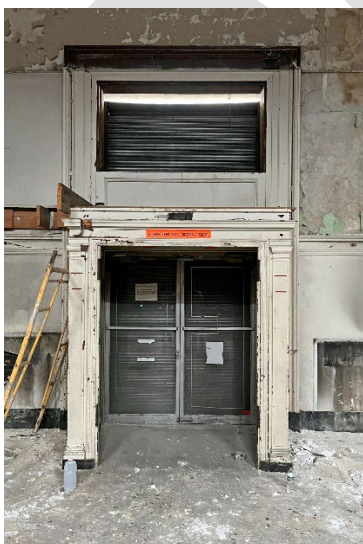
**Photo 14 (left):** Vestibule at the historic main entrance on the west elevation, looking west.

The entrance, which is covered by a modern, roll-down metal door and further secured by a metal cage, is level with a circa 1970s concrete platform that covers the area where the original granite steps were once located ([Photo 2](#)). Around the entrance is an architrave surround with an entablature containing the date of the bank's founding and the year the building was constructed in incised lettering: "ESTABLISHED 1904 ERECTED 1909." Although not currently visible on the exterior, the entrance itself consists of 1970s-era aluminum-framed glass double doors with an original, single-light transom, as seen on the interior side in [Photo 14](#).

Other historic features in the banking hall include a small vestibule at the main entrance on the west elevation ([Photo 14](#)). The vestibule, which extends about six feet into the space, is framed in wood and has painted wood pilasters and a cornice. At the northeast corner of the space, there is a freestanding rectangular vault, which has concrete walls clad in original white marble with a green marble base and retains its original vault door on the west side ([Photo 15](#)). North of the vault is an original marble stair, which is located parallel to the north elevation and leads to the offices on the second floor (or mezzanine level) at the north end of the space ([Photo 16](#)). West of the stair, there is a small office with carpeted floors and painted plaster walls and ceiling.

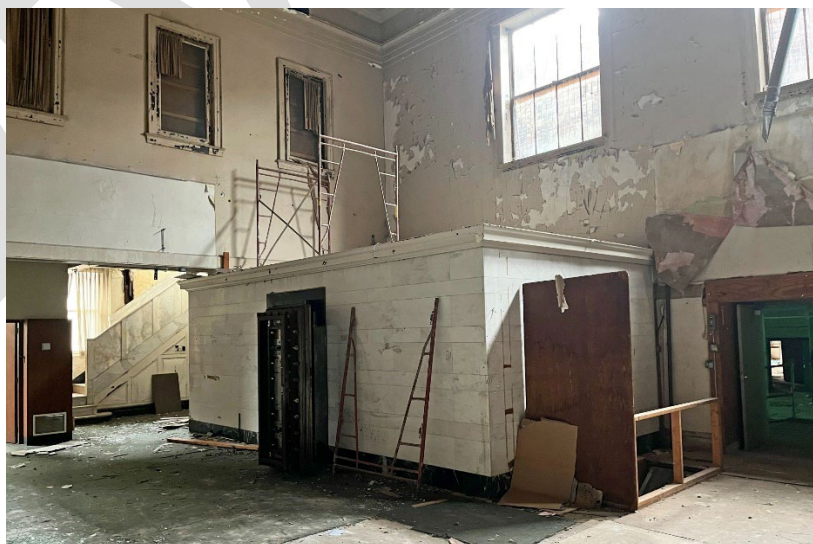
**Photo 15 (right):** Marble-clad vault at the northeast corner of the banking hall, looking northeast.

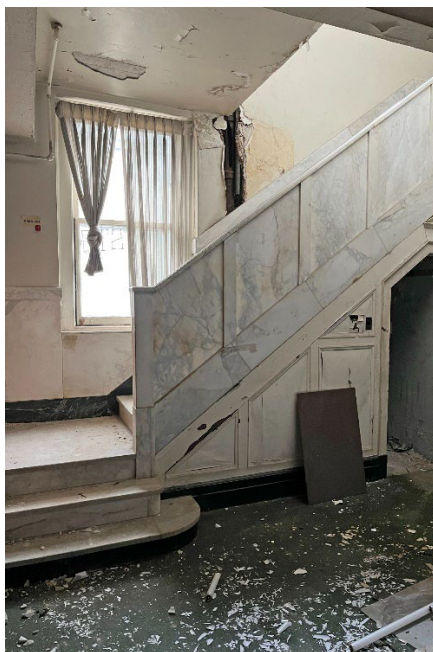
**Photo 16** (left): Marble stair north of the vault, leading to the second-floor (mezzanine-level) offices, looking north.

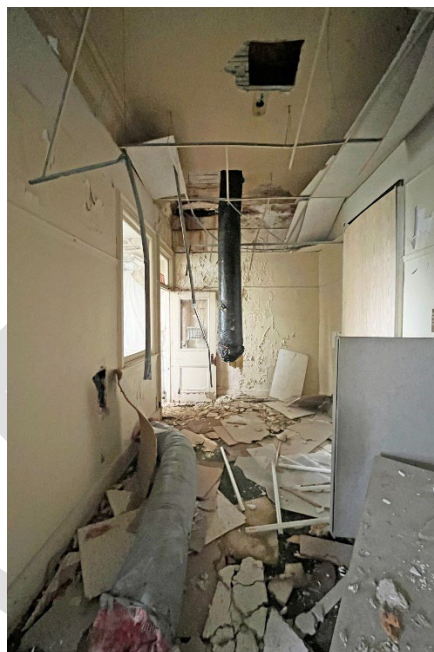
**Photo 17** (right): One of the offices on the second floor, looking east.

At the north end of the banking hall, there is a second floor or mezzanine level, which contains two office spaces with carpeted floors and painted plaster walls and ceilings, as well as remnants of a later, suspended acoustical tile ceiling (Photos 17, 18). On the south wall of the offices, there are original, single-light wood windows that overlook the interior space of the banking hall.

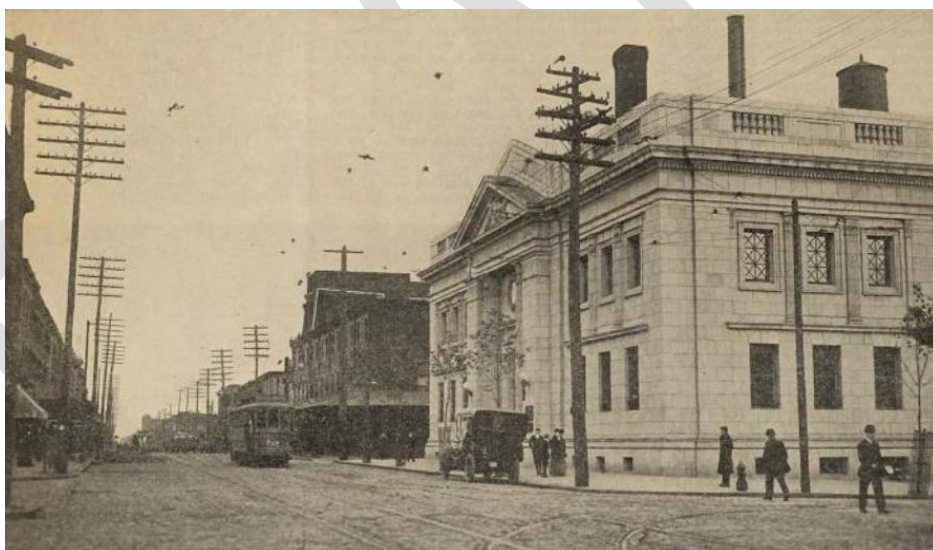
**Figure 6:** Looking north on Kensington Avenue with the Textile National Bank at right. This photo, probably taken around 1910, shows the area before the construction of the Market-Frankford Elevated Line. From the November 1910 edition of *Philadelphia* (magazine).<sup>22</sup>

Miller designed the new home of the Textile National Bank in the popular Classical Revival style, employing a Palladian composition with a temple-fronted central bay that suited the long and narrow site (Figures 5 and 6). While Furber had specified granite for the exterior walls, Miller chose terra cotta, which could achieve the same architectural effects as natural stone at a much lower price. The building was completed less than a year after the permit was issued, opening on November 1, 1909, just days after a fire nearly destroyed Textile Hall, the bank's home up until that point.<sup>20</sup> On March 16, 1910, the bank held a formal grand opening during which 3,000 people, "mostly business men and depositors," reportedly visited the new building.<sup>21</sup>

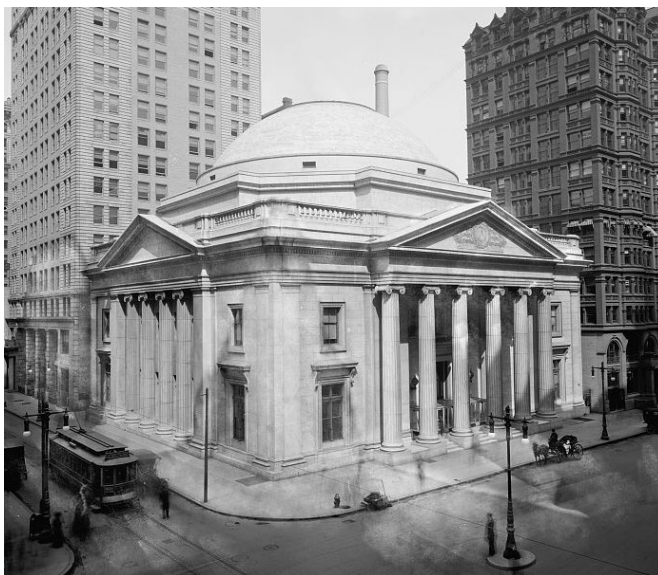
**Figure 8:** The Girard Trust Company Building at South Broad and Chestnut Streets, as it appeared around 1910. Designed by the firm of Furness & Evans with McKim, Mead & White, the bank was built in 1907 and is extant (Detroit Publishing Company Collection, Library of Congress).

Faced in white marble reminiscent of the monuments of Ancient Rome, Girard Trust has “all the characteristics of a classical temple,” in the words of architect John Andrew Gallery.<sup>43</sup> With its pedimented temple front and dome, the building is one of the more direct interpretations of a classical monument – in this case, Rome’s Pantheon – to appear in a Philadelphia during the early twentieth century. Much more common were the smaller neighborhood banks, nearly all designed by well-known architects, that appeared in virtually every part of the developed city during the same period. Important early examples include the North Philadelphia Trust Company at Germantown Avenue and Broad Street in North Philadelphia, designed by Carl P. Berger and built in 1904 (PA-SHARE No. 2023RE03560; extant with National Register Nomination pending); the Hamilton Trust Company at 40<sup>th</sup> and Market Streets in West Philadelphia, designed by the renowned architect Horace Trumbauer and built in 1906 (demolished); and the Union National Bank at 3<sup>rd</sup> and Arch Streets in Old City, designed by Newman & Harris and built in 1906 (PA-SHARE No. 1972RE00330; extant; contributing resource in the Old City Historic District) (Figures 9-11). Like the much larger Girard Trust Company, these banks were unmistakably classical in their design, serving as high-quality interpretations of Greek, Roman, and Renaissance-era works in characteristic light-colored stone and/or terra cotta. In all four works, the respective designers created allusions to the classical temple, employing the orders and classical principles like symmetry, balance, and proportion.

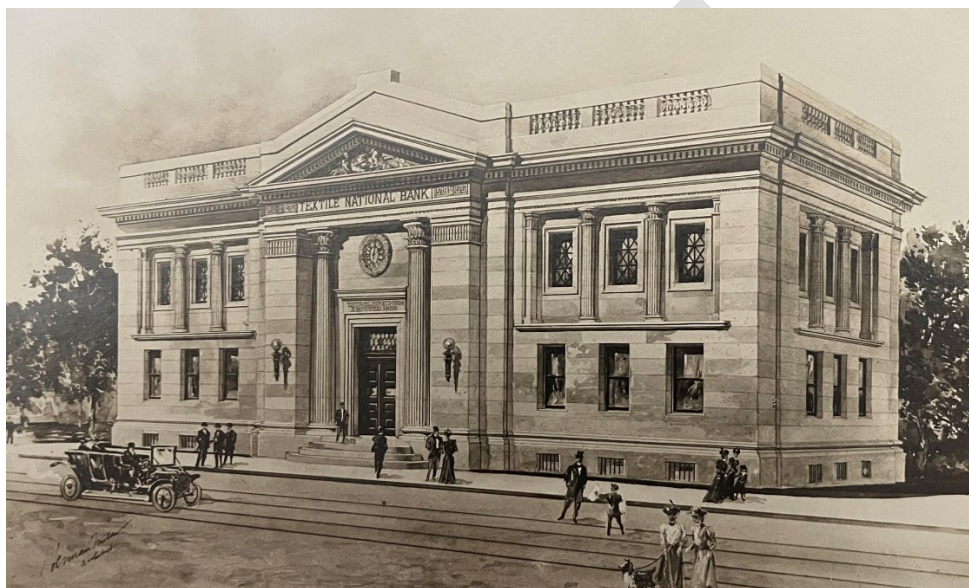
**Figure 15:** The Textile National Bank as seen in a photograph of a watercolor rendering by Herman Miller, undated but likely made in 1908. Miller's signature appears in the lower lefthand corner. (Herman Miller Collection, Athenaeum of Philadelphia).

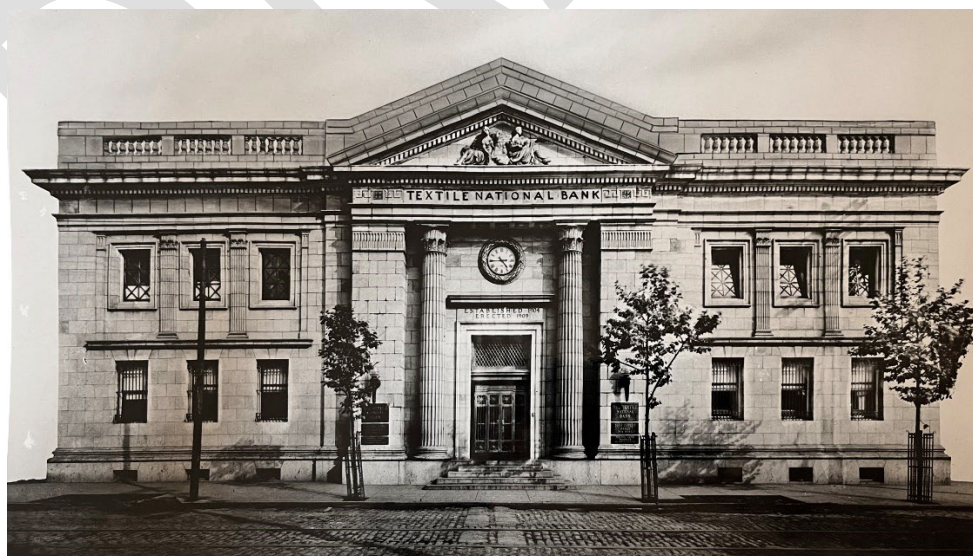
**Figure 16:** The Textile National Bank as seen in a photograph taken before 1916 (Herman Miller Collection, Athenaeum of Philadelphia).

The Textile National Bank, completed in 1909, is also highly characteristic of the classical influence in bank architecture during the early twentieth century (Figures 15 and 16). Its Palladian form, with a pedimented temple front in the central bay, was a common one for banks as illustrated by the Girard and Hamilton trust companies, discussed above. The Palladian design also echoes the architecture of one of the city's, and country's first financial institutions, the First
