ADDRESS: 1500-10 N BROAD ST

Proposal: Rehabilitate buildings; construct addition

Burk Mansion Renewal

Re: Burk Mansion | 1500 North Broad Street
Historical Commission Preliminary Review

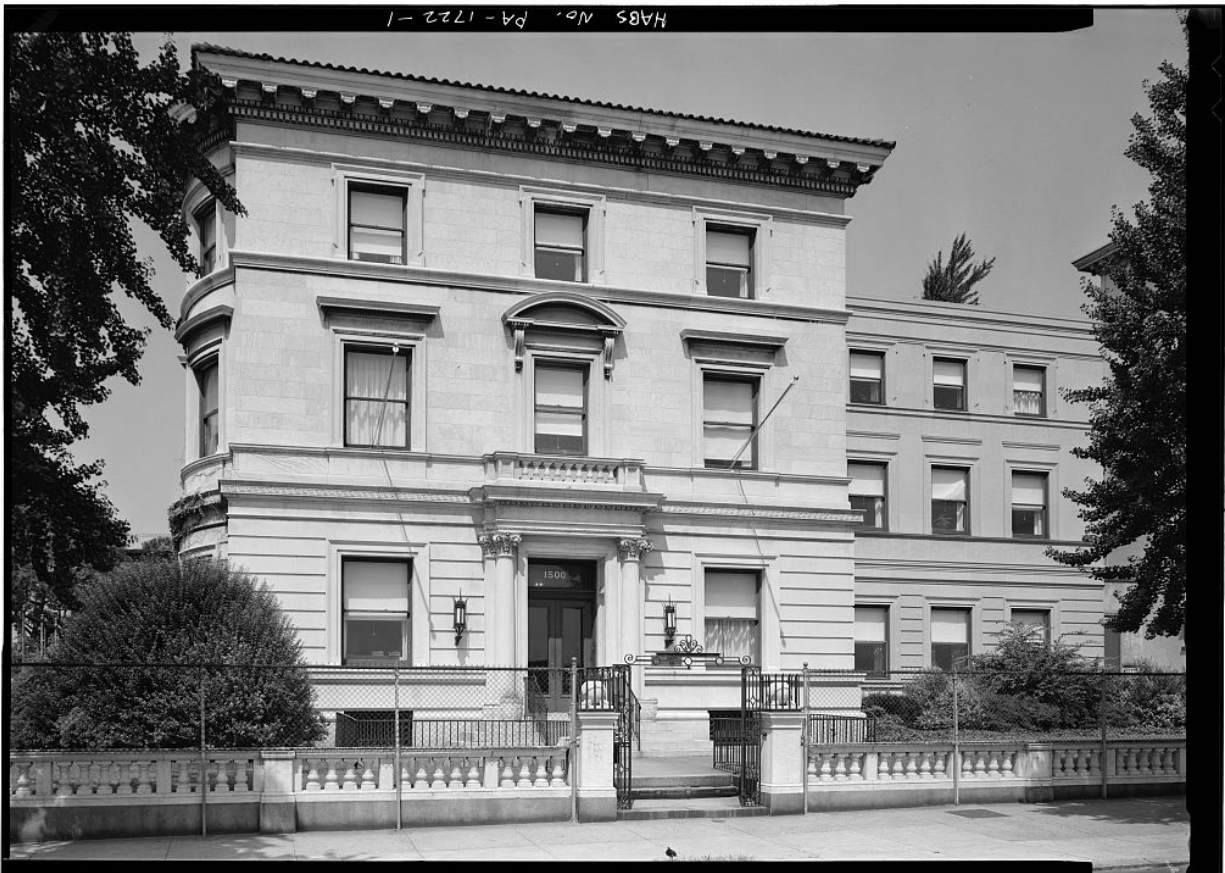
Figure 2: Broad St elevation, documented in the Historic American Buildings Survey, 1972.

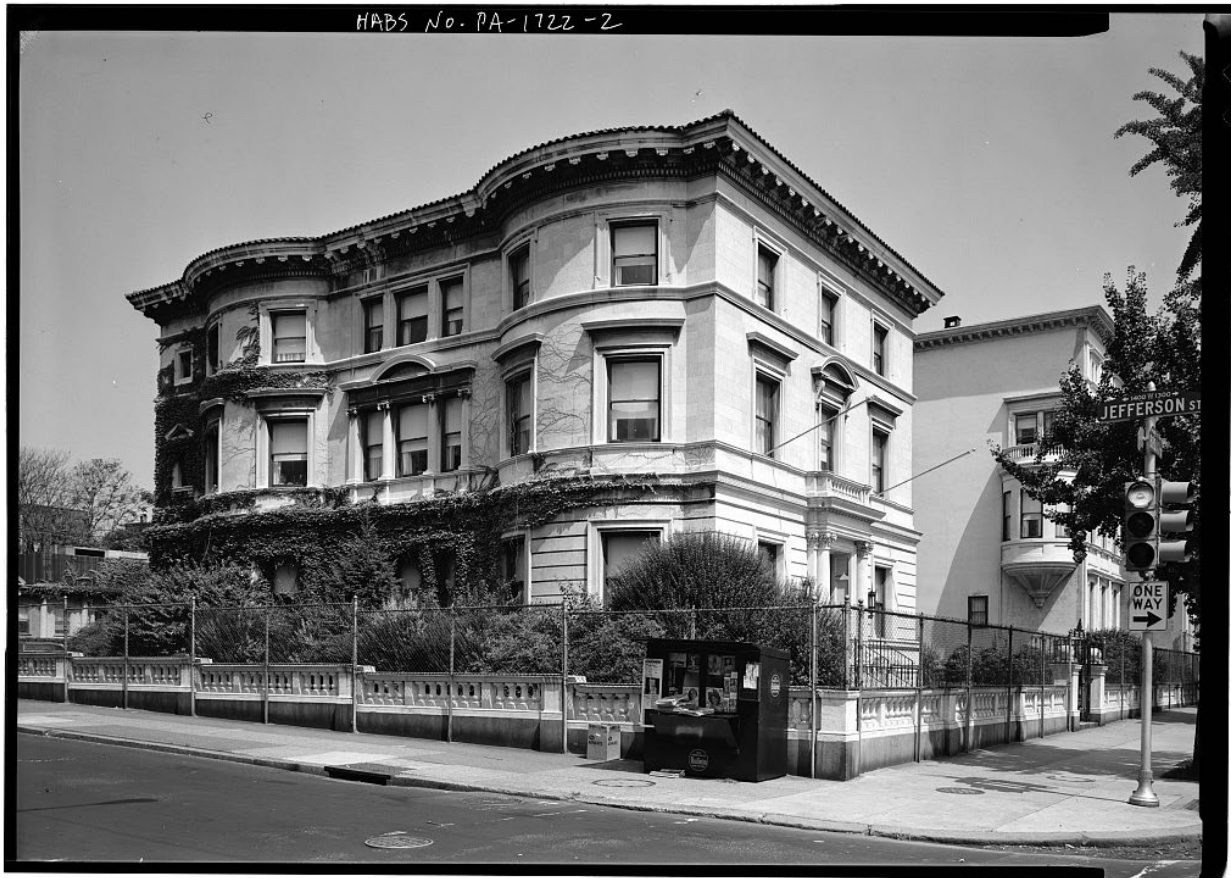
Figure 3: Jefferson St elevation, documented in the Historic American Buildings Survey, 1972.

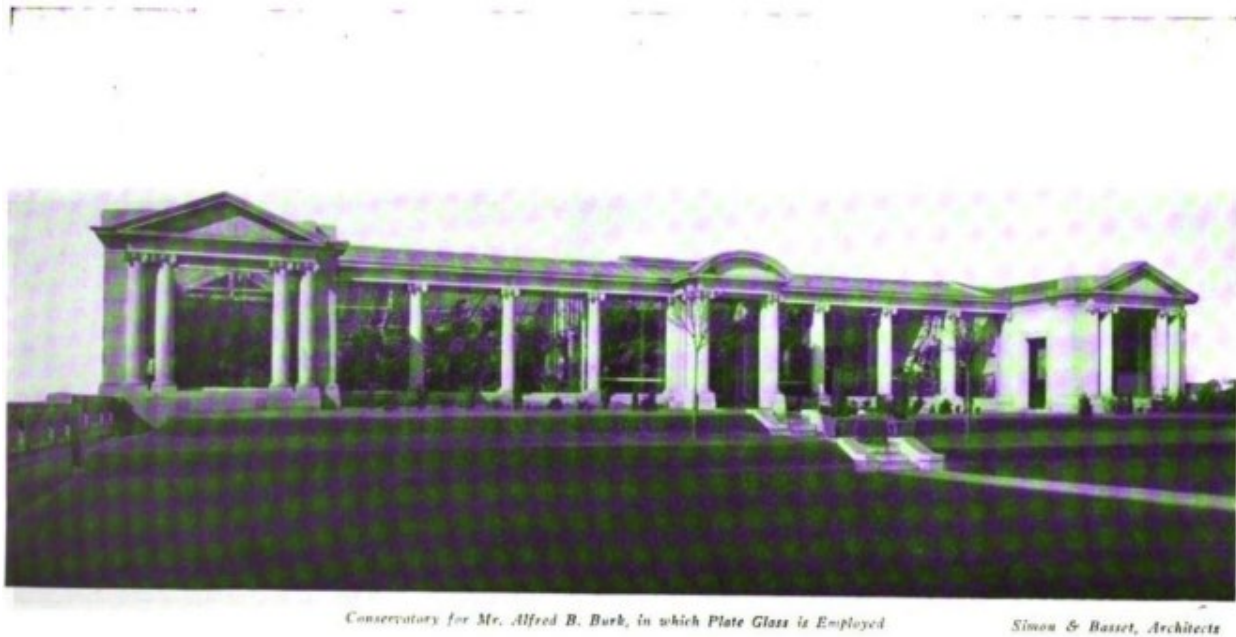
Figure 4: Image of the conservatory published in *The Architect & Engineer of California*, Vol. XXVI, No. 1, August 1911, page 96.

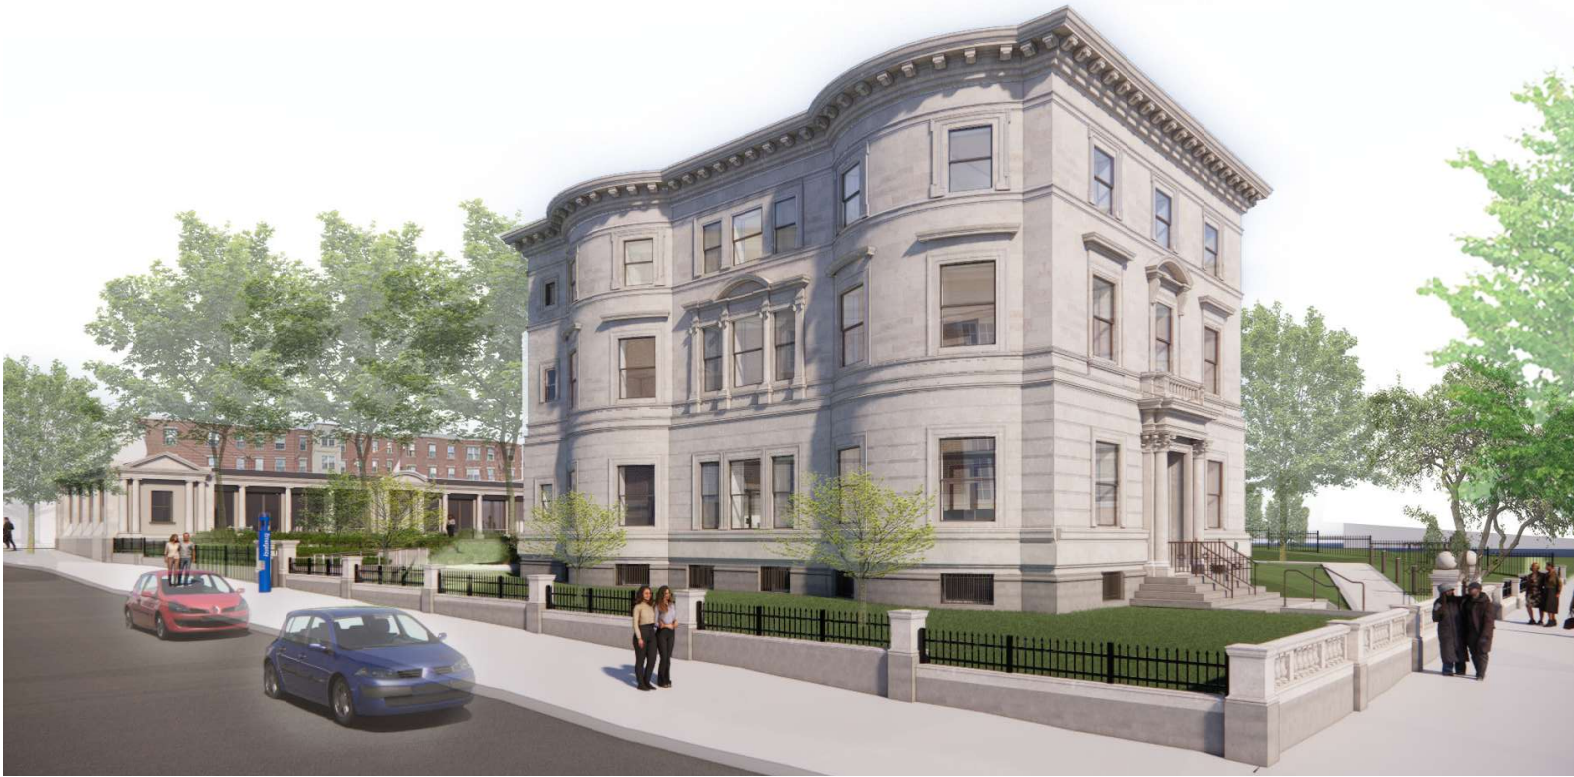
View From Broad Street Looking Northwest

Proposed Balustrade Alteration Notes

- Remove chain link fence from Balustrade perimeter.
- Existing historic fabric to be restored; new infill material used where fabric is missing.
- Existing decorative metal entrance gate on Broad Street to be refurbished.
- Remove chain link vehicle gate on Jefferson Street; replace with metal picket fence.

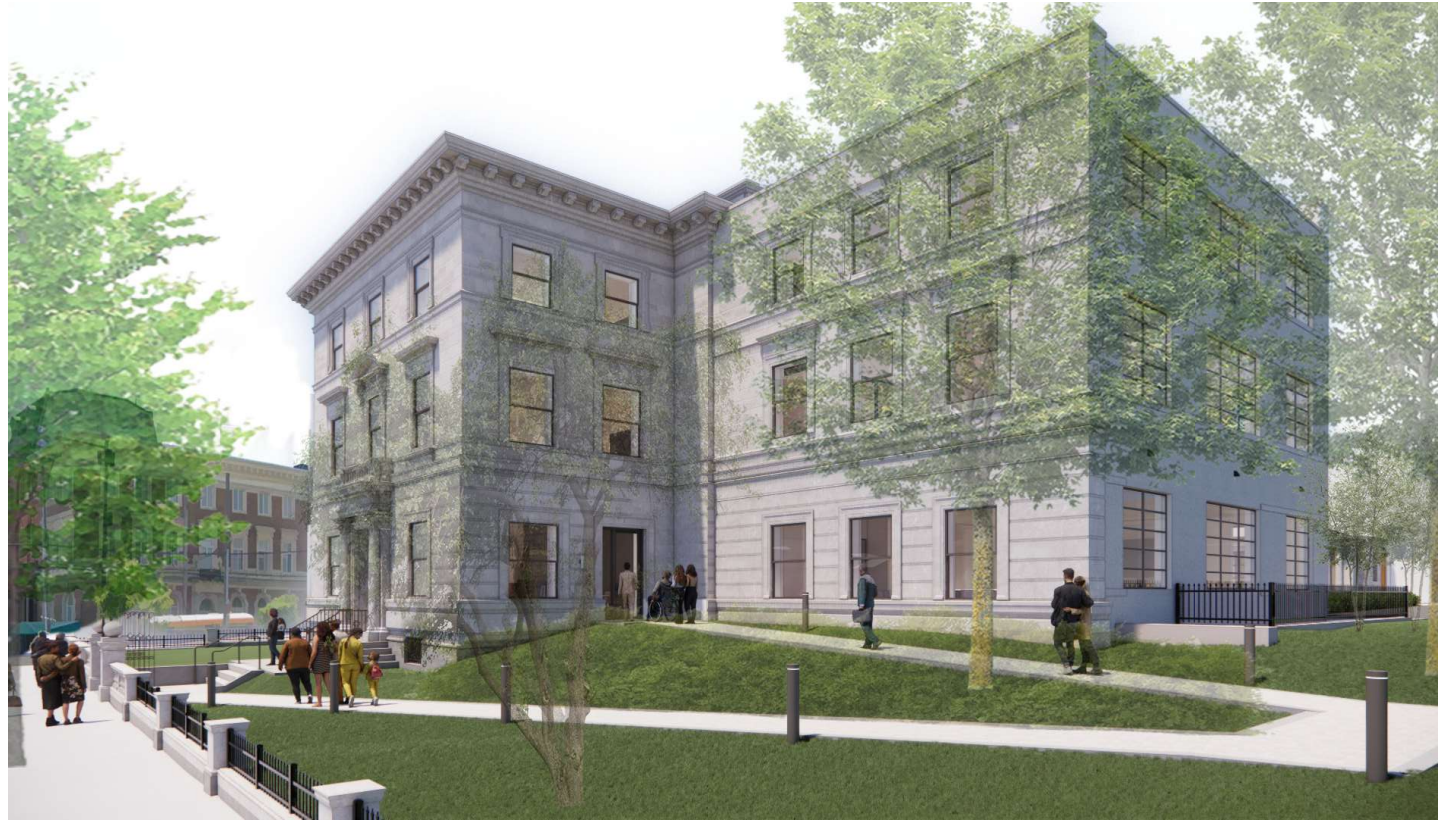
View of Main Entrance from Broad Street Looking Southwest

Proposed Accessible Entrance Notes

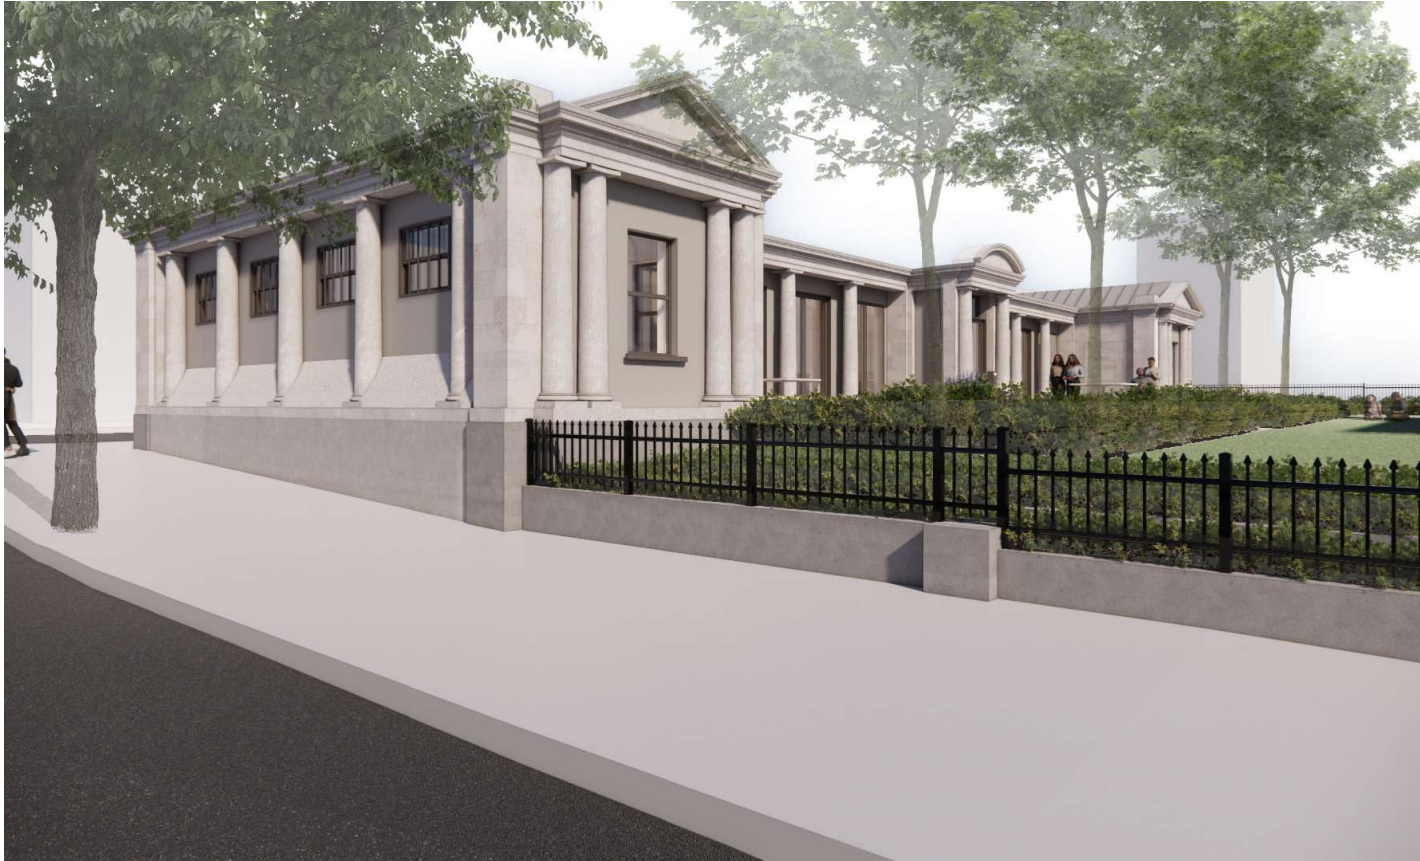
View of Conservatory from Jefferson Street Looking Northwest

- Restore existing stone masonry and stucco; see restoration scope.
- Replace windows to match historic profiles at west, south, and north facades; see elevations for louver locations and infilled windows.
- At east colonnade, enlarge (8) existing window openings to include (4) double doors and (4) full-height windows which were originally plate glass; see windows details.
- Replace existing walkway at east colonnade with paved terrace (approximately 20 feet wide) and landscaping.

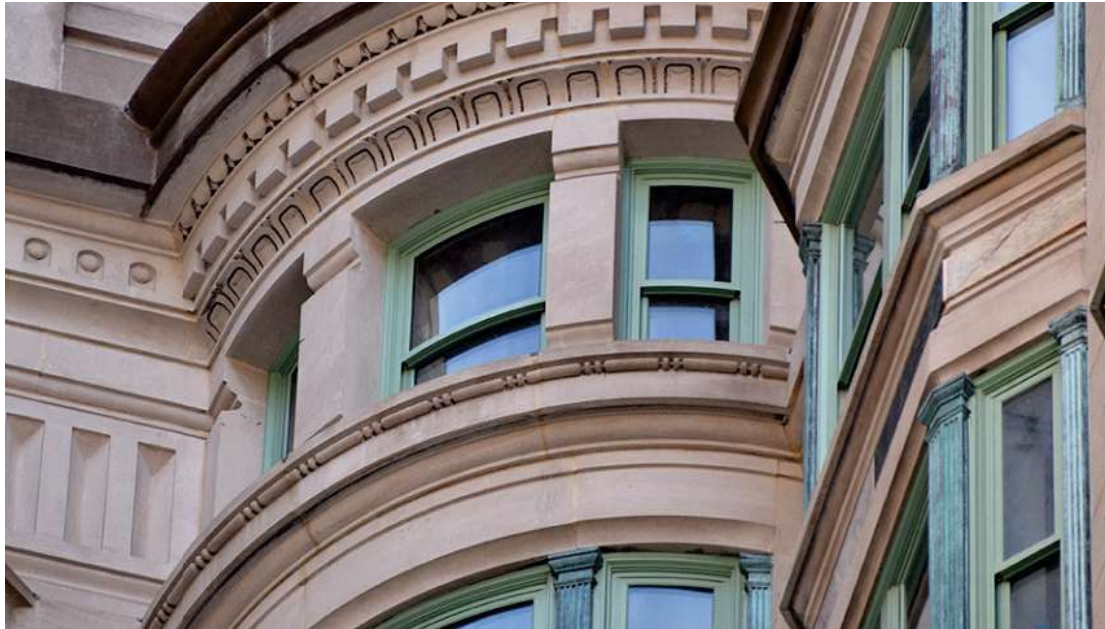
Mansion Windows, similar to Graham S2200 Double Hung with custom trim to match historic profile TBD

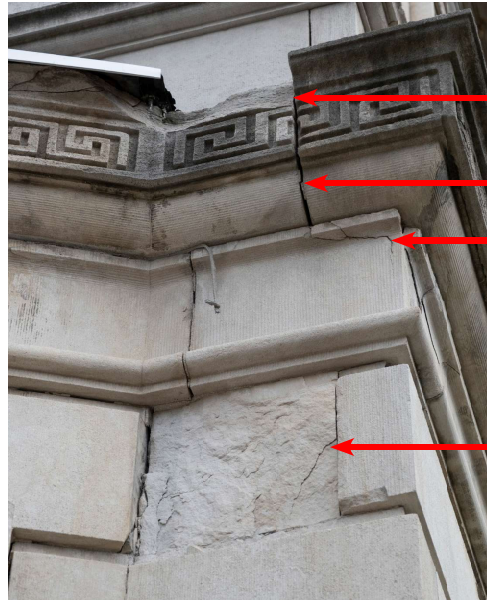
Dutchman repair

Repointing

Crack repair

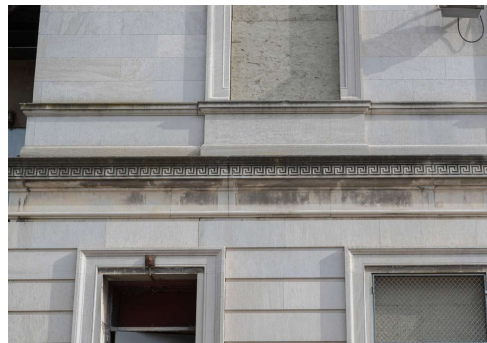
Clean general and heavy soiling

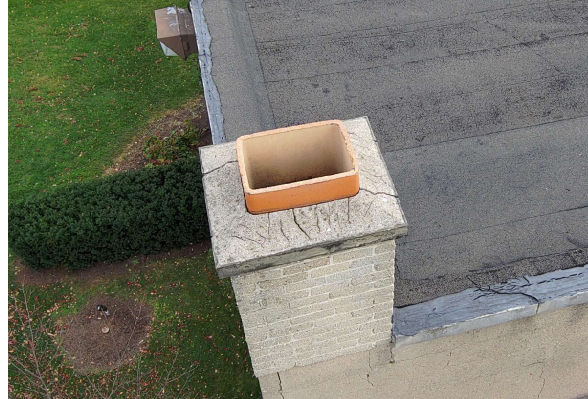
Replace brick wash coat

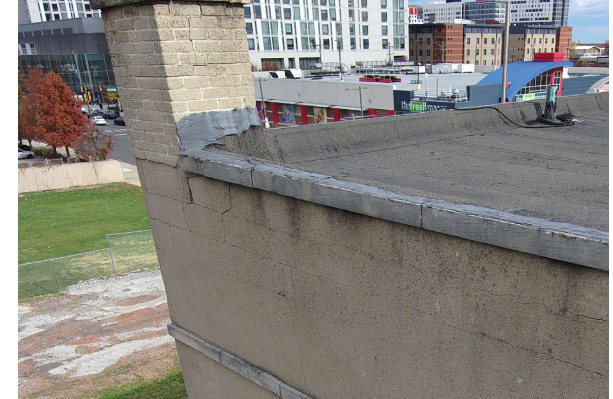
Repair detached stucco

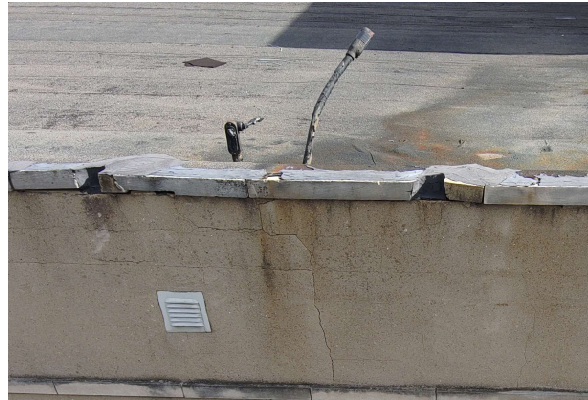
Replace damaged coping stone

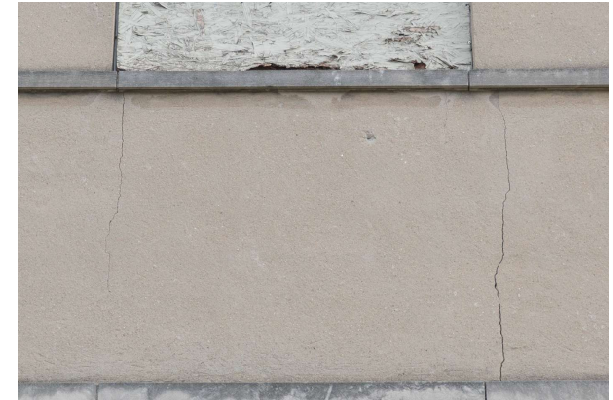
Repair stucco crack

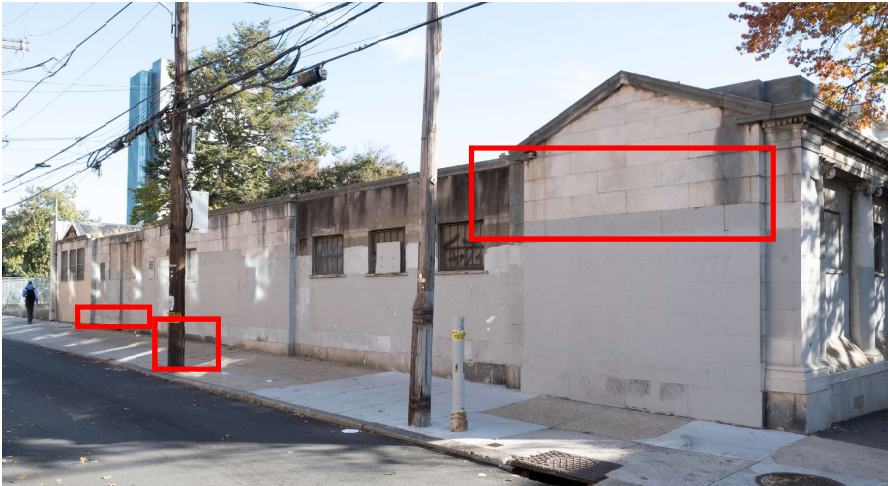
West Elevation - Carlisle Street

- 1 Repairs for conditions causing or allowing water infiltration.
- 2 Repairs for conditions that may lead to life safety issues.
- 3 Repairs for conditions that could lead to further material loss if not addressed.
- 4 Typical repairs:
 - Crack repairs
 - Repointing
 - Dutchman repairs
 - Patching
 - Reset displaced stone units
 - Replace damaged stone units
 - Cleaning
 - Paint removal
 - Stucco repair + mineral silicate coating

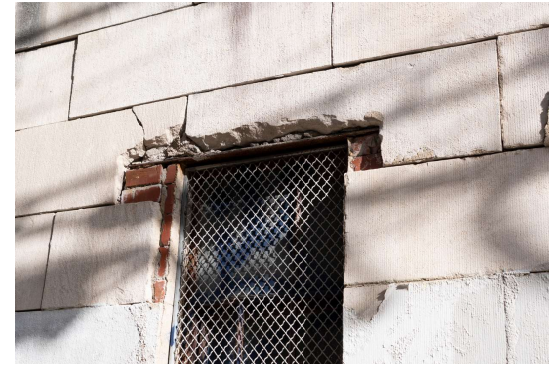
Replace damaged stone units

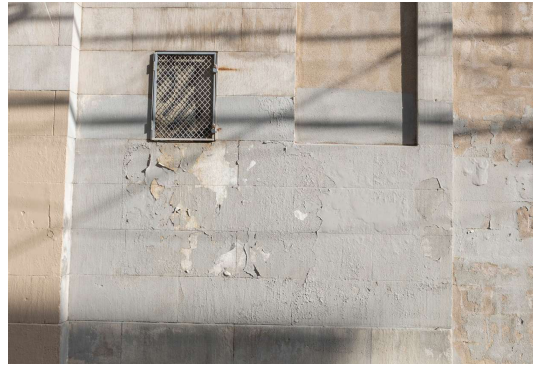
Remove paint

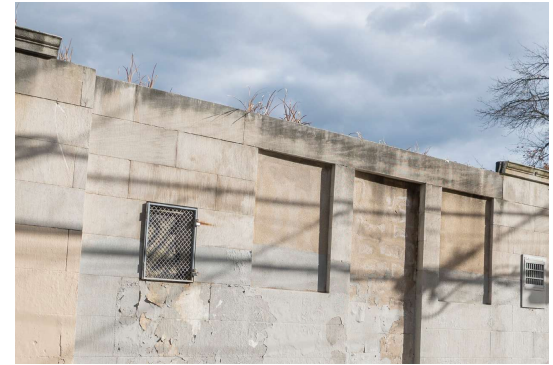
Replace missing cornice

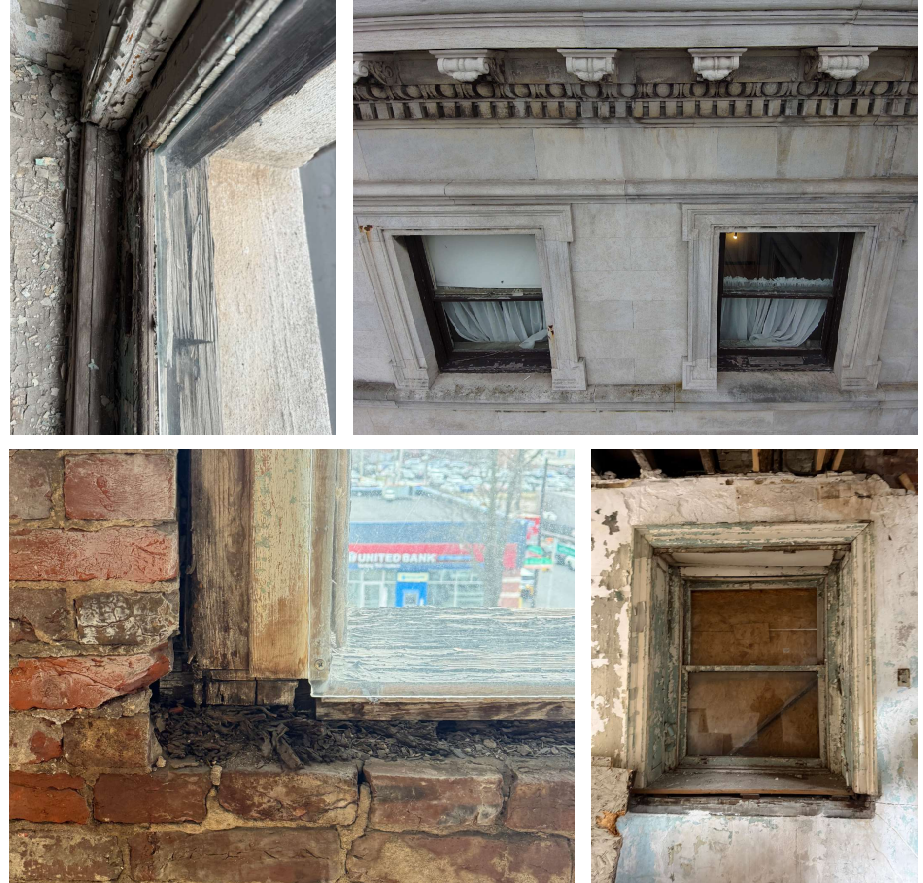
Typical Existing Window Detail at Mansion

Proposed Mansion Window Alteration Notes

- Wood window and wood lintel replacement in Mansion is required due to severe deterioration; window probes are underway to determine head, jamb, and sill conditions at existing masonry wall.
- Replace existing wood lintels at Mansion with steel lintels.
- Replace existing wood windows with thermally broken aluminum windows to match historic profile.

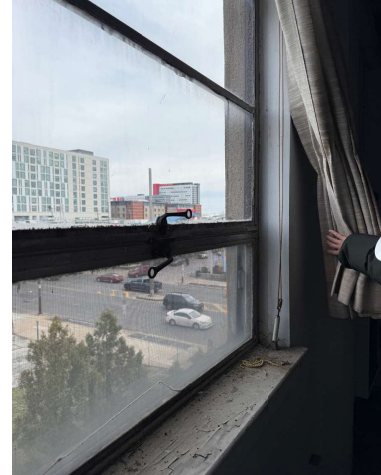
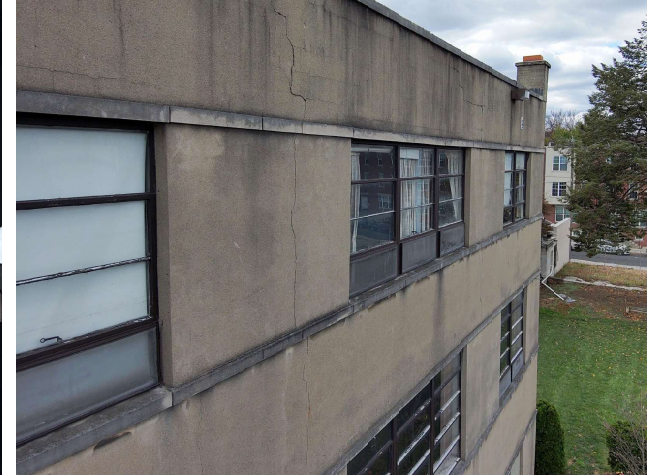
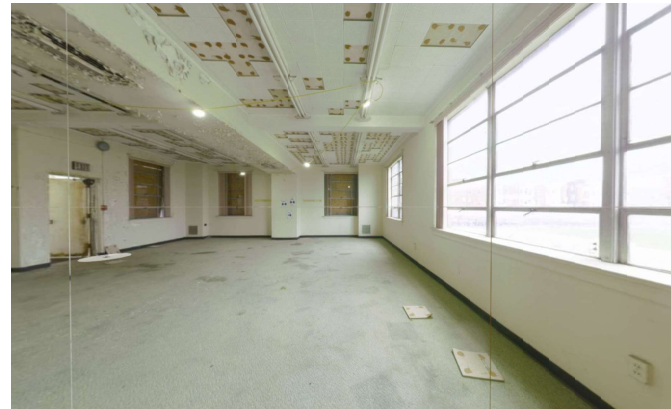
Typical Existing Window Detail at Addition

Proposed Addition Window Alteration Notes

- Aluminum window replacement in Addition is recommended to comply with energy code and maintenance goals of Temple University.
- Refurbish existing steel lintels at masonry wall.
- Replace existing aluminum windows with thermally broken aluminum windows to match historic profile.

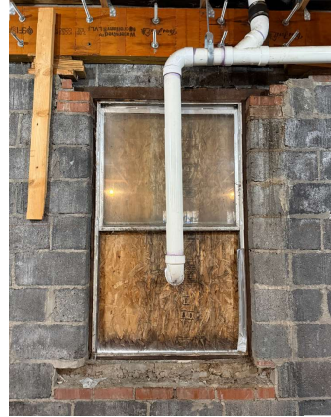
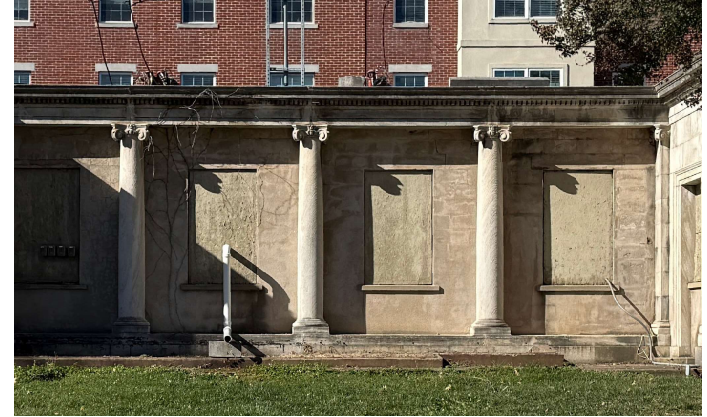
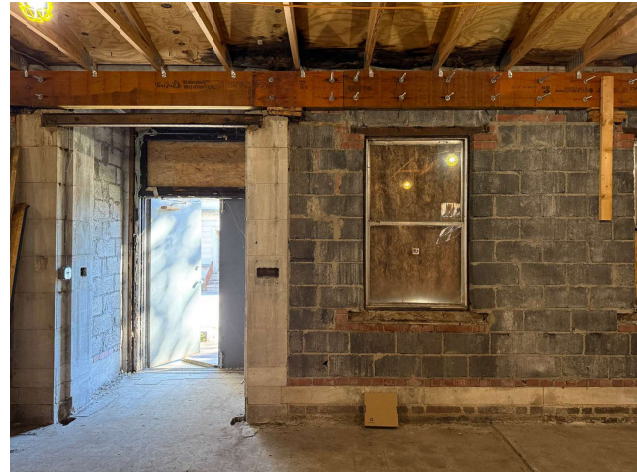
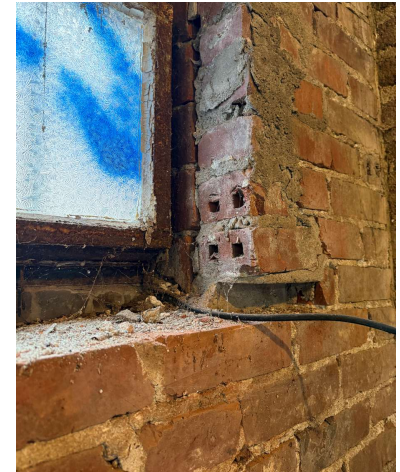
Typical Existing Window Section at Conservatory

Proposed Conservatory Window Alteration Notes

- Wood and aluminum window replacement at Conservatory is recommended due to deterioration of wood, and for aluminum windows to comply with energy code and maintenance goals of Temple University.
- Replace wood lintels with steel lintels at masonry wall; Refurbish existing steel lintels.
- Replace existing wood and aluminum windows with thermally broken aluminum windows to match historic profile.
- Replace (4) aluminum windows with double doors at new terrace; remove stone sill for accessible access.
