**ADDRESS: 1601 MOUNT VERNON ST**

Proposal: Amend approval of façade materials

Review Requested: Final Approval

History: 1859; Robert Purvis House; storefront, 1920

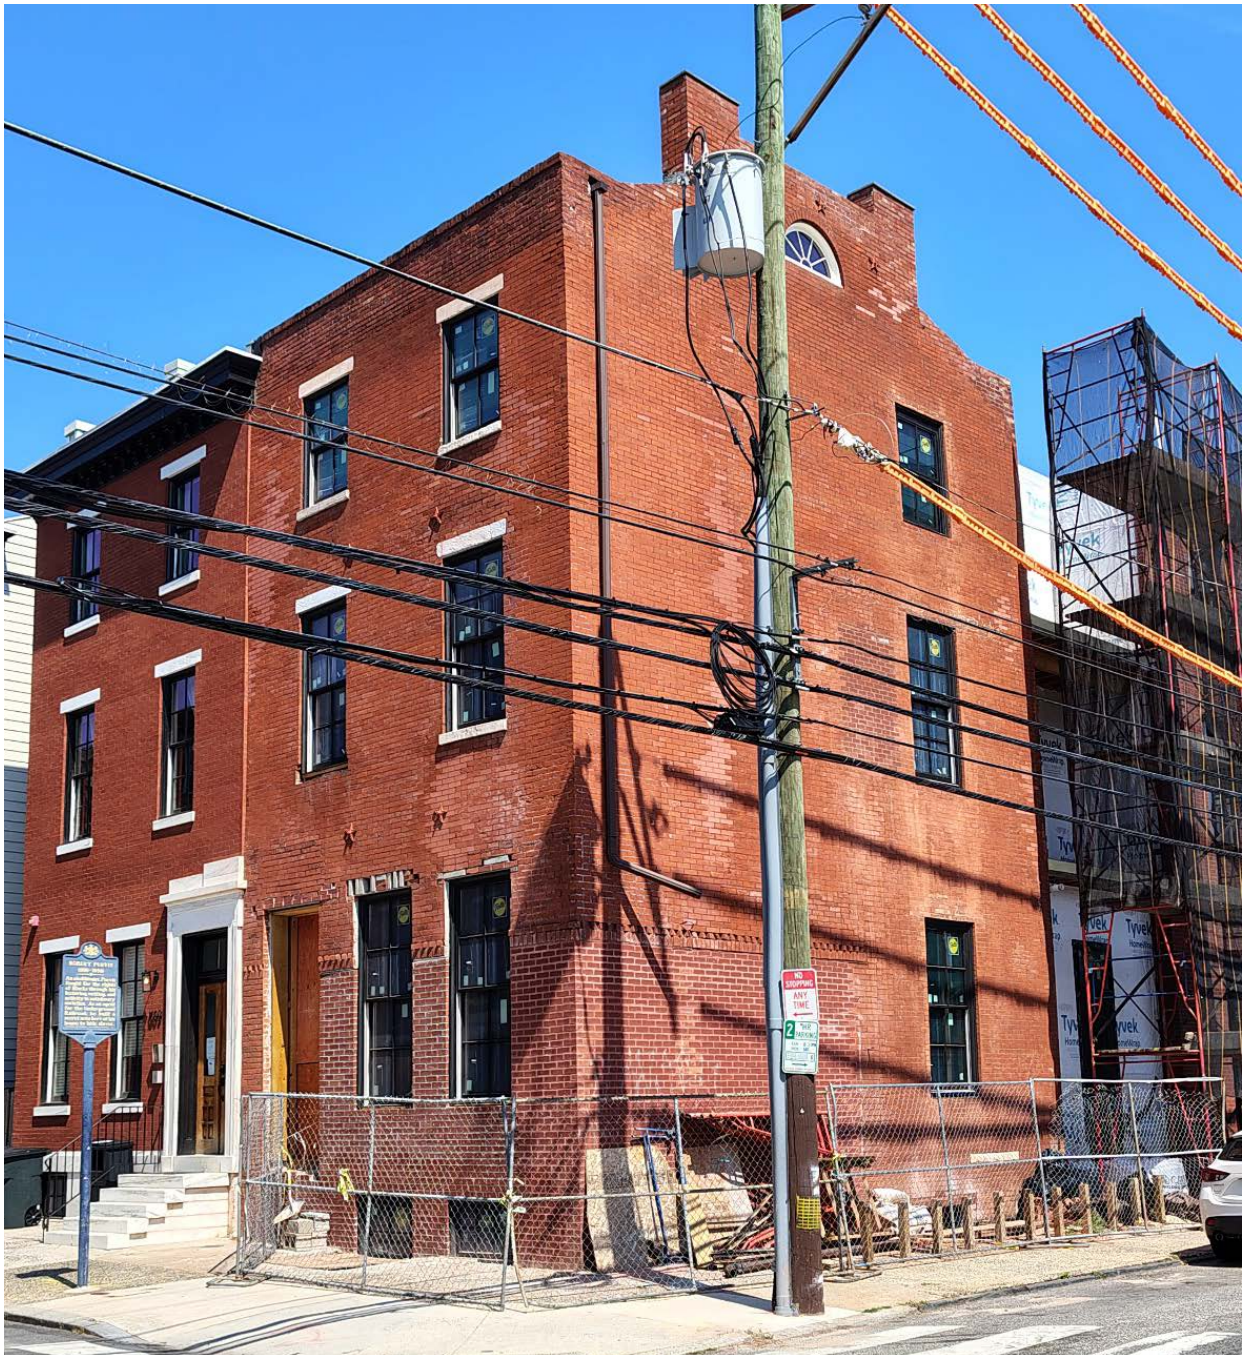
Figure 1: Current South (primary) façade and east façade under rehabilitation.

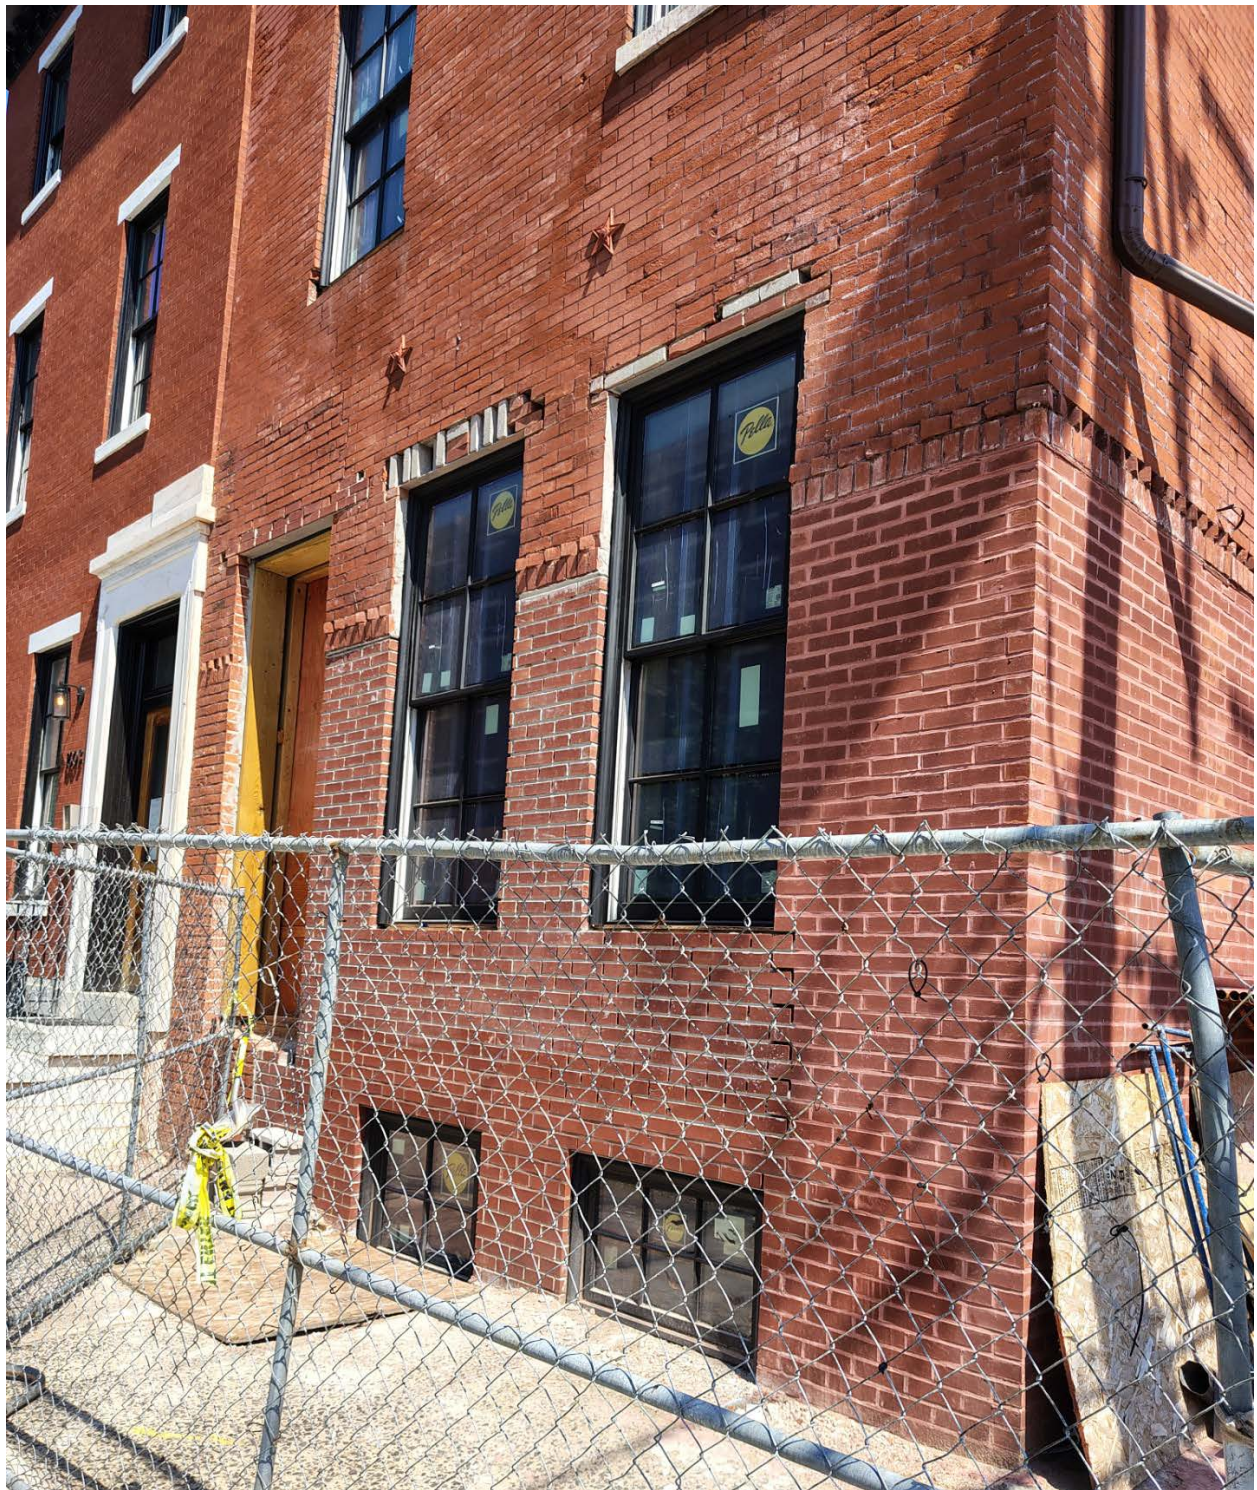
**Figure 2: Current first floor restoration under construction.**

- o The only remaining portion of the original building, the main block, had a storefront installed c. 1920. That intervention removed the original entryway and marble stoop. Two large openings for storefront windows were cut into the masonry on the front façade and side wall at the first story, and a new corner entrance was constructed.
