**ADDRESS: 1018 WINTER ST**

Proposal: Demolish and reconstruct upper floors with roof deck

Review Requested: Final Approval

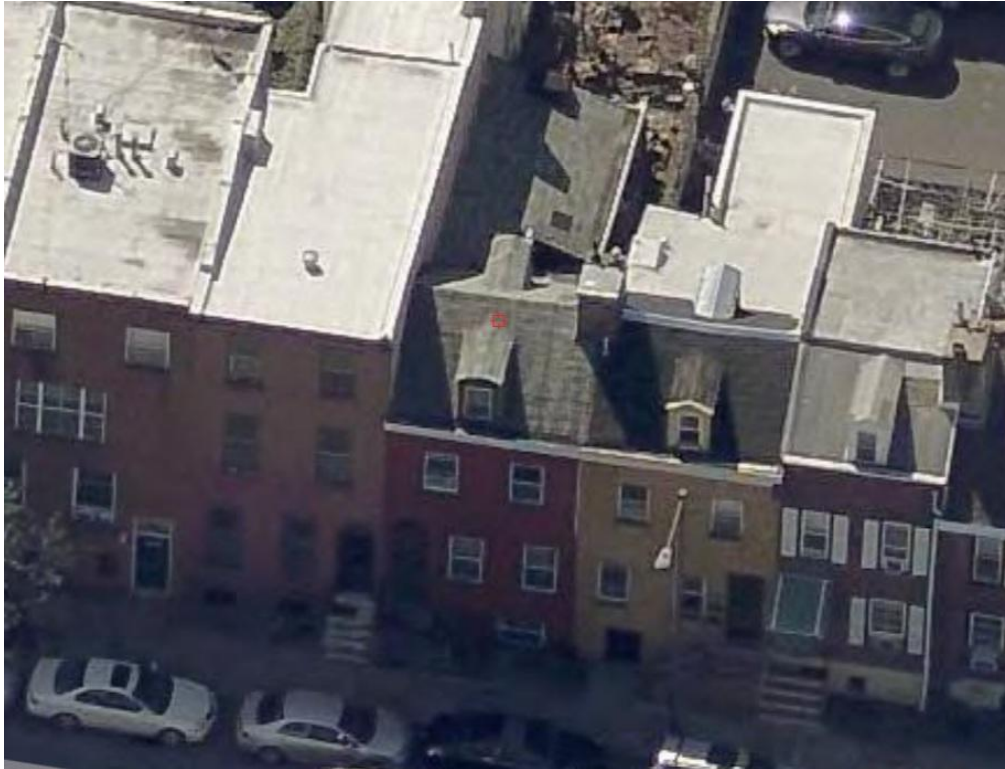
**Image 3:** Rear photograph of property. The rear of the building is not visible from the public right-of-way. The rear of property can only be viewed through private parking lots. *Historical Commission staff, 2026.*

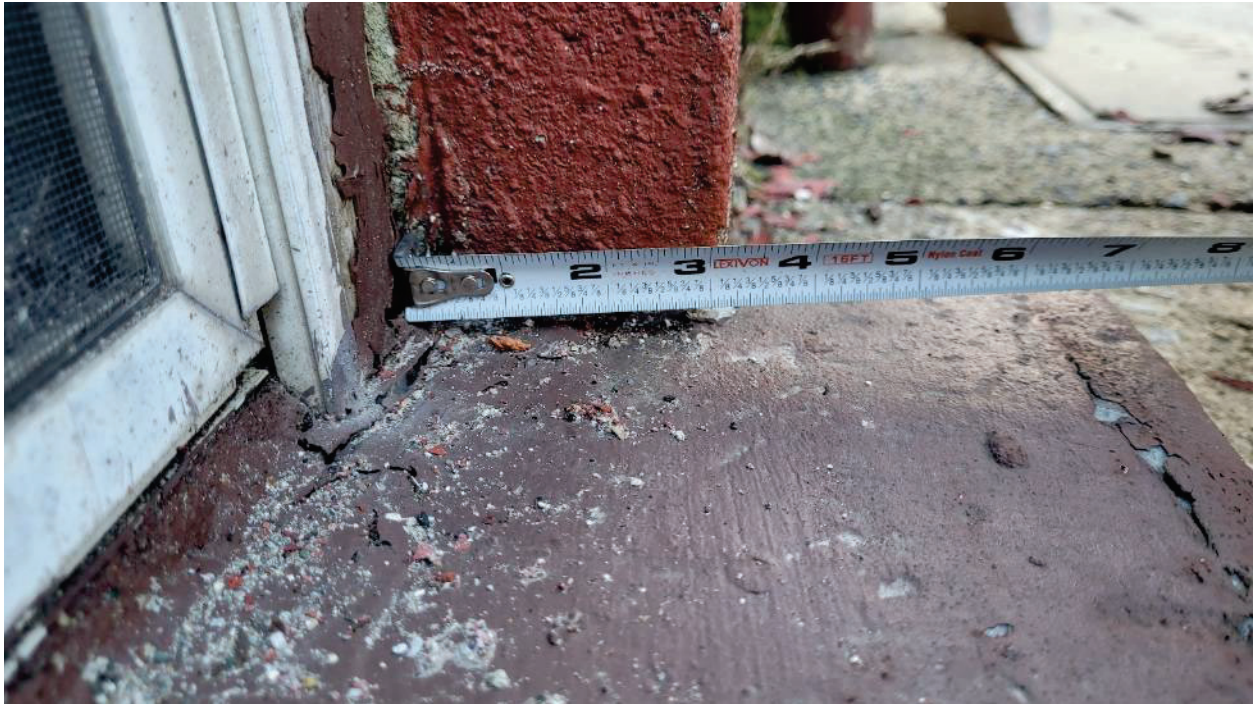
**Photo No. 6. View of the measured distance from the basement window frame to the front wall at the bottom of the window (approximately 3-1/8 inches)**

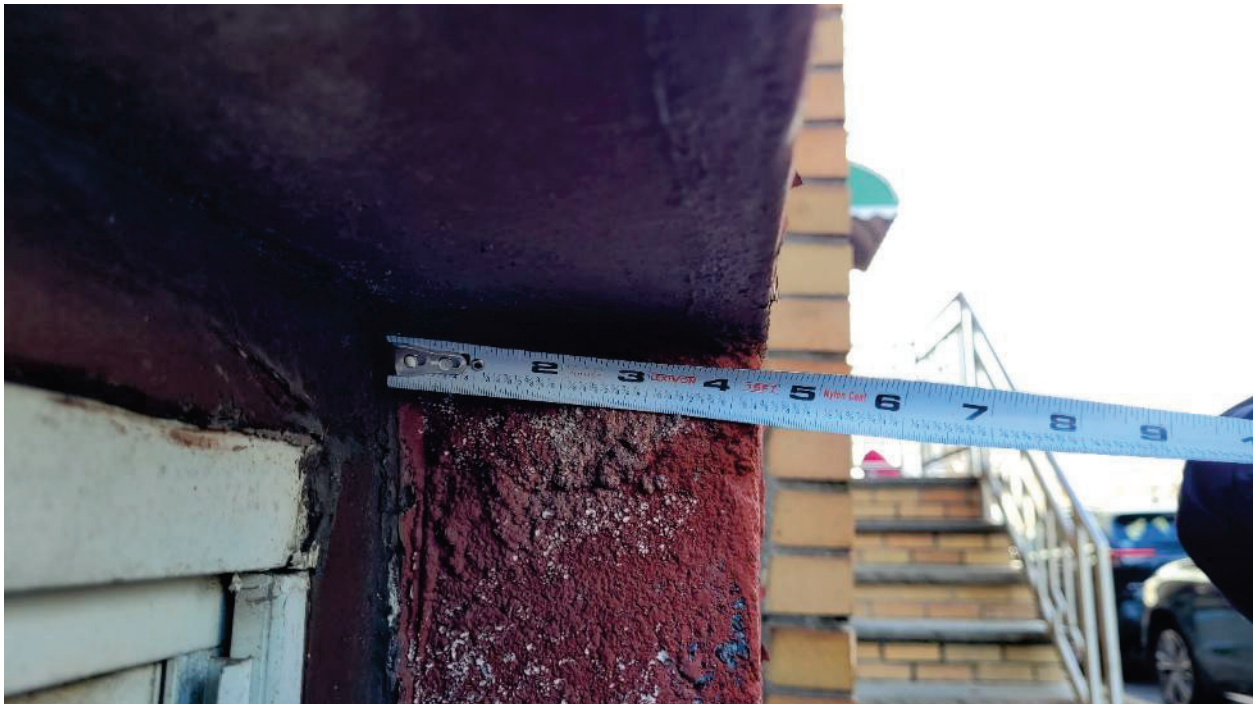
**Photo No. 7. View of the measured distance from the basement window frame to the front wall at the top of the window (approximately 4-1/4 inches)**

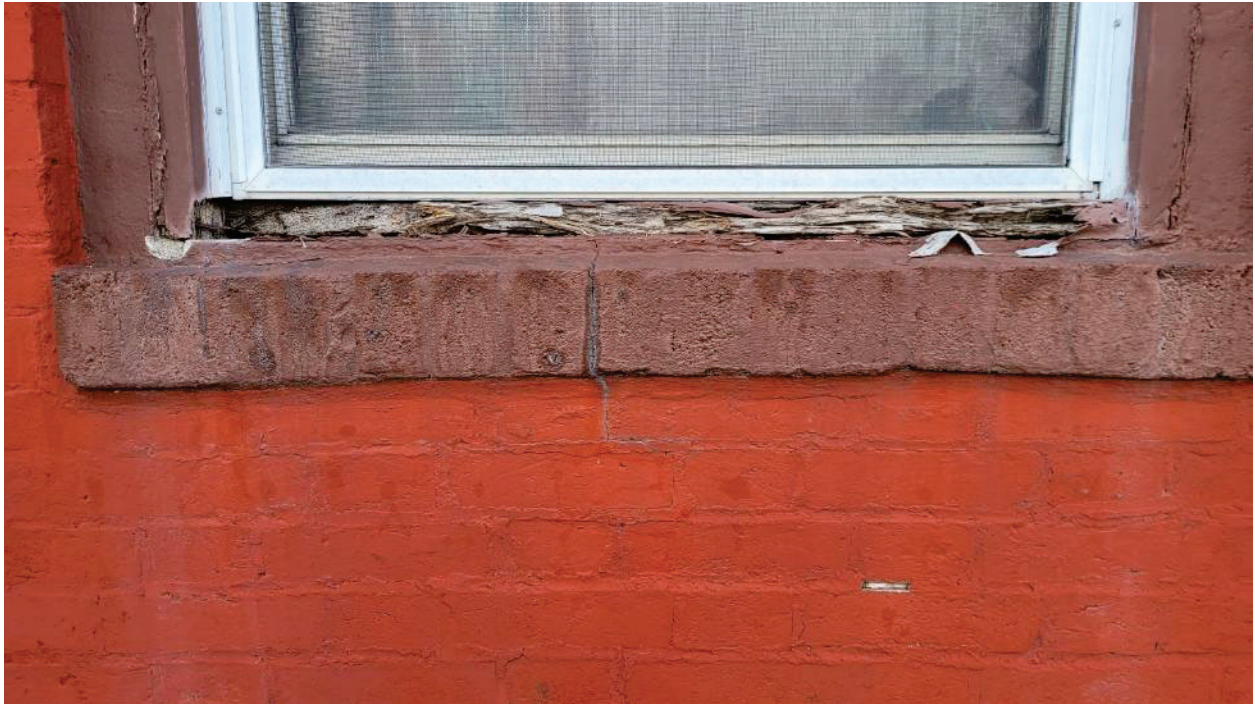
**Photo No. 8. View of the cracked and sagging 1<sup>st</sup> floor windowsill**

- b. The windowsill of the front 1<sup>st</sup> floor window is noted to be sagging and exhibits cracking (see Photo No. 8).
  - c. The brick masonry of the front façade is noted to have multiple decrepit and deteriorated sections throughout (see Photo No. 9-11).

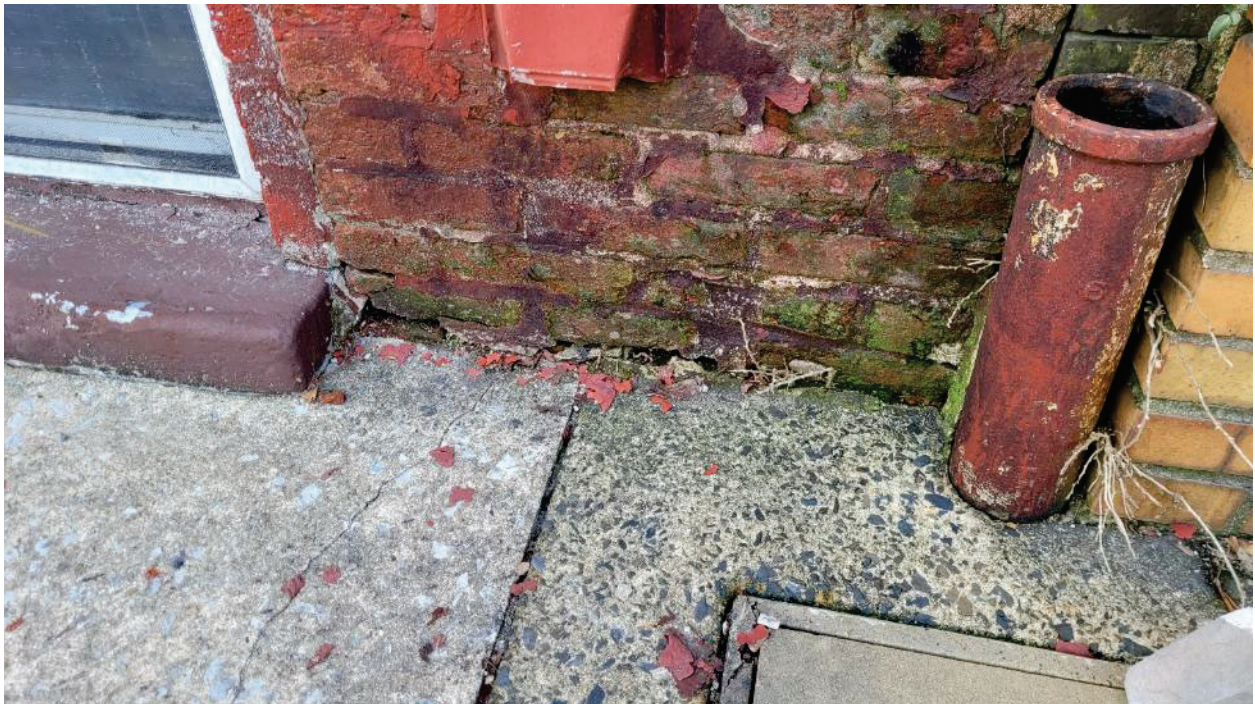
**Photo No. 9. View of the decrepit and deteriorated brick masonry throughout the front  
façade**

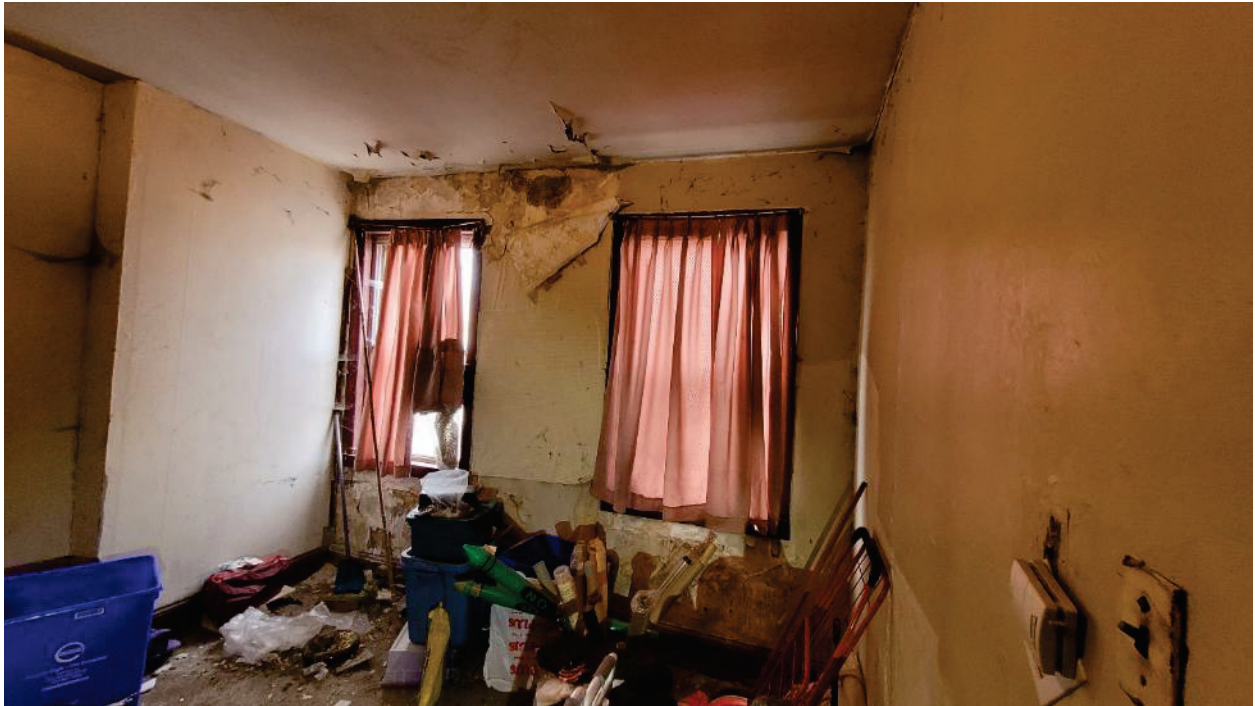
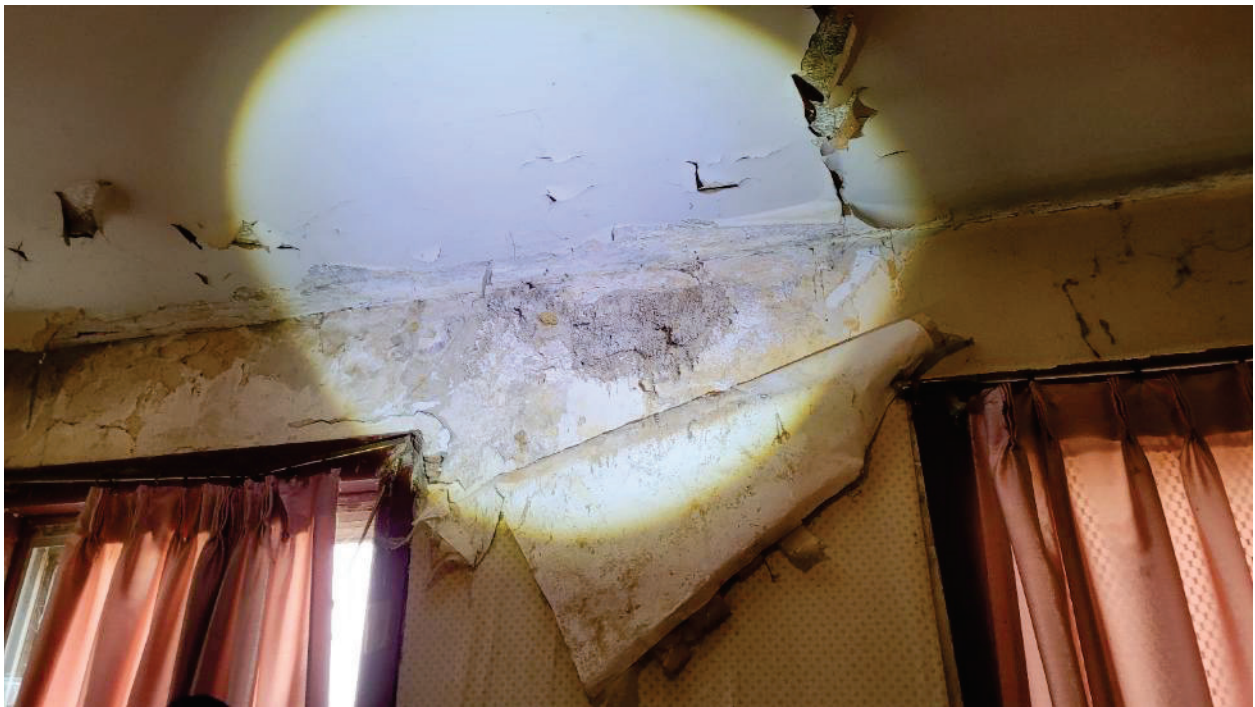
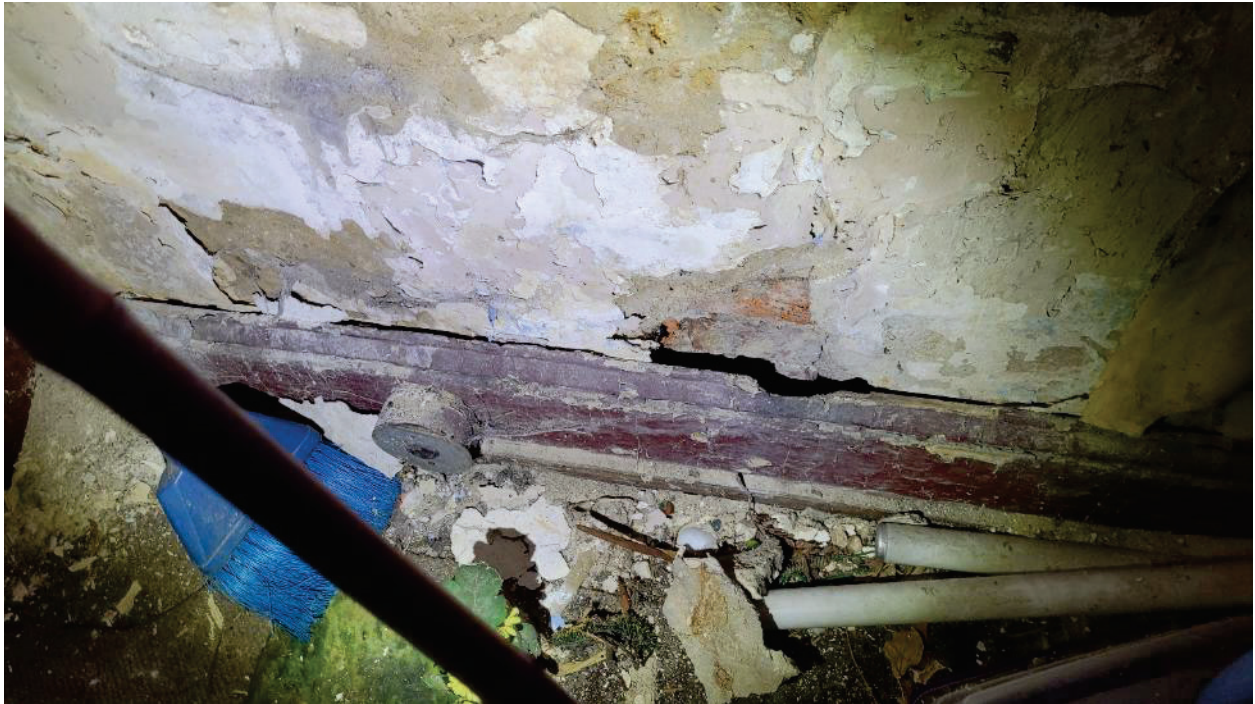
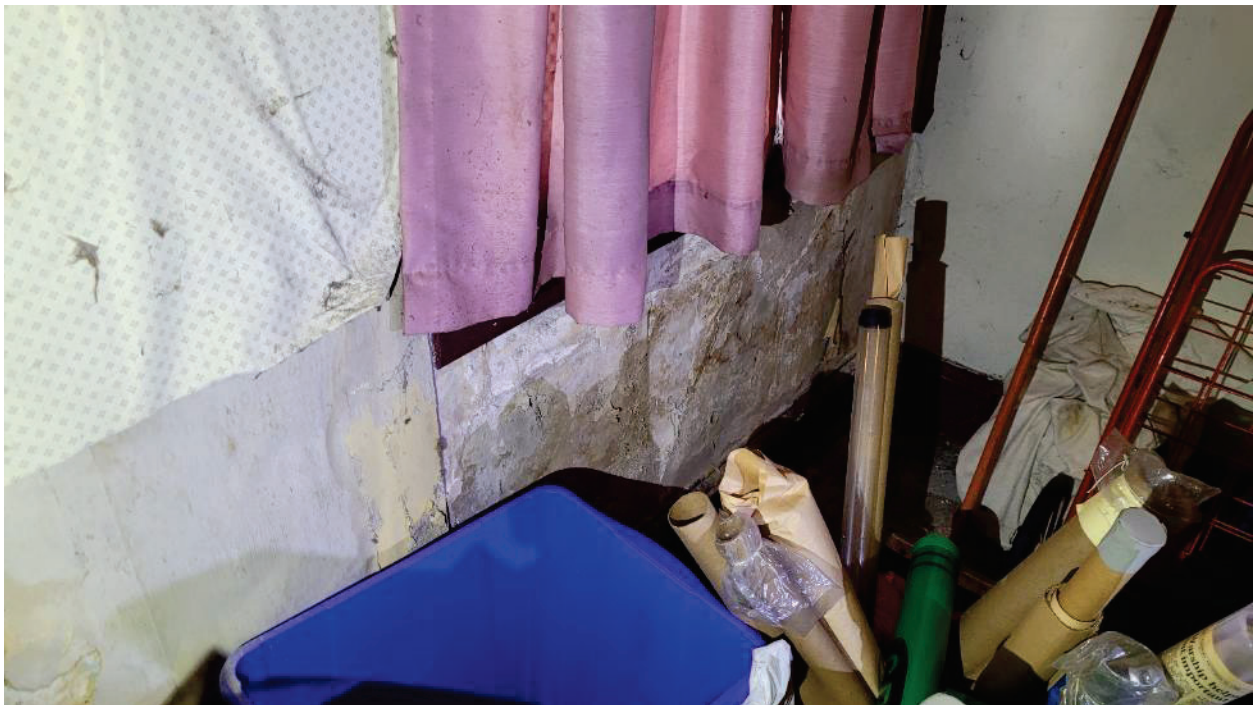
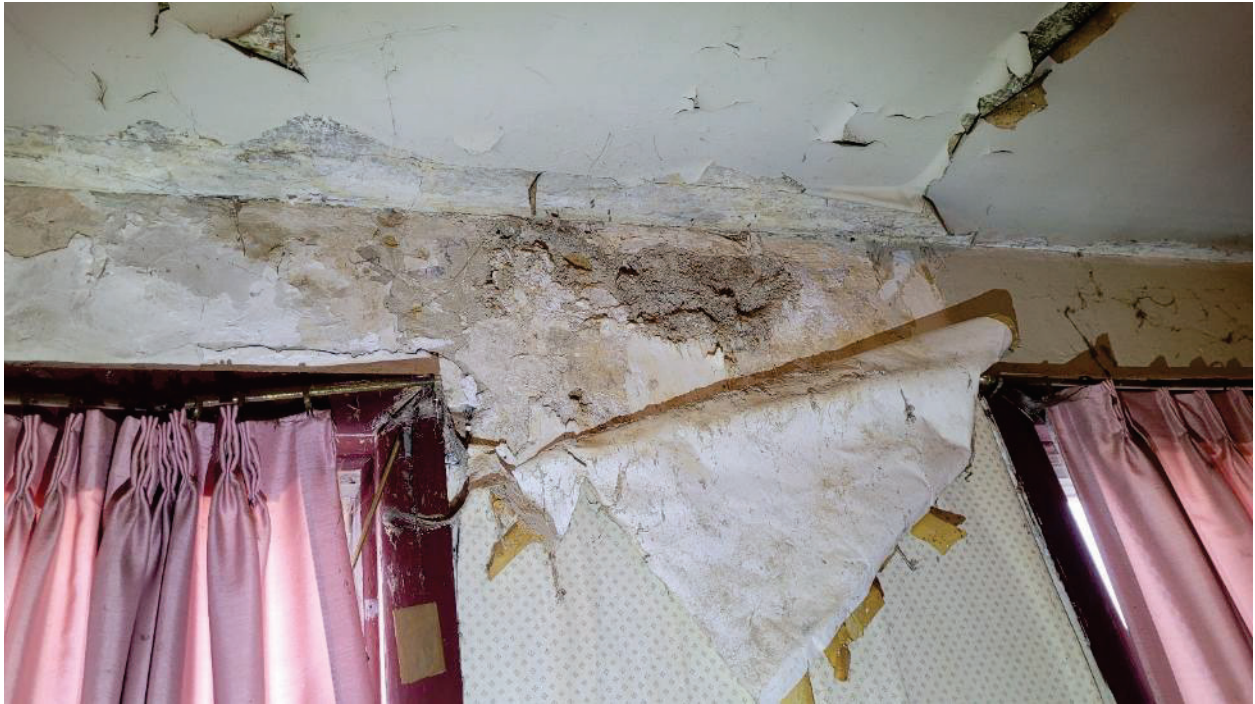
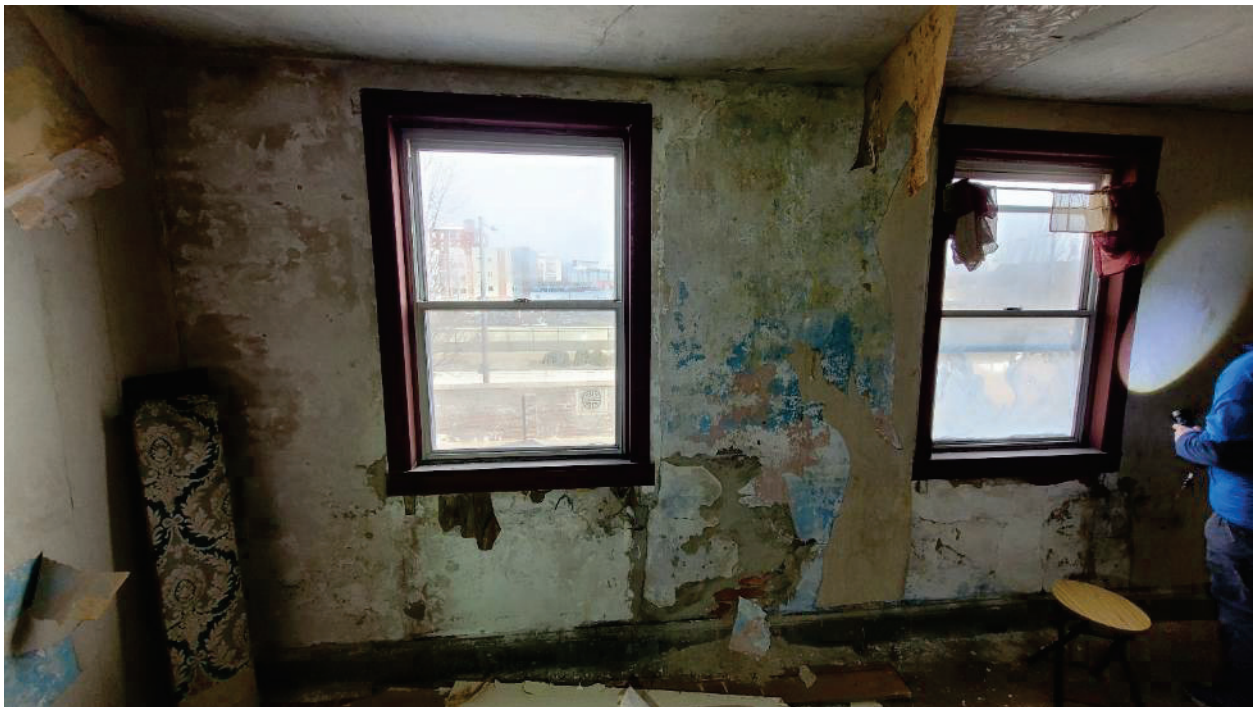
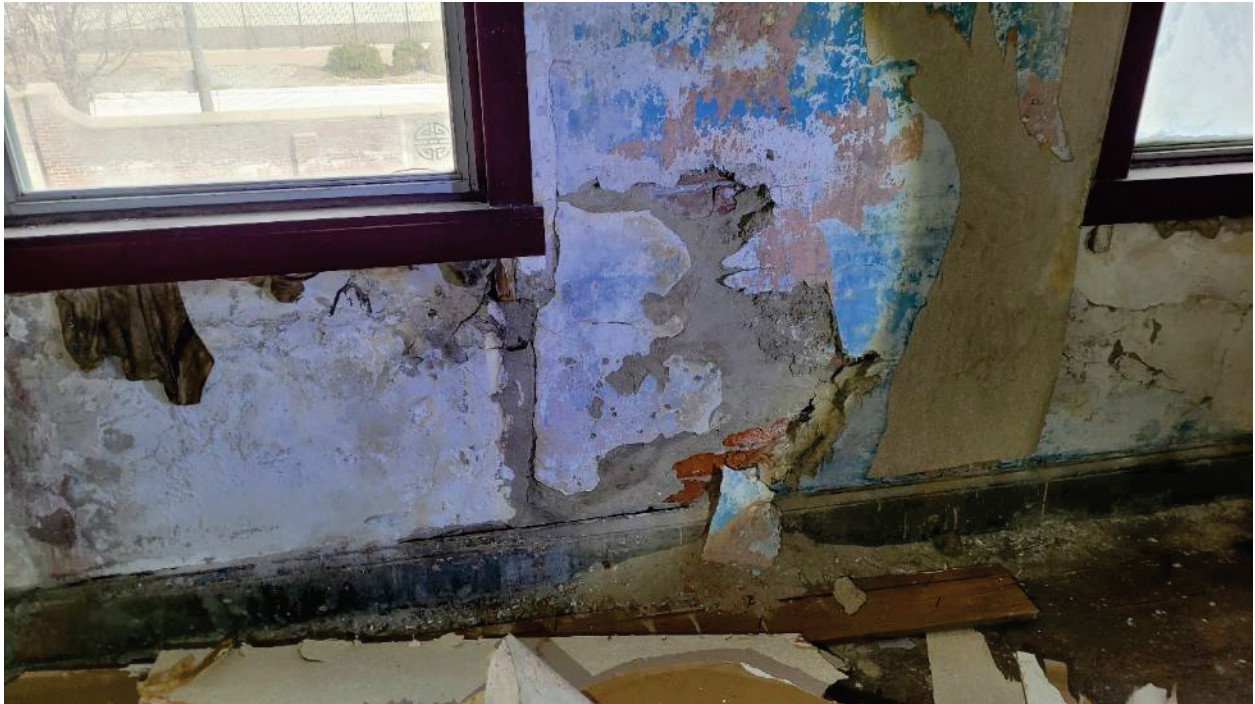
- d. The interior plaster of the front wall is noted to have multiple deteriorated sections throughout, consistent with ongoing water infiltration (see Photo No. 12-18).

**Photo No. 13. View of the deteriorated interior plaster of the 1<sup>st</sup> floor front wall**

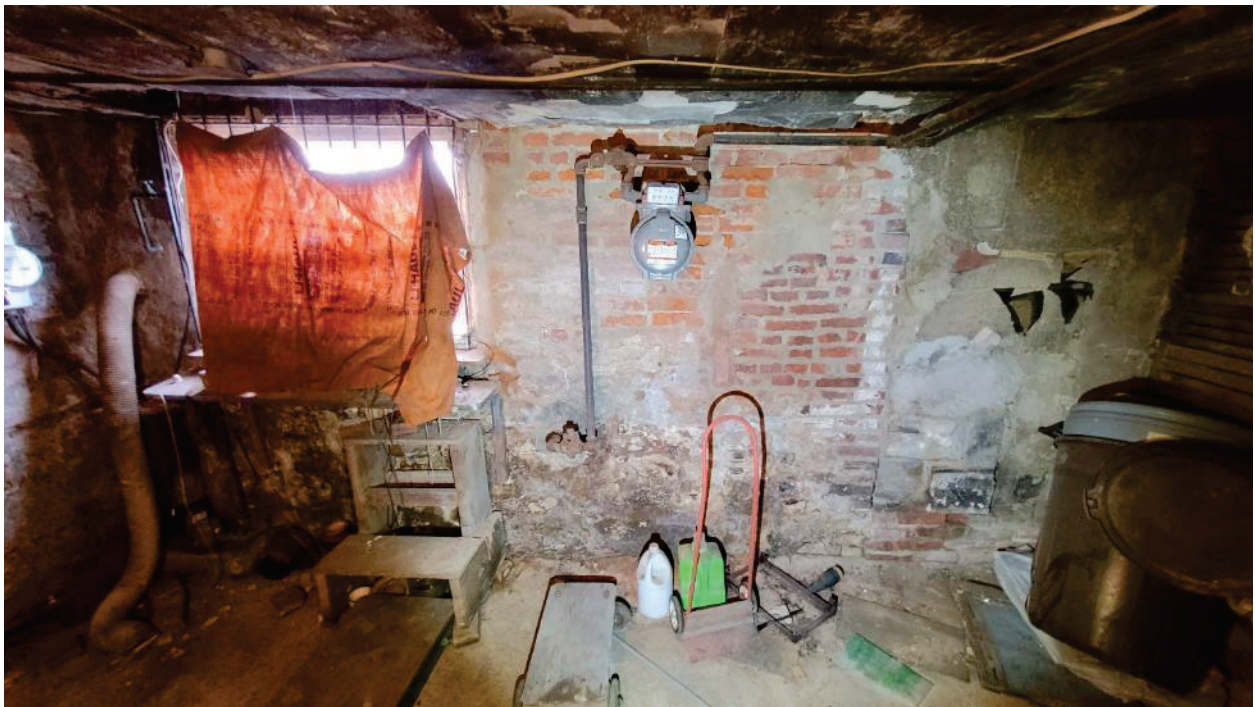
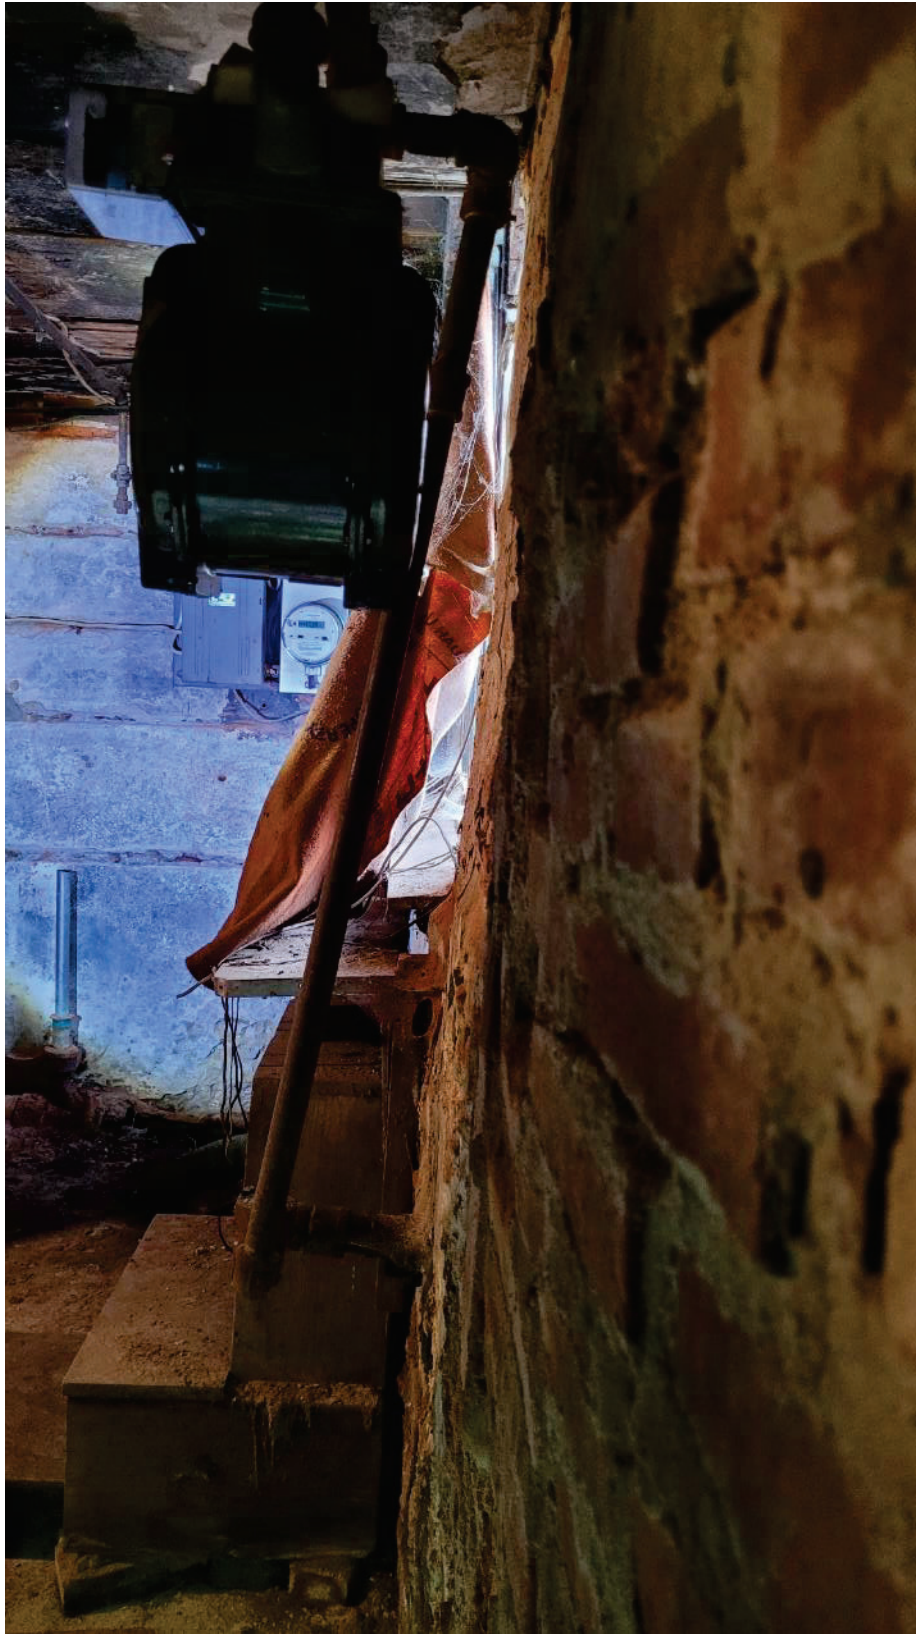
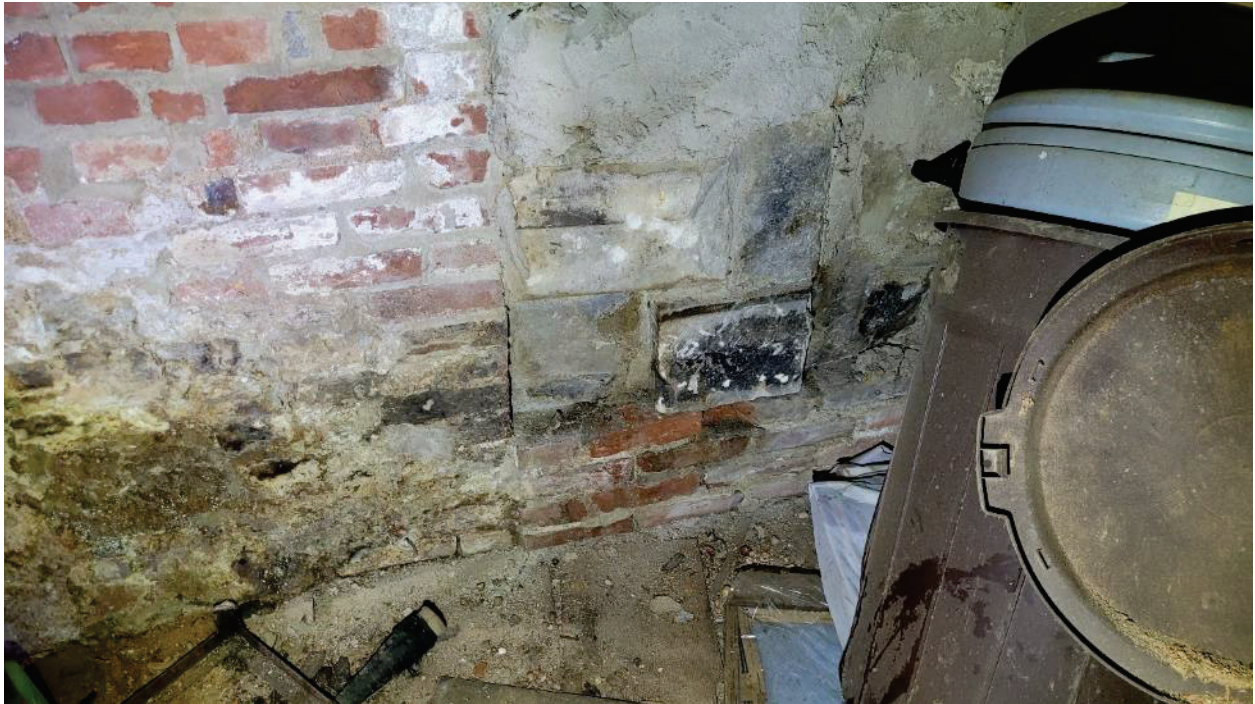
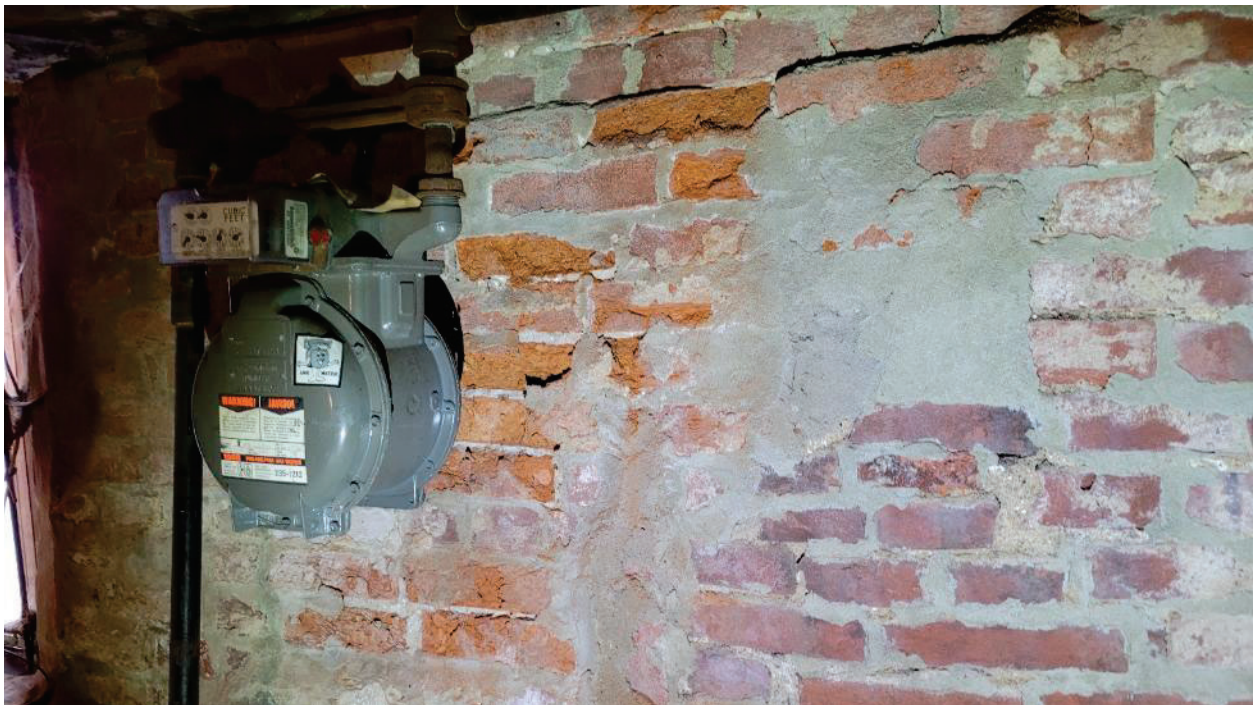
- e. The front foundation wall of the building is noted to be significantly leaning and has multiple deteriorated sections throughout (see Photo No. 19-22).

**Photo No. 20. View of the significant leaning of the front foundation wall**

1. The front wall of the building is noted to have star bolts already installed. However, the front wall is noted to be significantly leaning (see Photo No. 2-5). It is recommended that the front wall be fully demolished and reconstructed, including the front foundation wall.

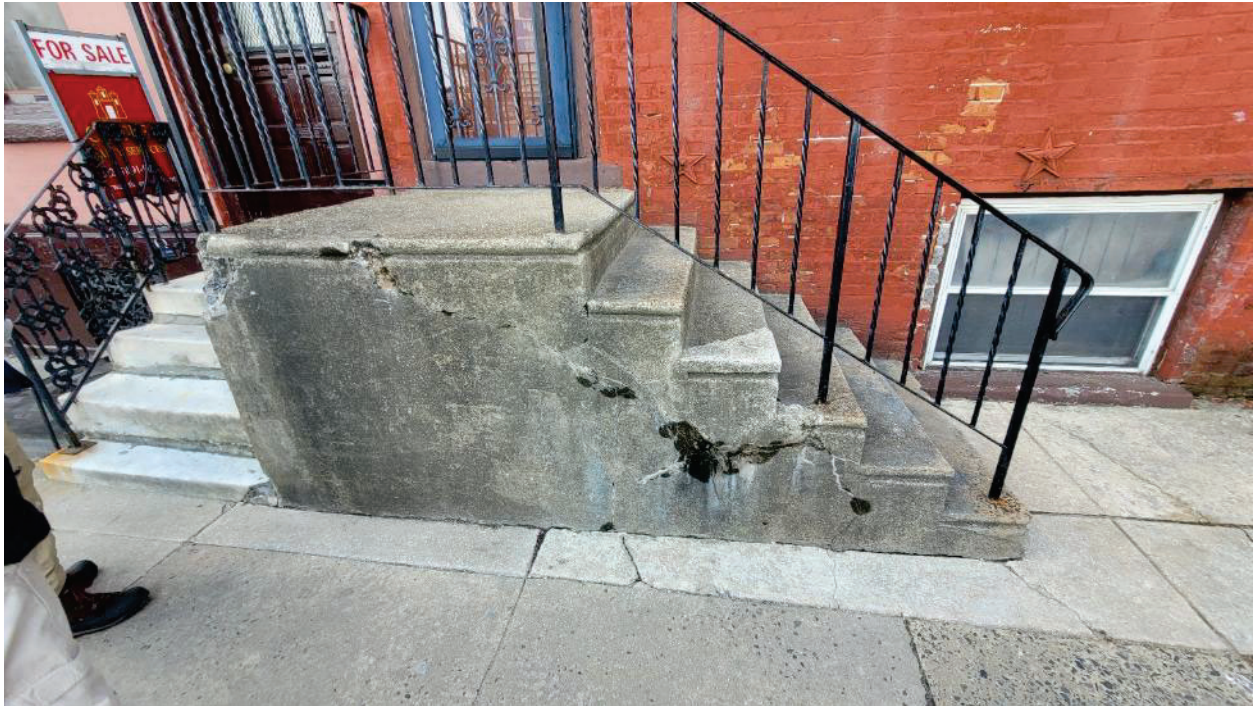
**Photo No. 23. View of the concrete steps at the front door with section loss and cracking throughout**

2. The concrete steps at the front door are noted to have section loss with cracking throughout (see Photo No. 23). It is recommended that the front concrete steps be removed and replaced.

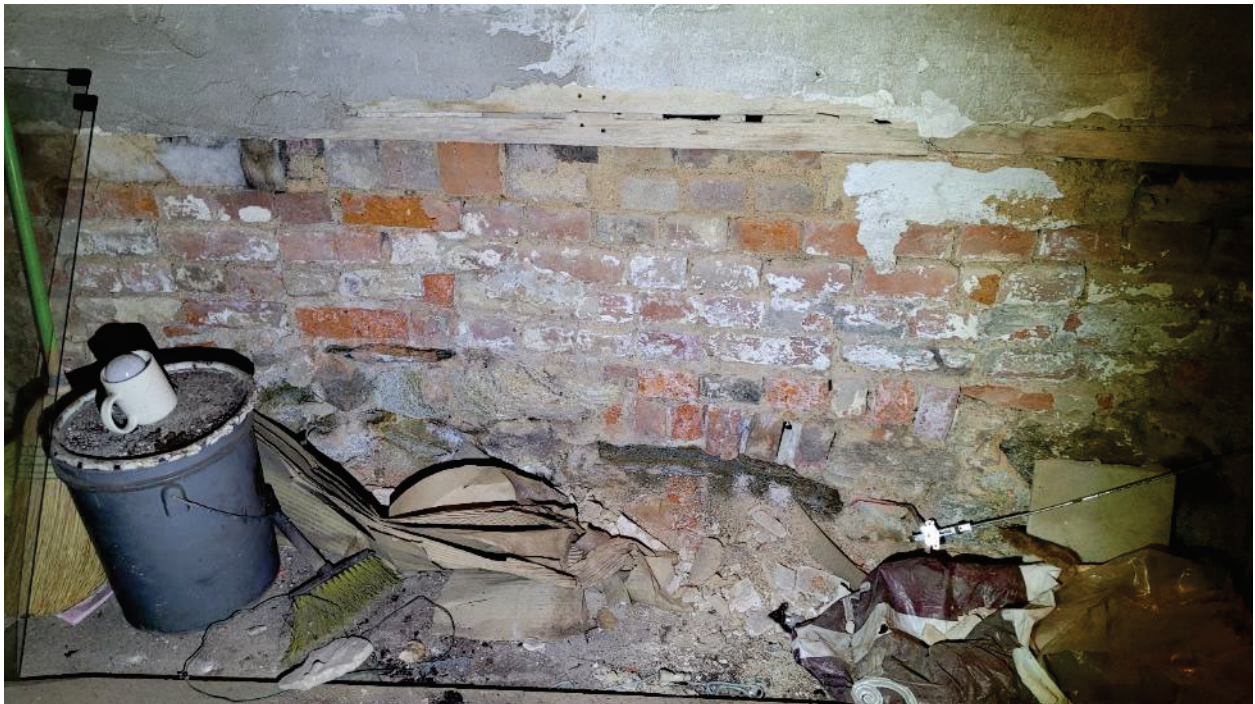
**Photo No. 24. View of the decrepit foundation wall of the side load-bearing walls**

3. The foundation of the side load-bearing walls is noted to be decrepit (see Photo No. 24). It is recommended that the decrepit foundation walls be repointed and parged.

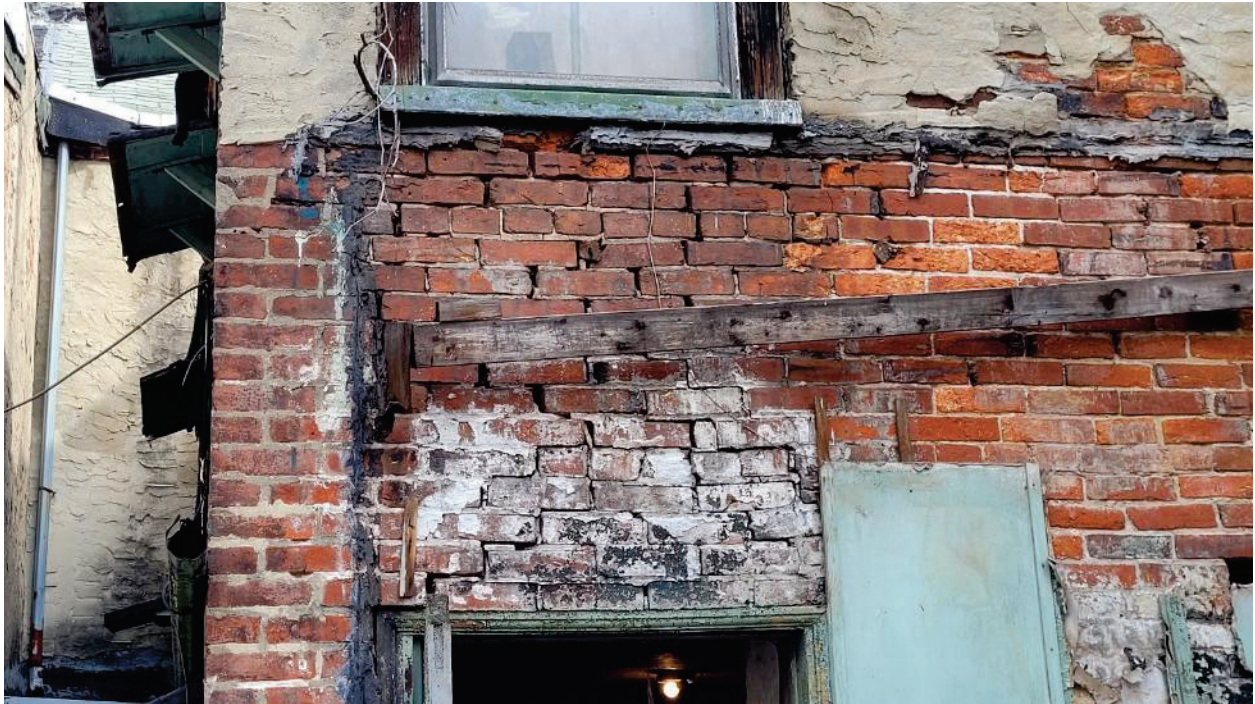
**Photo No. 25. View of the decrepit exterior brick masonry of the rear wall**

4. The exterior brick masonry of the rear wall is noted to be decrepit, it appears to be missing a structural header above the opening (see Photo No. 25). It is recommended that the brick masonry be repaired and proper header installed. All window and door openings should be verified for proper header.

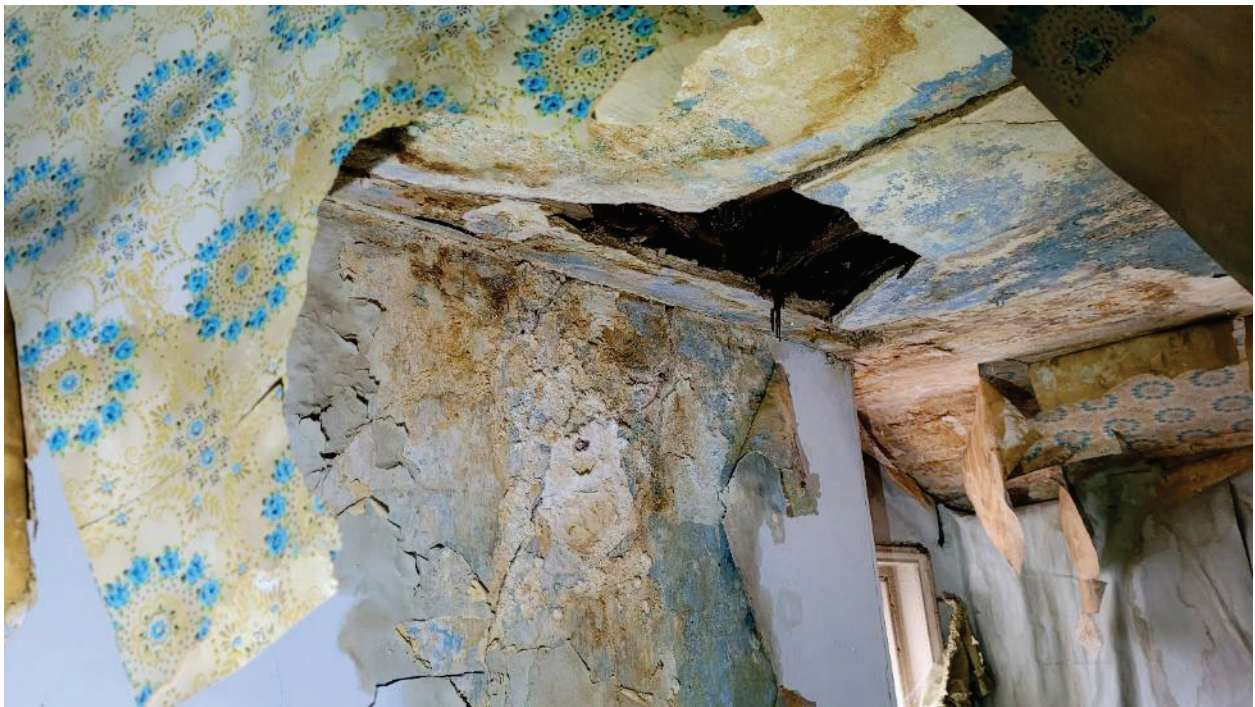
**Photo No. 26. View of the rotted roof along the rear of the building**

5. The roof along the rear of the building is noted to have significantly rotted due to water infiltration (see Photo No. 26). It is recommended that the rotted roof framing be locally removed and replaced, and the roof made weather-tight.

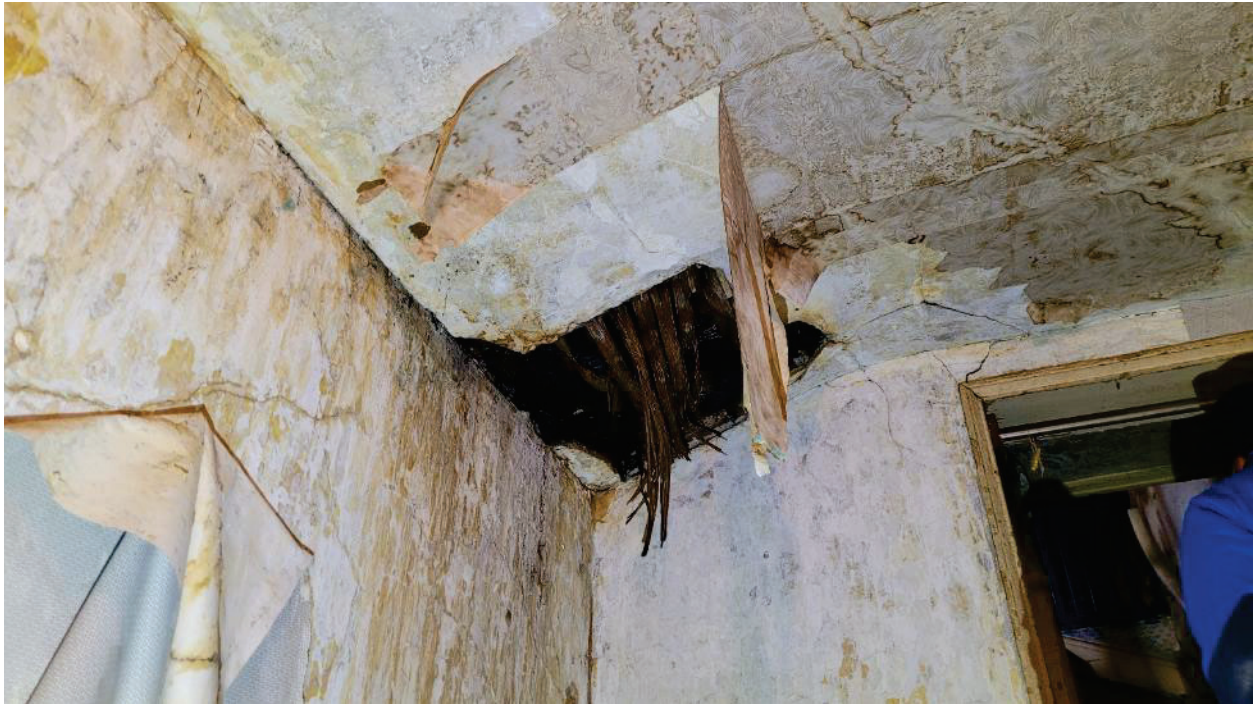
**Photo No. 27. View of the rotted roof along the middle of the building, above the interior staircase**

6. The roof along the middle portion of the building, above the interior staircase, is noted to have significantly rotted due to water infiltration (see Photo No. 27). It is recommended that the rotted roof framing be locally removed and replaced, and the roof made weather-tight.

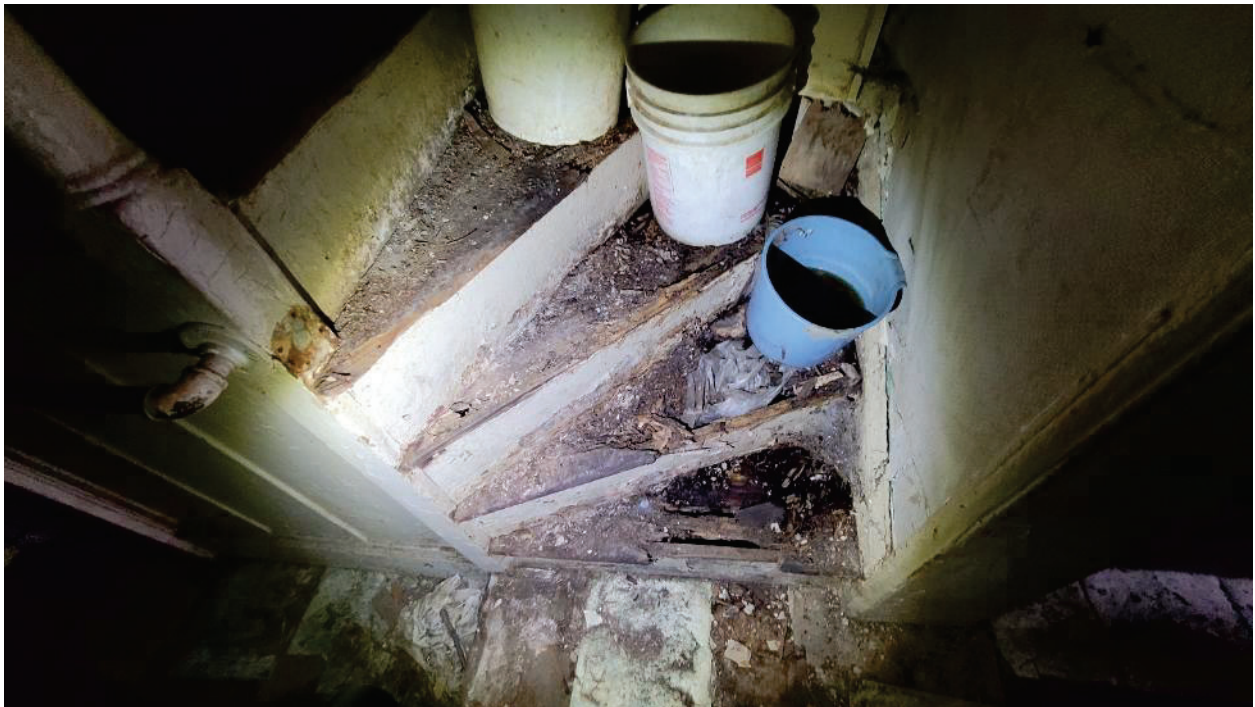
**Photo No. 28. View of the significantly rotted staircase due to prolonged water exposure**

- a. The staircase beneath this area is noted to have significantly rotted due to prolonged water exposure (see Photo No. 28). It is recommended that the rotted staircase be removed and replaced.
7. Attic roof framing appears to be sagging and is likely undersized, replacement of roof framing is recommended
8. Staircases throughout are noted be structurally inadequate due to undersized framing, it is recommended that all staircase framing be replaced
9. Floor framing is noted to be sagging or structurally inadequate in many locations. It is recommended that all floor framing be addressed, replacement needed in many locations and sistering of the rest.
  - a. 1<sup>st</sup> floor rear floor framing is partially collapsed
  - b. 2<sup>nd</sup> floor bathroom floor framing appears to be severely deteriorated
