Feasibility Study
of the
Royal Theater
for
Universal Companies

January 17, 2007

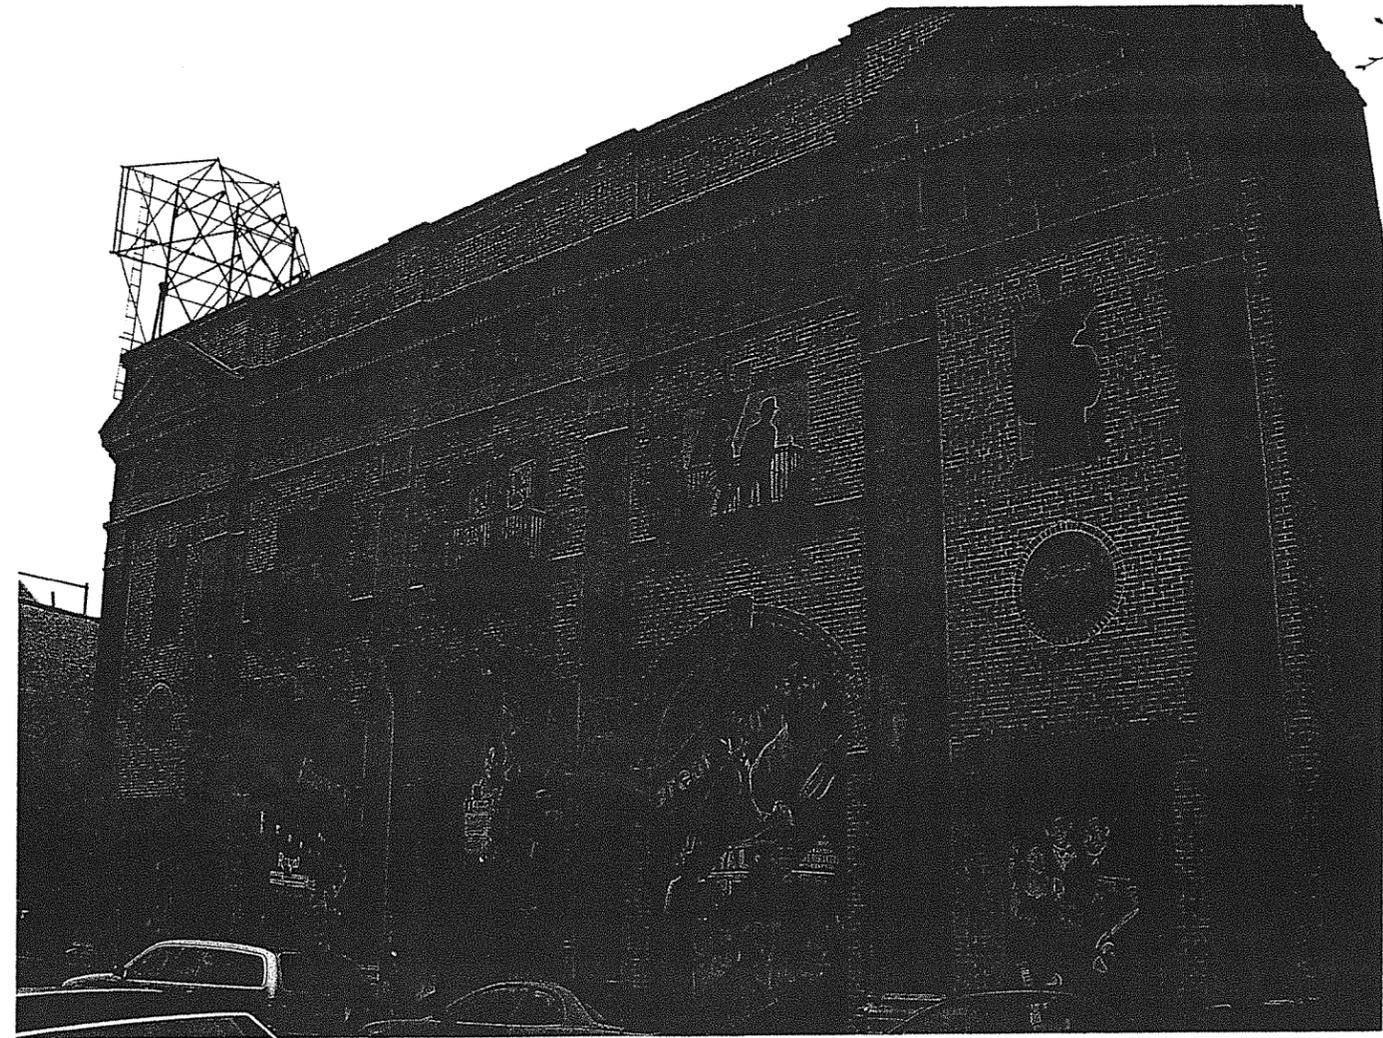
Figure 1: Front Elevation of Royal Theater

The exterior of the building is in good condition along South Street and fair condition on the other three elevations. The masonry wall along South Street has been repointed and the majority of the terra cotta appears to be in good condition with the exception of the lower eight feet of terra cotta pilasters that were painted. The terra cotta cornice is discolored but appears to be in good condition, the iron balconies also appear to be in good condition. The side and rear masonry are missing a majority of the mortar and there are areas where the face brick is missing. The top sections of the brick walls are covered with invasive vegetation that grows from the inside of the building out through the gutter and brick wall and over the top of the parapet walls. There are also smaller vines and plants that are causing damage to the masonry wall. The door openings located in the east and west walls have been secured with unpainted plywood.
