**Existing Mechanical, Electrical, Plumbing, and Fire Protection Conditions Report by
Edwards & Zuck Consulting Engineers**

1904, 1906, 1920 SANSOM MEP/FP Existing Building Narratives

October 8th, 2015

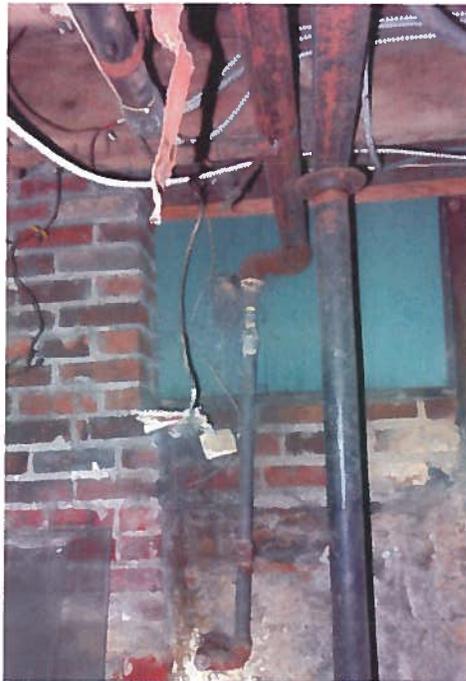
- a) Gas
The existing building contains a 1" incoming gas main. The gas main was not metered and is non-operational. Gas piping throughout is black steel. Piping throughout is in fair condition.

- b) Water
Water service for the building appears to come from Moravian Street. Exact location could not be determined in field. Piping into the building is 3" ductile iron. Piping is corroded throughout & in poor condition. There was no backflow prevention device located within the building, as required by code. The water service is currently not active.

- c) Sanitary
Sanitary piping throughout the building is extra-heavy cast iron (XHCI) with hub & spigot fittings. Various areas of sanitary & vent piping appear to have been modified with cast iron no-hub pipe & fittings. There were no house traps visible within the cellar, as required by code. Sanitary system piping is in poor condition & corroded throughout.

- d) Storm
There was no storm water system visible within the building, as required by code.
