5. INVENTORY

MIDVALE AVENUE

MIDVALE – ODD-NUMBERED SIDE

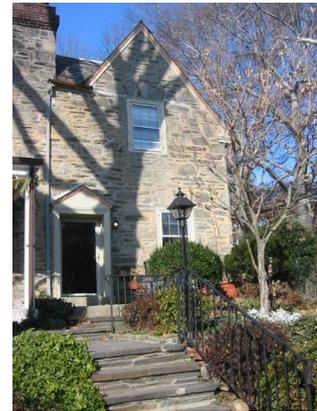
3401 Midvale

Exterior Physical Condition: Good

Front - Lamp: Replaced

Front - Second Floor, D/H Window: Exterior storm window added

Miscellaneous: First and second floor shutters removed

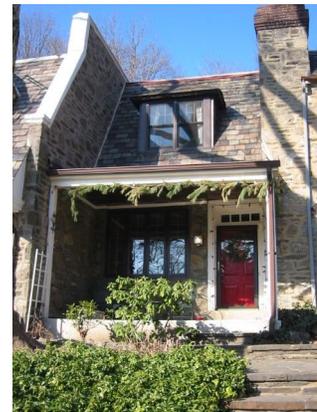
3403 Midvale

Exterior Physical Condition: Good

Front - Lamp: Replaced

Front - Second-Floor Steel Casement: Replaced with one/one double-hungs, artificial divided lights

Front - Storm/Screen Door: Replaced with aluminum storm door

Front - Second Floor Casement Surround: Aluminum clad

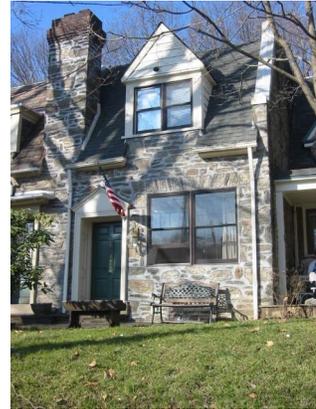
Exterior Physical Condition: Good

Roof - Slate: Slate replaced with asphalt shingles

Front - Lamp: Replaced

Front - Second-Floor Steel Casement: Replaced with one/one double-hungs, artificial divided lights

Front - Second Floor Casement Surround: Aluminum clad

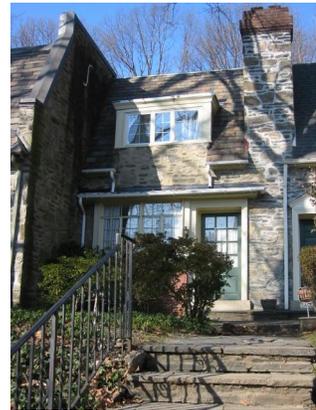
3411 Midvale

Exterior Physical Condition: Good

Front - Lamp: Replaced

Front - Second-Floor Steel Casement: Replaced with three single pane casement windows, artificially divided lights

Front - Second Floor Casement Surround: Aluminum clad

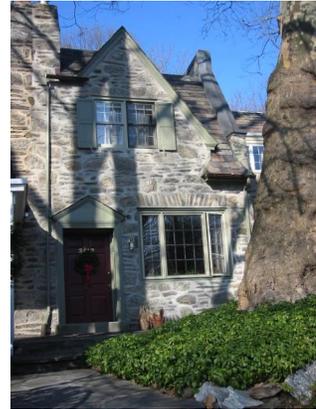
3413 Midvale

Exterior Physical Condition: Good

Front - Lamp: Replaced

Front - Second-Floor Steel Casement: Replaced with one/one double-hungs, artificial divided lights

Miscellaneous: Shutters added to second floor window

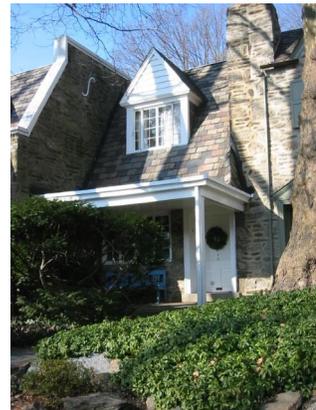
3415 Midvale

Exterior Physical Condition: Good

Front - Lamp: Assumed original

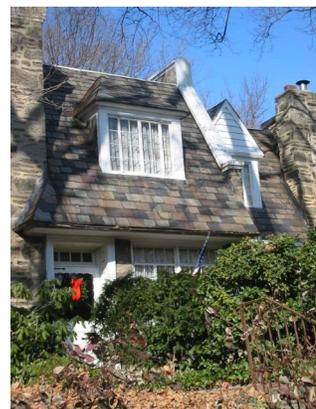
3417 Midvale

Exterior Physical Condition: Good

Front - Storm/Screen Door: Replaced with aluminum storm door

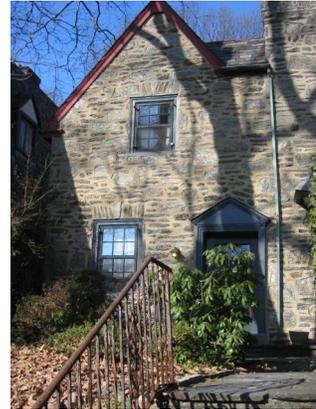
3419 Midvale

Exterior Physical Condition: Good

Front - Lamp: Replaced

Front - Storm/Screen Door: Replaced with storm door

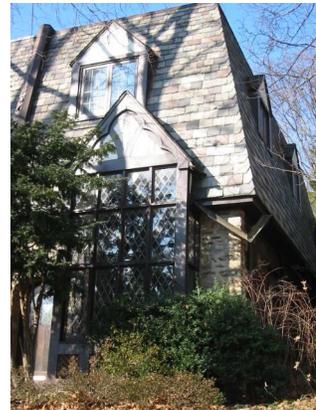
3421 Midvale

Exterior Physical Condition: Good

Front - Lamp: Damaged

Front - Second-Floor Steel Casement: Replaced with two casement leaves, artificial divided lights

Front - Storm/Screen Door: Replaced with aluminum storm door

Side Elevation - Windows: Second floor eight-light casements replaced with single pane casements, artificial divided lights

Side Elevation – Dormers: Aluminum clad

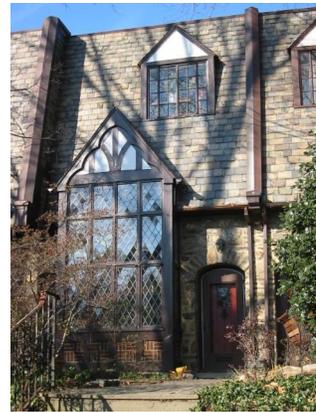
Exterior Physical Condition: Good

Front - Lamp: Glass damaged

Front - Door Leaded Glass Pane: Replaced with leaded glass, non-facsimile

Front - Storm/Screen Door: Replaced with aluminum storm door

Front - Leaded Bay Surround: Aluminum clad sill

Front - Second Floor Casement Surround: Aluminum clad sill

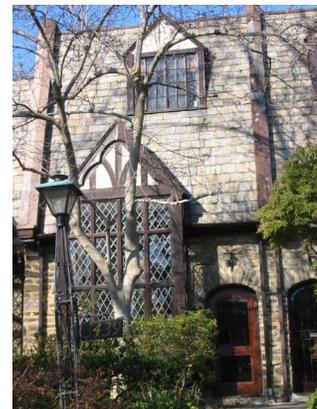
Exterior Physical Condition: Good

Front - Lamp: Replaced

Front - Door Leaded Glass Pane: Replaced with leaded glass, non-facsimile

Front - Storm/Screen Door: Replaced with wood storm door

Front - Leaded Bay Surround: Possibly aluminum clad sill

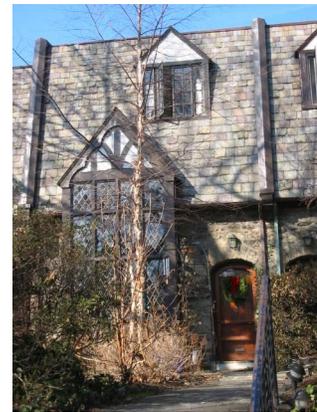
Exterior Physical Condition: Good

Front - Lamp: Replaced

Front - Storm/Screen Door: Replaced with storm/screen door

Front - Second Floor Casement Surround: Aluminum clad sill

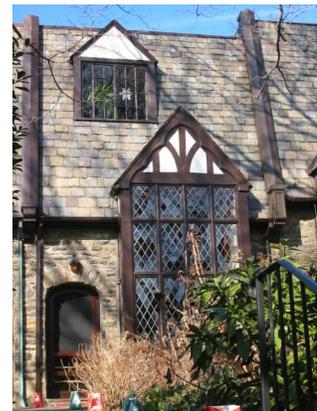
3445 Midvale

Exterior Physical Condition: Good

Front - Storm/Screen Door: Replaced with screen door

Front - Second Floor Casement Surround: Aluminum clad sill

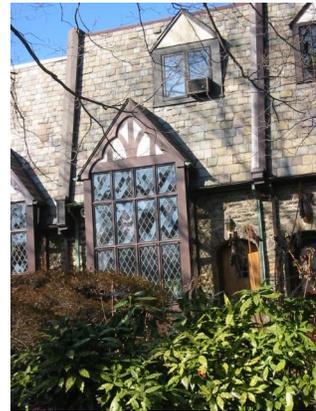
3447 Midvale

Exterior Physical Condition: Good

Front - Second-Floor Steel Casement: Replaced with two casement leaves, artificial divided lights

Front - Door Leaded Glass Pane: Leaded facsimile or original

Front - Dormer: Aluminum clad

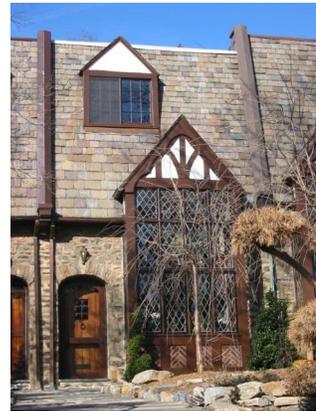
3449 Midvale

Exterior Physical Condition: Good

Front - Lamp: Replaced

Front - Second-Floor Steel Casement: Replaced with two casement leaves, artificial divided lights

Front - Storm/Screen Door: Replaced with wood storm door

Front - Dormer: Aluminum clad

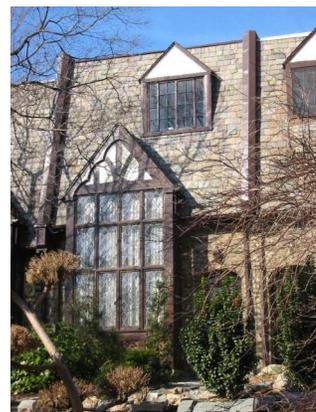
3451 Midvale

Exterior Physical Condition: Good

Front - Storm/Screen Door: Replaced with aluminum storm door

Front - Second Floor Casement Surround: Aluminum clad sill

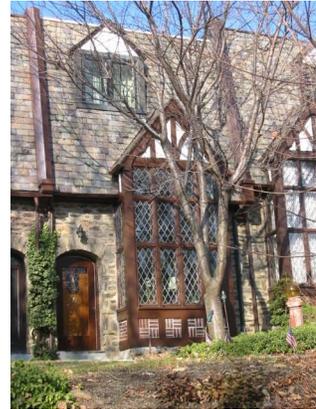
3453 Midvale

Exterior Physical Condition: Good

Front - Lamp: Replaced

Front - Second-Floor Steel Casement: Replaced with two casement leaves, artificial divided lights

Front - Storm/Screen Door: Replaced with aluminum storm door

Front - Dormer: Aluminum clad

Front - Second Floor Six/Six D/H Surround: Aluminum clad

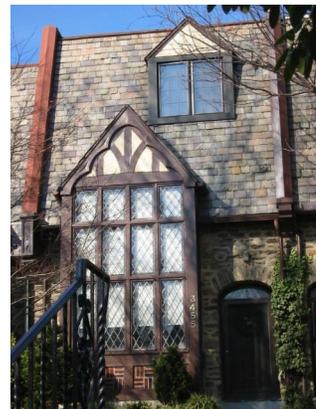
3455 Midvale

Exterior Physical Condition: Good

Front - Lamp: Replaced

Front - Second-Floor Steel Casement: Replaced with two casement leaves, artificial divided lights

Front - Storm/Screen Door: Replaced with aluminum storm door

Front - Dormer: Aluminum clad

Front - Second Floor Casement Surround: Aluminum clad

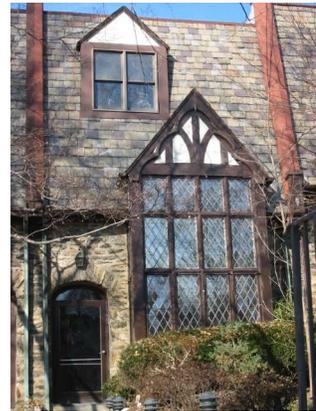
3457 Midvale

Exterior Physical Condition: Good

Front - Second-Floor Steel Casement: Replaced with one/one double-hungs

Front - Storm/Screen Door: Replaced with aluminum storm door

Front - Dormer: Aluminum clad

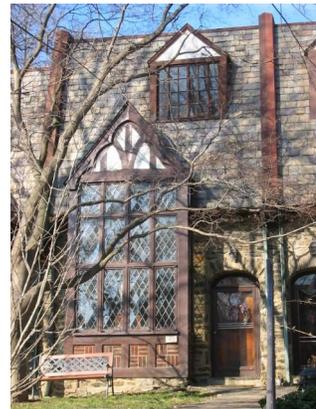
3459 Midvale

Exterior Physical Condition: Good

Front - Storm/Screen Door: Replaced with aluminum storm door

Front - Leaded Bay Surround: Aluminum clad sill

Front - Dormer: Aluminum clad

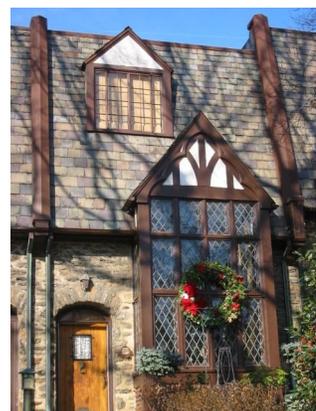
3461 Midvale

Exterior Physical Condition: Good

Front - Door Leaded Glass Pane: Replaced with leaded facsimile*

Front - Storm/Screen Door: Replaced with wooden storm door*

Front - Second Floor Casement Surround: Aluminum clad

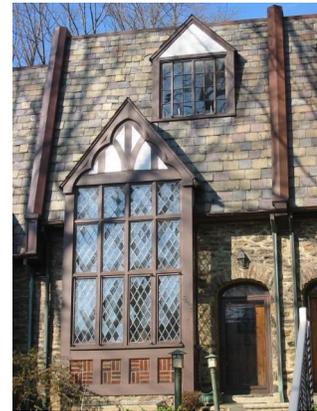
3463 Midvale

Exterior Physical Condition: Good

Front - Door Leaded Glass Pane: Replace with non-standard leaded glass, iron filigree grill added

Front - Storm/Screen Door: Replaced with aluminum storm door

Front - Dormer: Aluminum clad

Front - Second Floor Casement Surround: Aluminum clad

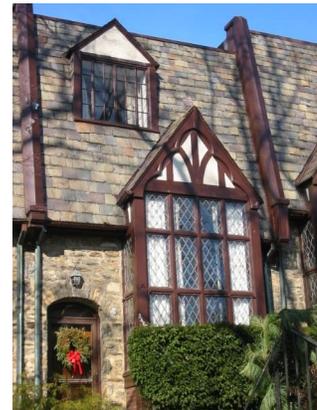
3465 Midvale

Exterior Physical Condition: Good

Front - Door Leaded Glass Pane: Replaced with solid pane

Front - Storm/Screen Door: Replaced with aluminum storm door

Front - Leaded Bay Surround: Aluminum clad sill

Front - Second Floor Casement Surround: Aluminum clad sill

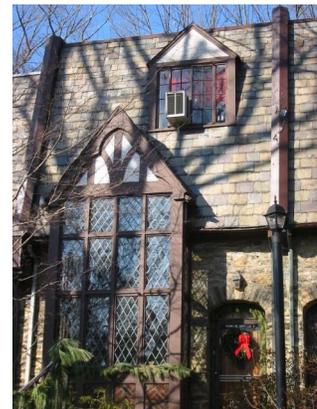
3467 Midvale

Exterior Physical Condition: Good

Front - Second-Floor Steel Casement: Muntins removed for air conditioning unit

Front - Door Leaded Glass Pane: Replaced with leaded glass, non-facsimile

Front - Storm/Screen Door: Replaced with aluminum storm door

Front - Dormer: Aluminum clad

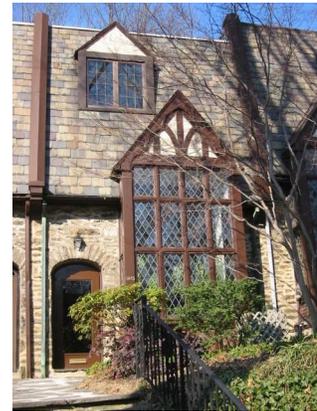
3469 Midvale

Exterior Physical Condition: Good

Front - Lamp: Glass damaged

Front - Second-Floor Steel Casement: Replaced with two casement leaves, artificial divided lights

Front - Door Leaded Glass Pane: Replaced with leaded glass, non-facsimile

Front - Storm/Screen Door: Replaced with aluminum storm door

Front - Leaded Bay Surround: Aluminum clad sill

Front - Dormer: Aluminum clad

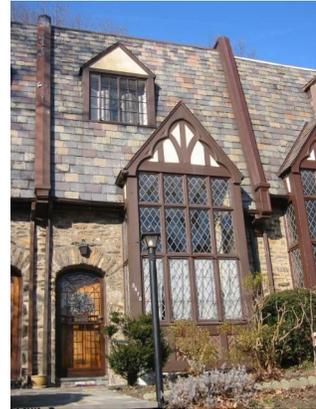
Exterior Physical Condition: Good

Front - Stucco: Inset dormer stucco painted

Front - Storm/Screen Door: Replaced with aluminum storm door

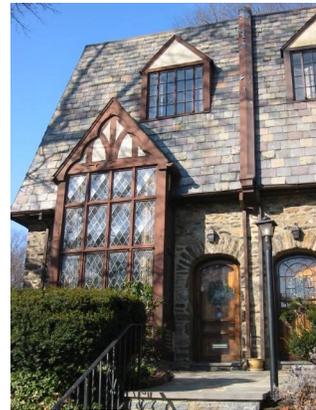
3475 Midvale

Exterior Physical Condition: Good

Front - Storm/Screen Door: Replace with screen door

Side Elevation - Windows: One first floor casement, two second floor casement, and one third floor casement replaced with single pane casements, artificial divided lights

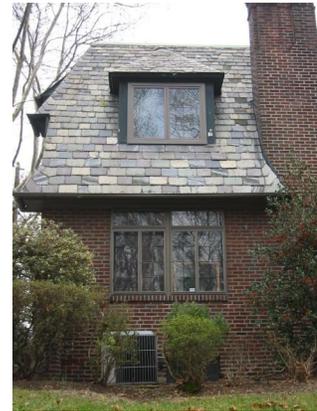
Exterior Physical Condition: Good

Front - Lamp: Replaced

Front - Second-Floor Steel Casement: Replaced with two casement leaves, artificial divided lights

Front - Storm/Screen Door: Replaced with wood storm door

Side Elevation - Windows: First level exterior storm windows added. All second floor eight-light casements replaced with single pane casements, artificial divided lights One second floor original diamond pane two-sash casement remains.

Side Elevation - Window Surrounds: Replaced second floor windows have aluminum clad

Miscellaneous: Central air conditioning unit on property at northwest side

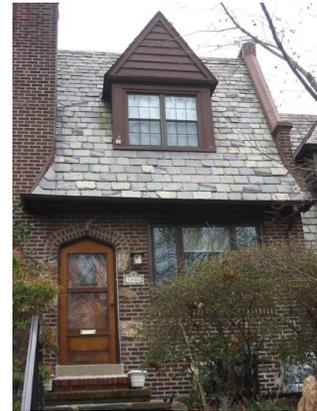
3402 Midvale

Exterior Physical Condition: Good

Front - Lamp: Replaced

Front - Second-Floor Steel Casement: Replaced with one/one double-hungs, artificial divided lights

Front - Storm/Screen Door: Replaced with wood storm door

Front - First Floor Casement Surround: Aluminum clad

Front - Second Floor Casement Surround: Aluminum clad

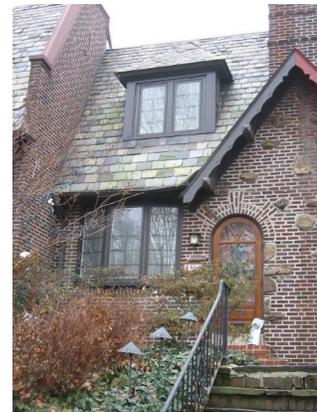
3404 Midvale

Exterior Physical Condition: Good

Front - Lamp: Replaced

Front - Second-Floor Steel Casement: Replaced with two casement windows, artificial divided lights

Front - Storm/Screen Door: Replaced with wood storm door

Front - First Floor Casement Surround: Aluminum clad

Front - Second Floor Casement Surround: Aluminum clad

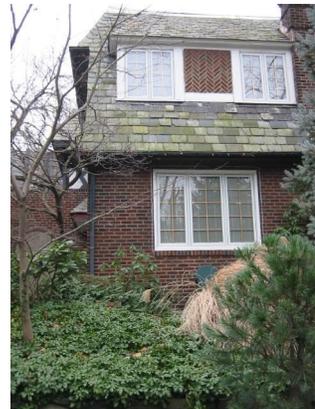
3426 Midvale

Side Elevation - Windows: All replaced with casement leaves, artificial divided lights

Side Elevation - Window Surrounds: All wood removed and not replaced

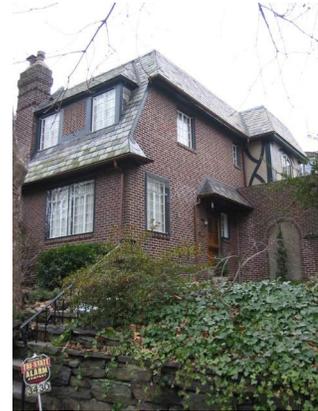
3428 Midvale

Front - Storm/Screen Door: Replaced with wood storm door

Side Elevation - Windows: Exterior storms added to first floor

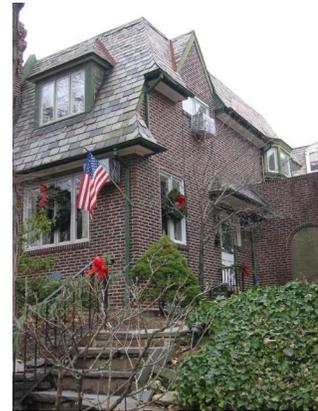
3432 Midvale

Exterior Physical Condition: Good

Front - Second-Floor Steel Casement: Replaced with three single pane casement windows

Side Elevation - Windows: All side elevation windows replaced with single pane casement windows

Miscellaneous: Air conditioning unit added through brick of first floor front and second floor forward side elevation

Miscellaneous: Side forward casement in gablet replaced solid pane casements with artificial divided lights

Miscellaneous: Side rearward second level bay replace with solid pane casement leaves

Style Irregularity: Rather than two casements with eight-light leaves divided by wall panel of brick, façade has one casement window with two operable eight-light leaves, and eight fixed lights. Second floor forward side elevation has gablet with original small casement consisting of three four-light leaves. Second floor rearward side elevation has bay window with stucco corbel rather than stucco bay.

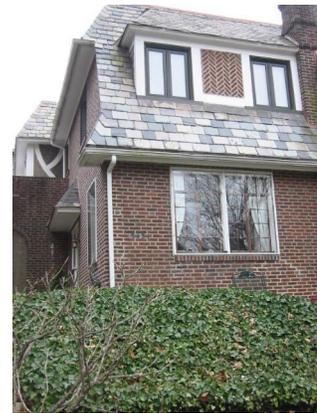
3434 Midvale

Exterior Physical Condition: Good

Front - Second-Floor Steel Casement: Replaced with pair of two casement leaves

Front - Storm/Screen Door: Replaced with aluminum storm door

Front - Second Floor Six/Six D/H Surround: Aluminum clad on second floor window surrounds

Side Elevation - Windows: Exterior acrylic storm added to first floor window; all but one forward side second floor casements replace, artificial divided lights; one replaced with jalousie window

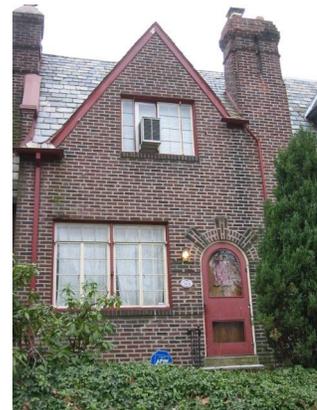
3436 Midvale

Exterior Physical Condition: Good

Front - Lamp: Replaced

Front - Storm/Screen Door: Replaced with aluminum storm door

Miscellaneous: Air conditioning unit added to window by removing one casement sash

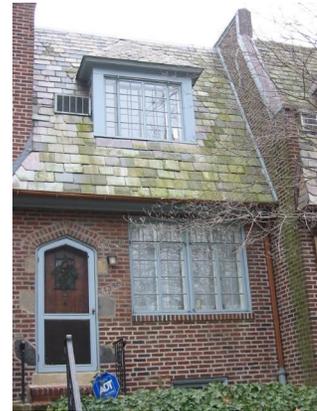
3438 Midvale

Exterior Physical Condition: Good

Front - Lamp: Replaced

Front - Storm/Screen Door: Replaced with wood screen door

Miscellaneous: Air conditioning unit added through slate roof

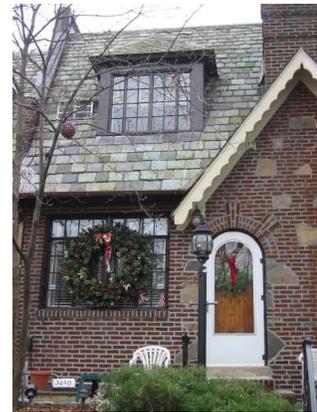
3440 Midvale

Exterior Physical Condition: Good

Front - Lamp: Replaced

Front - Storm/Screen Door: Replaced with aluminum storm door

Front - Windows: All steel casement windows replaced with artificial light casement. All casement surrounds aluminum clad.

Miscellaneous: Air conditioning unit added through slate roof

Miscellaneous: Gable's discrete horizontal wood beam supports removed

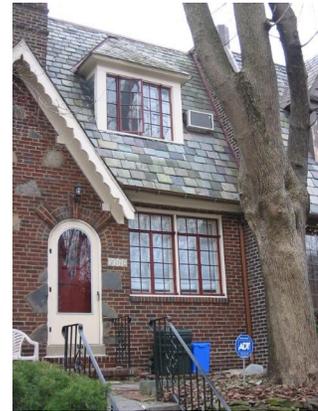
3442 Midvale

Exterior Physical Condition: Good

Front - Lamp: Replace and moved to directly above door

Front - Storm/Screen Door: Replaced with aluminum storm door

Miscellaneous: Air conditioning unit added through slate roof

Miscellaneous: Faux wrought hinge straps added to front door

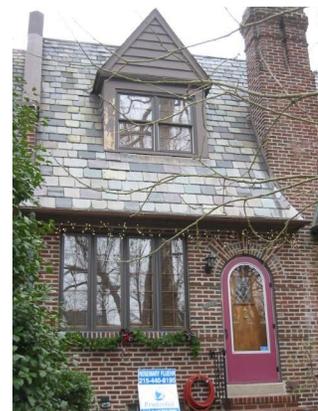
3444 Midvale

Exterior Physical Condition: Good

Front - Lamp: Replaced

Front - Second-Floor Steel Casement: Replaced with one/one double-hungs, artificial divided lights

Front - Storm/Screen Door: Replaced with aluminum storm door

Front - First Floor Casement Surround: Removed wood surround

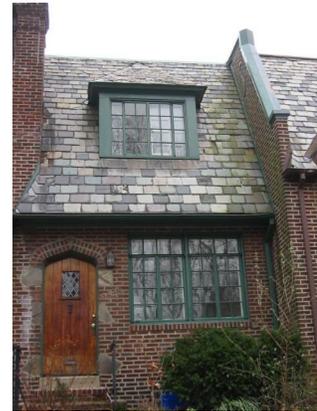
3446 Midvale

Exterior Physical Condition: Good

Front - Lamp: Replaced

Front - Door Leaded Glass Pane: Leaded facsimile or original

Front - Storm/Screen Door: None

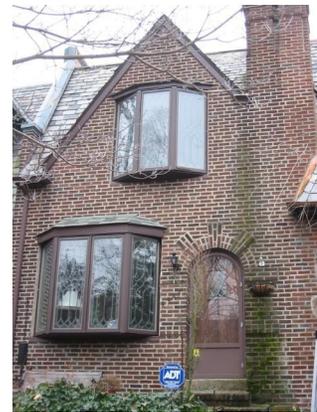
3448 Midvale

Exterior Physical Condition: Good

Front - Lamp: Replaced

Front - Second-Floor Steel Casement: Replaced with bay of three casement windows with leaded glass. Asphalt shingles added over bay projection

Front - Storm/Screen Door: Replaced with aluminum storm door

Front - Second Floor Casement Surround: Aluminum clad

Miscellaneous: Added bay windows have aluminum clad

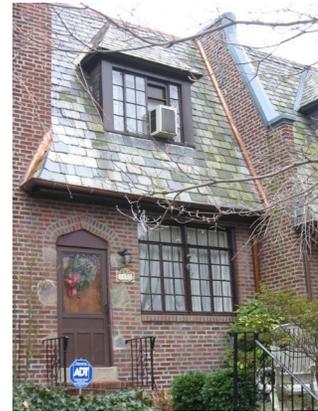
3450 Midvale

Exterior Physical Condition: Good

Front - Door Leaded Glass Pane: Replaced with leaded glass, non-facsimile

Front - Storm/Screen Door: Replaced with aluminum storm door

Front - Second Floor Casement Surround: Aluminum clad

Miscellaneous: Air conditioning unit added to window by removing one casement sash

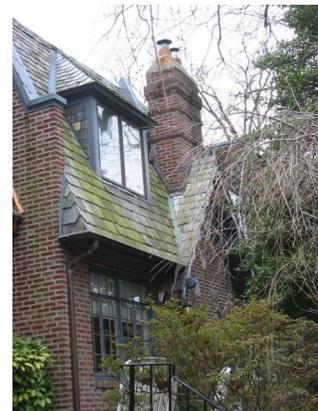
3452 Midvale

Exterior Physical Condition: Good

Front - Lamp: Replaced

Front - Second-Floor Steel Casement: Replaced with two casement windows

Front - Storm/Screen Door: Replaced with wood storm door

Front - Second Floor Casement Surround: Aluminum clad

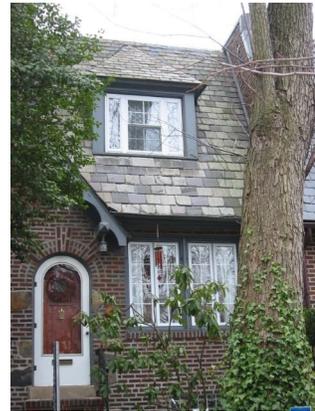
3454 Midvale

Exterior Physical Condition: Good

Front - Second-Floor Steel Casement: Replaced with one/one double-hung with two flanking panes, artificial divided lights

Front - Storm/Screen Door: Replaced with aluminum storm door

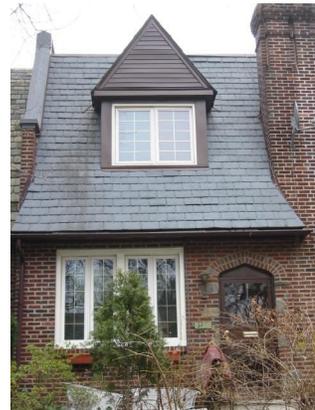
3456 Midvale

Exterior Physical Condition: Good

Roof - Slate: Original slate replaced with monochrome gray imitation slate. All standard size

Front - Lamp: Replaced

Front - Second-Floor Steel Casement: Replaced with two casement windows, artificial divided lights

Front - Storm/Screen Door: Replaced with aluminum storm door

Front - Soffit: Aluminum clad

Front - Second Floor Casement Surround: Aluminum clad

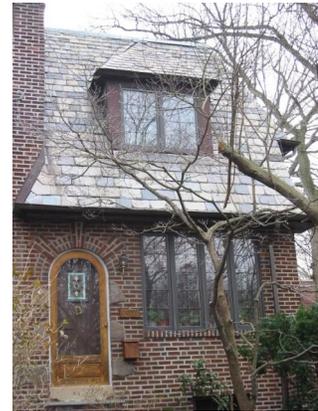
3458 Midvale

Exterior Physical Condition: Good

Front - Lamp: Replaced

Front - Second-Floor Steel Casement: Replaced with two casement windows, artificial divided lights

Front - Door Leaded Glass Pane: Replaced with leaded glass, non-facsimile

Side Elevation - Windows: All first and second floor side elevation windows replaced with casement windows, artificial divided lights One basement level rearward side elevation window replaced with glass block. Forward side basement level window appears to be replaced, true divided light

Style Irregularity: Similar to 3432 Midvale Avenue, second floor forward side elevation has minor gable punctuation originally with small casement composed of three four-light leaves. Second floor rearward side elevation has bay window with stucco corbel rather than stucco bay. Property also has second brick chimney on side elevation and door on rearward side.

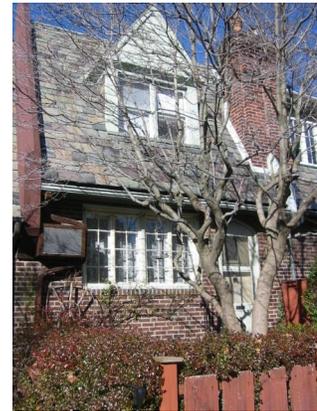
3403 Penn

Exterior Physical Condition: Good

Front - Lamp: Replaced

Front - Second-Floor Steel Casement: Replaced with one/one double-hungs

Front - Storm/Screen Door: Replaced with wood storm door

Parapet: Aluminum clad

Miscellaneous: First floor air conditioner added through wall

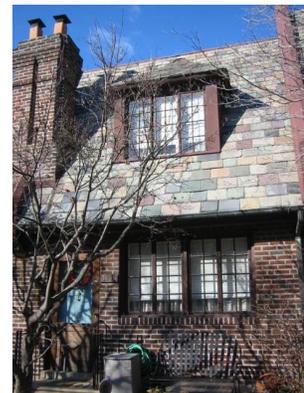
3405 Penn

Exterior Physical Condition: Good

Front - Second Floor Casement Surround: Aluminum clad

Parapet: Aluminum clad

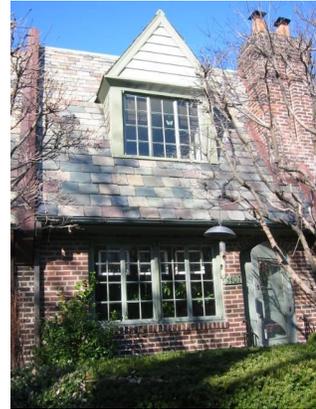
3407 Penn

Exterior Physical Condition: Good

Front - Storm/Screen Door: Replaced with aluminum storm door

Front - Second Floor Casement Surround: Aluminum clad

Parapet: Aluminum clad

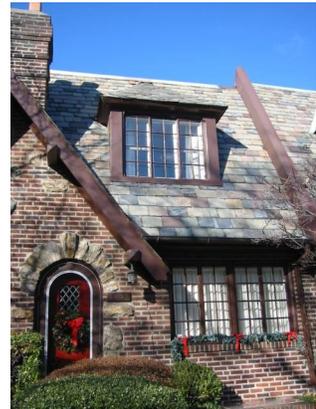
3409 Penn

Exterior Physical Condition: Good

Front - Storm/Screen Door: Replaced with aluminum storm door

Front - Second Floor Casement Surround: Aluminum clad

Parapet: Aluminum clad

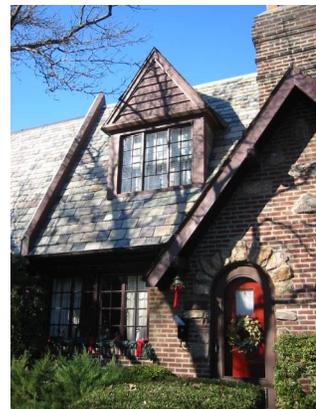
3411 Penn

Exterior Physical Condition: Good

Front - Door Leaded Glass Pane: Replaced with leaded facsimile*

Front - Storm/Screen Door: Replaced with aluminum storm door

Parapet: Aluminum clad

*Change occurred since date of photograph.

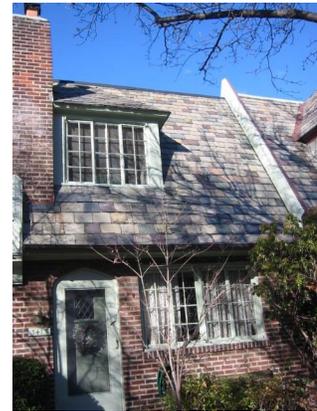
3413 Penn

Exterior Physical Condition: Good

Front - Lamp: Replaced

Front - Storm/Screen Door: Replaced with wood storm door

Front - First Floor Casement Surround: Aluminum clad

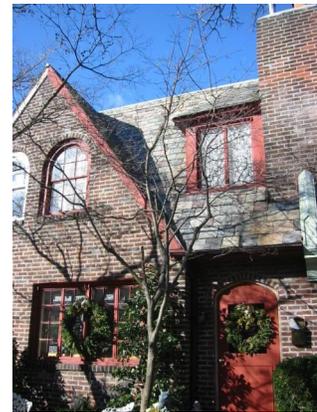
3415 Penn

Exterior Physical Condition: Good

Front - Lamp: Replaced

Front - Storm/Screen Door: Replaced with aluminum storm door

Front - Second Floor Casement Surround: Aluminum clad sill

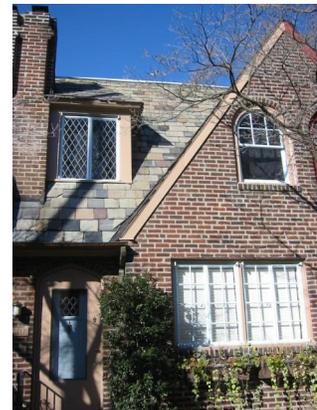
3417 Penn

Exterior Physical Condition: Good

Front - Lamp: Replaced

Front - Second-Floor Steel Casement: Lower six light sash replace by single pane

Front - Door Leded Glass Pane: Leded facsimile or original

Front - Storm/Screen Door: Replaced with aluminum storm door

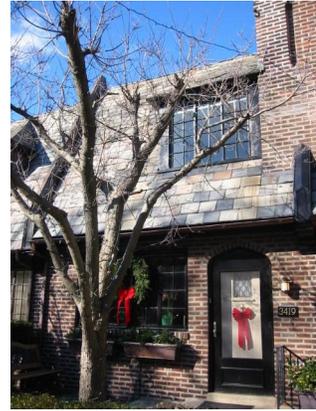
3419 Penn

Exterior Physical Condition: Good

Front - Lamp: Replaced

Front - Storm/Screen Door: Replaced with aluminum storm door

Front - Second Floor Casement Surround: Aluminum clad sill

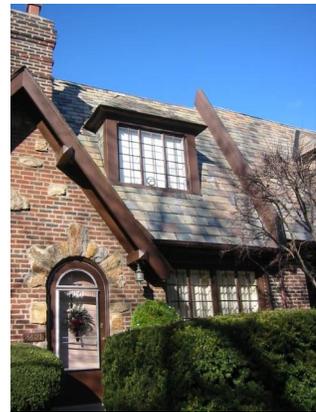
3421 Penn

Exterior Physical Condition: Good

Front - Storm/Screen Door: Replaced with aluminum storm door

Front - Second Floor Casement Surround: Aluminum clad

Parapet: Aluminum clad

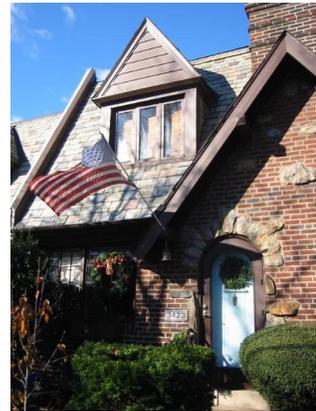
3423 Penn

Exterior Physical Condition: Good

Front - Second-Floor Steel Casement: Replaced with three casement leaves, artificial divided lights

Front - Storm/Screen Door: Replaced with aluminum storm door

Front - Second Floor Casement Surround: Aluminum clad

Parapet: Aluminum clad

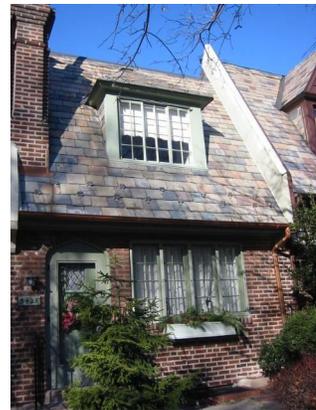
3425 Penn

Exterior Physical Condition: Good

Front - Lamp: Replaced

Front - Storm/Screen Door: Replaced with aluminum storm door

Front - Second Floor Casement Surround: Aluminum clad

Parapet: Aluminum clad

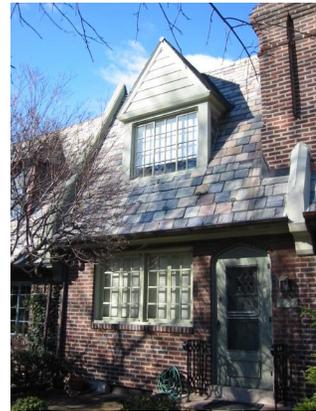
3427 Penn

Exterior Physical Condition: Good

Front - Lamp: Replaced

Front - Storm/Screen Door: Replaced with aluminum storm door

Front - Second Floor Casement Surround: Aluminum clad

Parapet: Aluminum clad

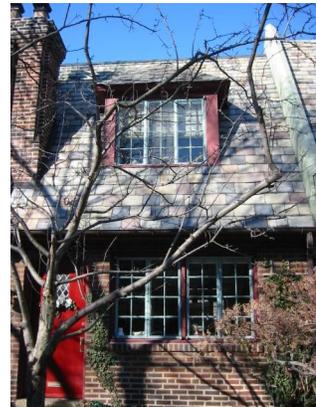
3429 Penn

Exterior Physical Condition: Good

Front - Second Floor Casement Surround: Aluminum clad

Parapet: Aluminum clad

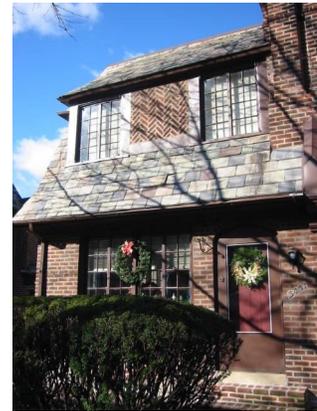
3431 Penn

Exterior Physical Condition: Good

Front - Lamp: Replaced

Front - Storm/Screen Door: Replaced with aluminum storm door

Side Elevation - Windows: Two replaced casement windows on second floor of side elevation with one/one double-hungs

Miscellaneous: Second floor window air conditioning unit added through window on side elevation

Miscellaneous: Garage converted into room with removal of garage door and addition of door and window

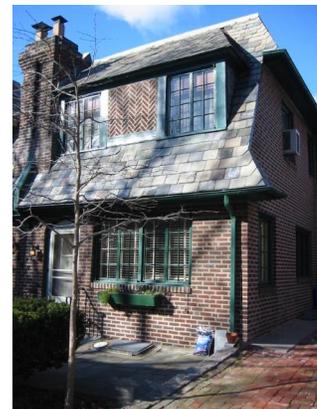
3433 Penn

Exterior Physical Condition: Good

Miscellaneous: Second floor window air conditioning unit added through window on side elevation

Miscellaneous: Garage converted into room with removal of garage door and addition of door and restored steel casement window. Installation of roof deck above garage.

Style Irregularity: Second floor rearward side elevation has French doors above garage

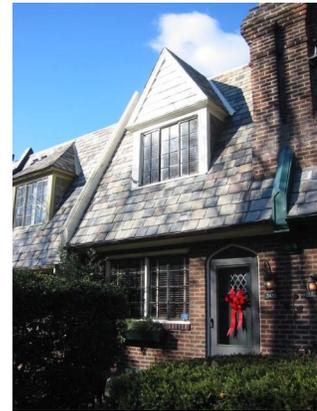
3435 Penn

Exterior Physical Condition: Good

Front - Lamp: Replaced

Front - Door Leded Glass Pane: Leaded facsimile or original

Front - Storm/Screen Door: Replaced with aluminum storm door

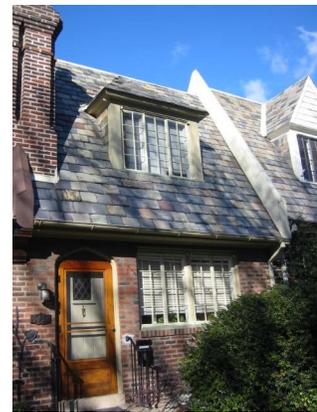
3437 Penn

Exterior Physical Condition: Good

Front - Storm/Screen Door: Replaced with wood storm door

Front - First Floor Casement Surround: Aluminum clad

Parapet: Aluminum clad

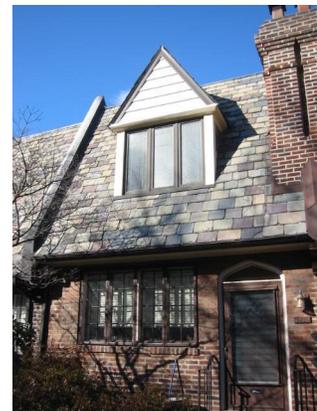
3439 Penn

Exterior Physical Condition: Good

Front - Lamp: Replaced

Front - Second-Floor Steel Casement: Replaced with three casement leaves, artificial divided lights

Front - Storm/Screen Door: Replaced with aluminum storm door

Front - Second Floor Casement Surround: Aluminum clad

Parapet: Aluminum clad

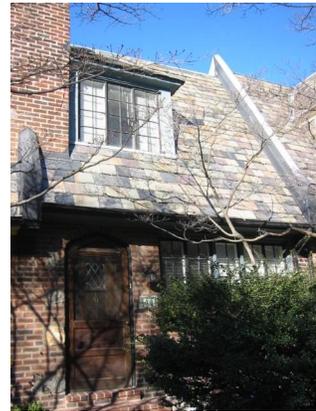
3441 Penn

Exterior Physical Condition: Good

Front - Storm/Screen Door: Replaced with wood storm door

Front - Second Floor Casement Surround: Aluminum clad

Parapet: Aluminum clad

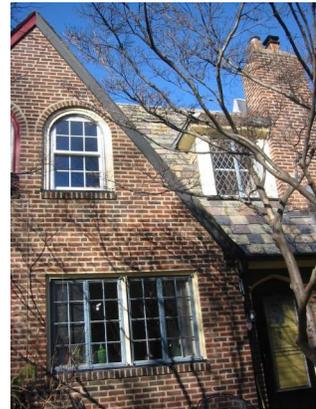
3443 Penn

Exterior Physical Condition: Good

Front - Second Floor, D/H Window: Replaced with one/one double-hung, artificial divided lights

Front - Storm/Screen Door: Replaced with aluminum storm door

Front - Second Floor Six/Six D/H Surround: Aluminum clad

Parapet: Aluminum clad

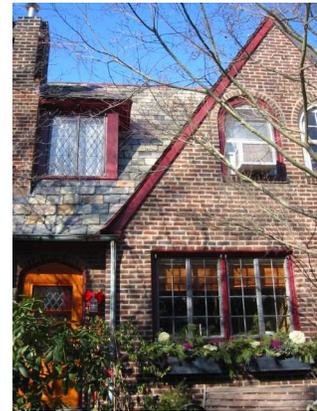
3445 Penn

Exterior Physical Condition: Good

Front - Lamp: Replaced

Front - Second Floor, D/H Window: Replaced with one/one double-hung

Front - Storm/Screen Door: Replaced with wood storm door

Front - Second Floor Six/Six D/H Surround: Aluminum clad

Parapet: Aluminum clad

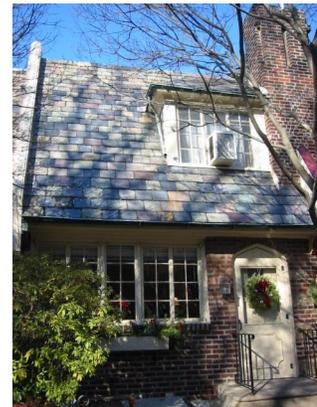
3447 Penn

Exterior Physical Condition: Good

Front - Lamp: Replaced

Front - Storm/Screen Door: Replaced with aluminum storm door

Miscellaneous: Second floor window air conditioning unit added through window

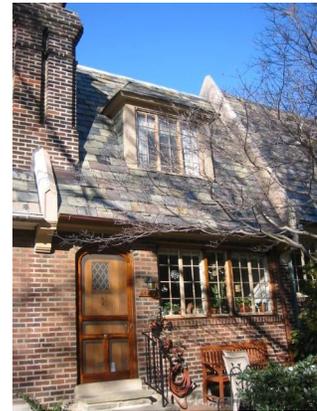
3449 Penn

Exterior Physical Condition: Good

Front - Lamp: Replaced

Front - Door Leaded Glass Pane: Leaded facsimile or original

Front - Storm/Screen Door: Replaced with wood storm door

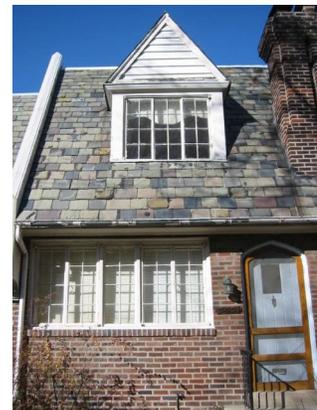
3453 Penn

Exterior Physical Condition: Good

Front - Door Leaded Glass Pane: Replaced with solid pane

Front - Storm/Screen Door: Replaced with aluminum storm door

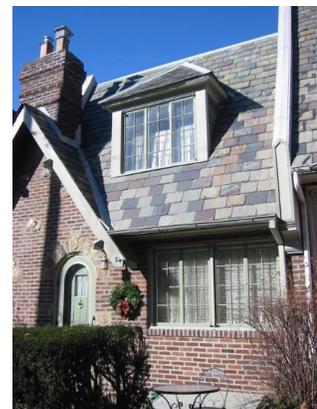
3455 Penn

Exterior Physical Condition: Good

Front - Lamp: Replaced

Front - Storm/Screen Door: Replaced with aluminum storm door

Parapet: Aluminum clad

Miscellaneous: Second floor window air conditioning unit added through window

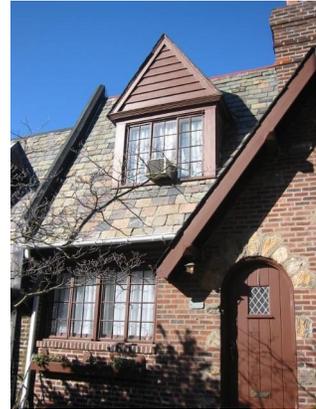
3457 Penn

Exterior Physical Condition: Good

Front - Lamp: Replaced

Parapet: Aluminum clad

Miscellaneous: Second floor window air conditioning unit added through window

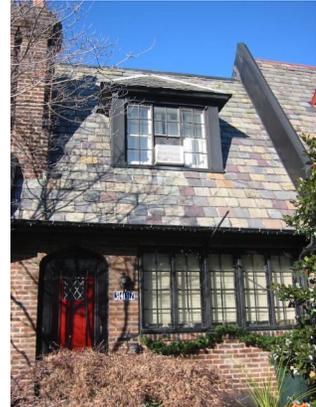
3459 Penn

Exterior Physical Condition: Good

Front - Lamp: Replaced

Front - Second Floor Casement Surround: Aluminum clad

Parapet: Aluminum clad

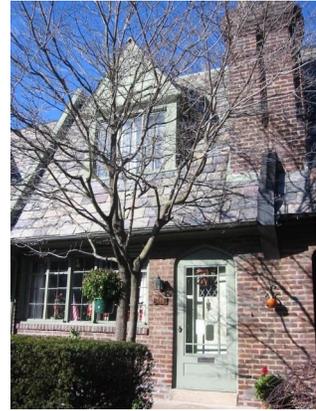
3461 Penn

Exterior Physical Condition: Good

Front - Lamp: Replaced

Front - Door Leaded Glass Pane: Replaced with solid pane

Front - Storm/Screen Door: Replaced with wood storm door

Miscellaneous: Second floor window air conditioning unit added through window

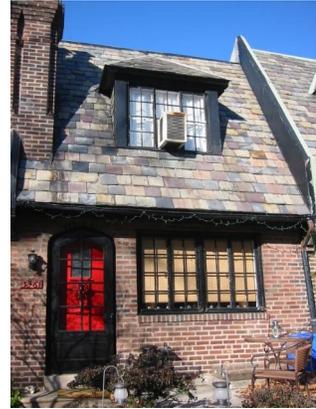
3463 Penn

Exterior Physical Condition: Good

Front - Lamp: Replaced

Front - Door Leded Glass Pane: Replaced with solid pane

Front - Storm/Screen Door: Replaced with aluminum storm door

Style Irregularity: Second floor façade has steel casement window with two operable eight-light leaves flanked by two brick herringbone panels; rather than, two casement windows divided by single panel brick. Second floor rearward side elevation has stucco half-timbered bay with balconet, finished with hipped slate roof.

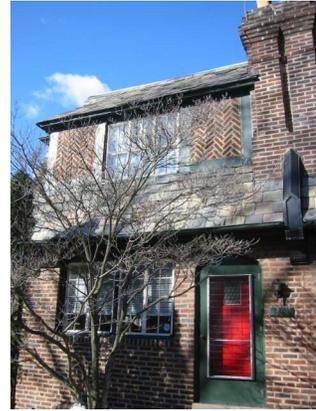
Exterior Physical Condition: Good

Roof - Slate: Slate on side elevation replace with asphalt shingles

Front - Lamp: Replaced

Front - Second-Floor Steel Casement: Replaced with one/one double-hungs

Front - Door Leaded Glass Pane: Replaced with solid pane

Side Elevation - Windows: All second floor windows replaced with one/one double hung, artificial divided lights Center window among three replaced with one/one double hung, artificial divided lights

Miscellaneous: Air conditioning unit added through first floor brick facing Penn Street

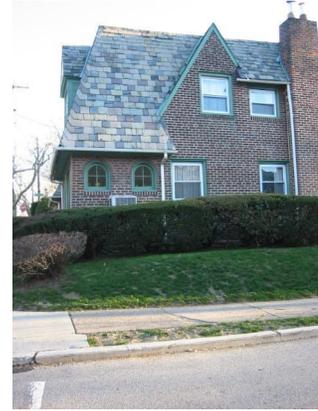
3402 Penn

Exterior Physical Condition: Good

Front - Storm/Screen Door: Replaced with wood storm door

Style Irregularity: Second-Floor Steel Casement window in dormer has leaded diamond-pane leaves rather than eight-light leaves (one of two houses of style A to have irregularity)

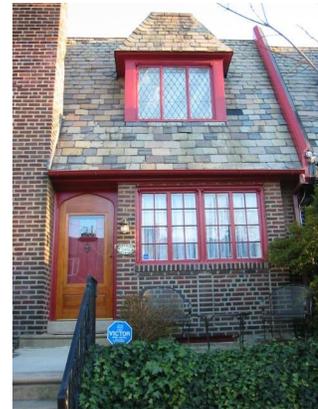
3404 Penn

Exterior Physical Condition: Good

Front - Lamp: Replaced

Front - Second-Floor Steel Casement: Replaced with one/one double-hungs

Front - Storm/Screen Door: Replaced with wood storm door

Front - Second Floor Casement Surround: Aluminum clad

Parapet: Aluminum clad

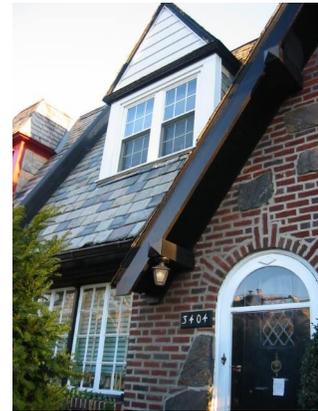
3406 Penn

Exterior Physical Condition: Good

Front - Storm/Screen Door: Replaced with wood storm door

Front - First Floor Casement Surround: Aluminum clad

Miscellaneous: Second floor window air conditioning unit added through window

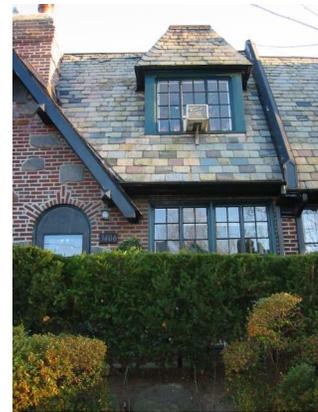
3408 Penn

Exterior Physical Condition: Good

Front - Brick: Re-pointed

Front - Door Leaded Glass Pane: Leaded facsimile or original

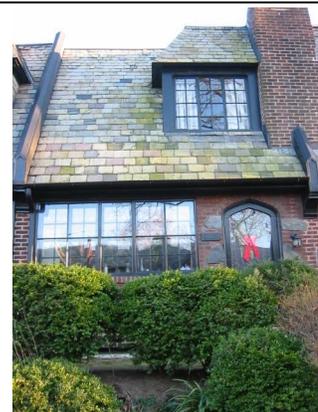
3410 Penn

Exterior Physical Condition: Good

Front - Storm/Screen Door: Replaced with wood storm door

Miscellaneous: Second floor window air conditioning unit added through window

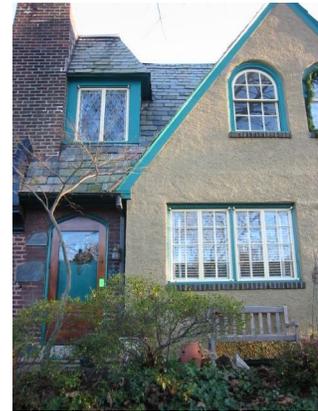
3412 Penn

Exterior Physical Condition: Good

Front - Lamp: Replaced

Front - Second-Floor Steel Casement: Replaced with restored steel eight-light casement leaves

Front - Second Floor, D/H Window: Replaced with one/one double hung

Front - Storm/Screen Door: Replaced with aluminum storm door

Front - First Floor Casement Surround: Aluminum clad

Style Irregularity: Rounded-arch plank door rather than gothic board door (only house of style C to have irregularity)

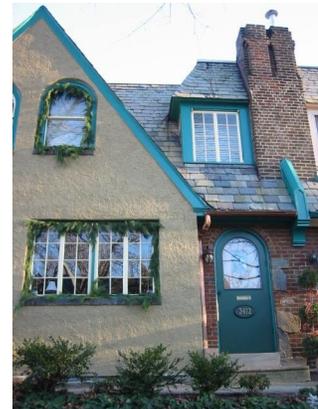
3414 Penn

Exterior Physical Condition: Good

Front - Lamp: Replaced

Front - Second-Floor Steel Casement: Replaced with two light slider window

Front - Tudor-arched Plank Door: Replaced with particle board core door

Front - Door Leaded Glass Pane: Replaced door has solid pane

Front - Storm/Screen Door: Replaced with aluminum storm door

Style Irregularity: Entry door has wooden surround (one of three houses of style A to have irregularity)

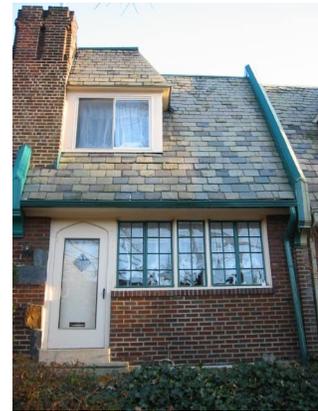
3416 Penn

Exterior Physical Condition: Good

Front - Lamp: Replaced

Front - Storm/Screen Door: Replaced with aluminum storm door

Style Irregularity: Entry door has wooden surround (one of three houses of style A to have irregularity)

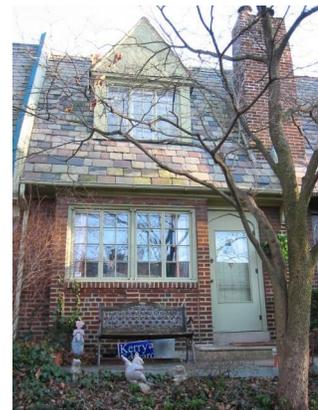
3418 Penn

Exterior Physical Condition: Good

Front - Storm/Screen Door: Replaced with aluminum storm door

Miscellaneous: Second floor window air conditioning unit added through window

Style Irregularity: Entry door has wooden surround (one of three houses of style A to have irregularity)

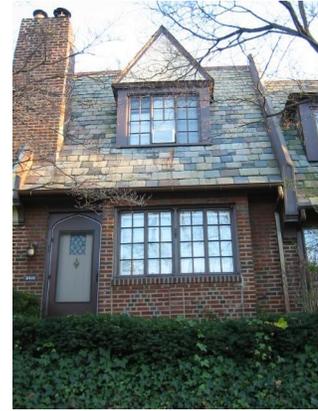
3420 Penn

Exterior Physical Condition: Good

Front - Lamp: Replaced

Front - Second-Floor Steel Casement: Replaced with one/one double-hungs, artificial divided lights

Front - Storm/Screen Door: Replaced with aluminum storm door

Front - Second Floor Casement Surround: Aluminum clad

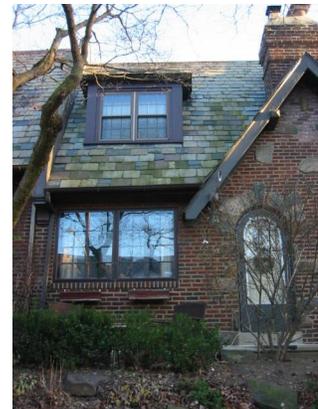
3422 Penn

Exterior Physical Condition: Good

Front - Lamp: Replaced

Front - Second-Floor Steel Casement: Replaced with one/one double-hungs, artificial divided lights

Front - Storm/Screen Door: Replaced with aluminum storm door

Front - Second Floor Casement Surround: Aluminum clad

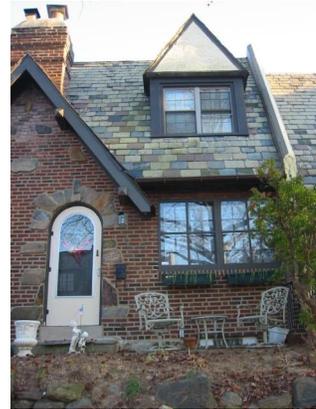
3424 Penn

Exterior Physical Condition: Good

Front - Lamp: Replaced

Front - Second-Floor Steel Casement: Replaced with three casement leaves, artificial divided lights

Front - Storm/Screen Door: Replaced with wood storm door

Front - Second Floor Casement Surround: Aluminum clad

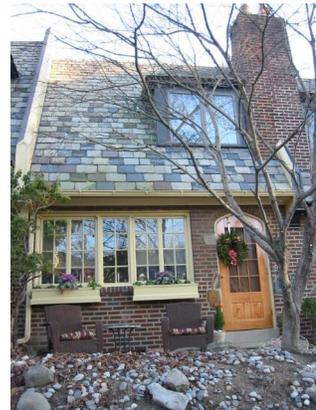
3426 Penn

Exterior Physical Condition: Good

Front - Door Leded Glass Pane: Repaired original

Front - Storm/Screen Door: None

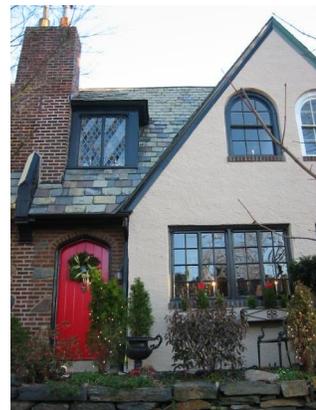
3428 Penn

Exterior Physical Condition: Good

Front - Brick: Re-pointed

Front - Storm/Screen Door: None

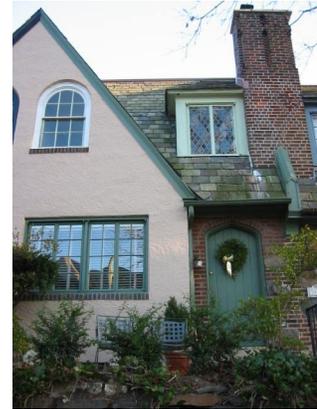
3430 Penn

Exterior Physical Condition: Good

Front - Door Leaded Glass Pane: Leaded facsimile or original

Front - Storm/Screen Door: Replaced with aluminum storm door

Style Irregularity: Entry door has wooden surround

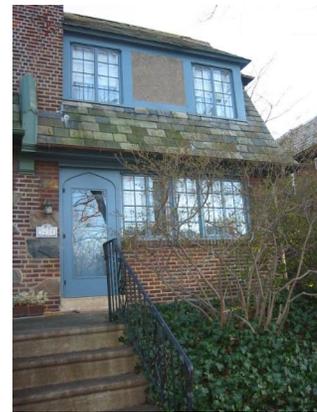
3432 Penn

Exterior Physical Condition: Good

Front - Door Leaded Glass Pane: Leaded facsimile or original

Front - Storm/Screen Door: Replaced with wood storm door

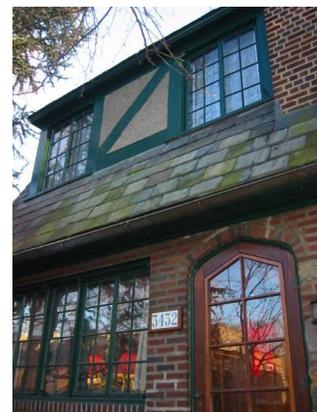
3434 Penn

Exterior Physical Condition: Good

Front - Lamp: Replaced

Front - Second-Floor Steel Casement: Replaced with three casement leaves, artificial divided lights

Front - Storm/Screen Door: Replaced with aluminum storm door

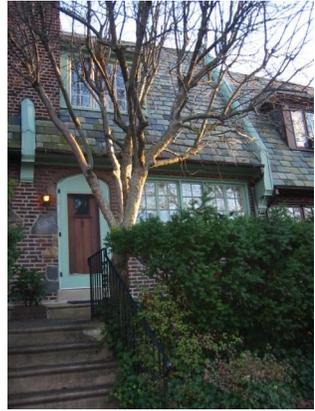
3436 Penn

Exterior Physical Condition: Good

Front - Second-Floor Steel Casement: Replaced with three casement leaves, artificial divided lights

Front - Storm/Screen Door: Replaced with aluminum storm door

Miscellaneous: Second floor window air conditioning unit added through window

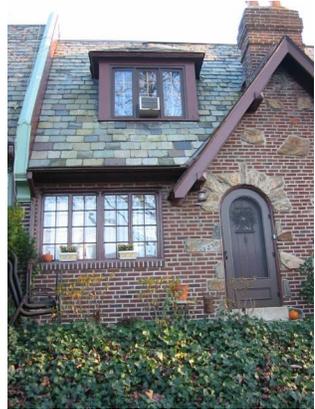
3438 Penn

Exterior Physical Condition: Good

Front - Brick: Re-pointed

Front - Storm/Screen Door: Replaced with aluminum storm door

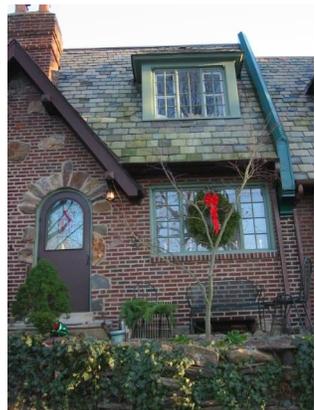
3440 Penn

Exterior Physical Condition: Good

Front - Storm/Screen Door: Replaced with wood screen door

Miscellaneous: Second floor window air conditioning unit added through window

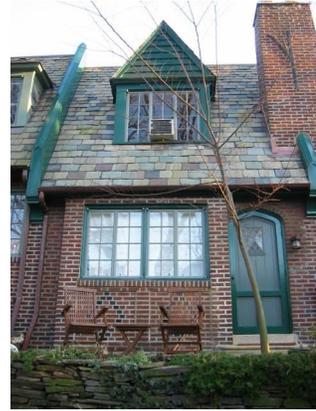
3442 Penn

Exterior Physical Condition: Good

Front - Second-Floor Steel Casement: Replaced with one/one double-hungs

Front - Storm/Screen Door: Replaced with wood screen door

Front - Second Floor Casement Surround: Aluminum clad

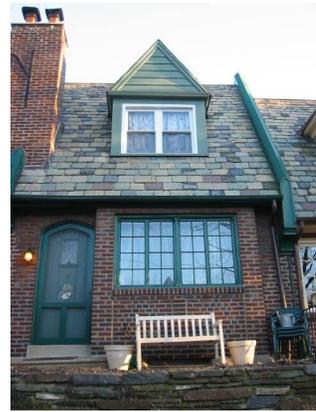
3444 Penn

Exterior Physical Condition: Good

Front - Second-Floor Steel Casement: Replaced with restored steel casements, side panels fixed

Front - Door Leaded Glass Pane: Leaded facsimile or original

Front - Storm/Screen Door: Replaced with wood screen door

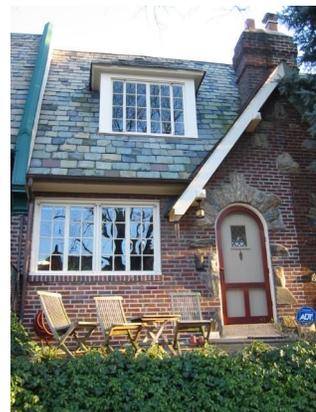
3446 Penn

Exterior Physical Condition: Good

Front - Lamp: Replaced

Front - Storm/Screen Door: Replaced with wood screen door

Miscellaneous: Second floor window air conditioning unit added through window

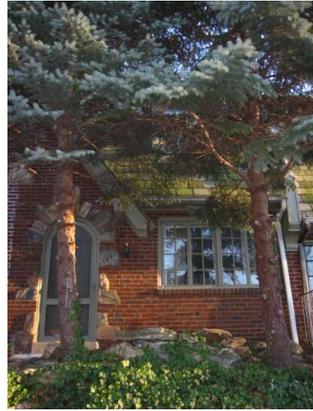
3448 Penn

Exterior Physical Condition: Good

Front - Brick: Re-pointed

Front - Door Leaded Glass Pane: Replaced with solid pane

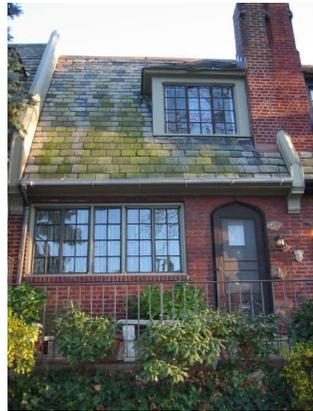
3450 Penn

Exterior Physical Condition: Good

Front - Lamp: Replaced

Front - Storm/Screen Door: Replaced with aluminum storm door

Miscellaneous: Second floor window air conditioning unit added through window

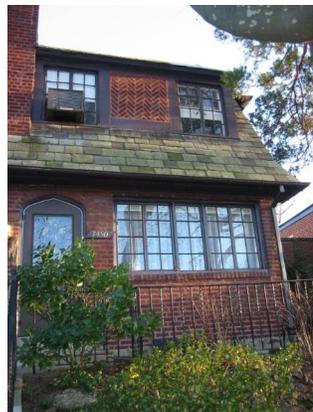
3452 Penn

Exterior Physical Condition: Good

Front - Lamp: Replaced

Front - Door Ledged Glass Pane: Replaced with solid pane with artificial lights*

Miscellaneous: Air conditioning unit added through second level side elevation brick

*Change occurred since date of photograph.

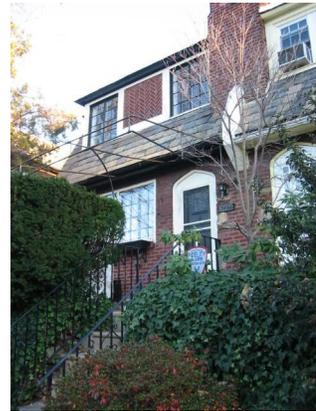
3454 Penn

Exterior Physical Condition: Good

Front - Lamp: Replaced

Front - Second-Floor Steel Casement: Replaced with one/one double-hungs, artificial divided lights

Front - Door Ledged Glass Pane: Leaded facsimile or original

Parapet: Aluminum clad

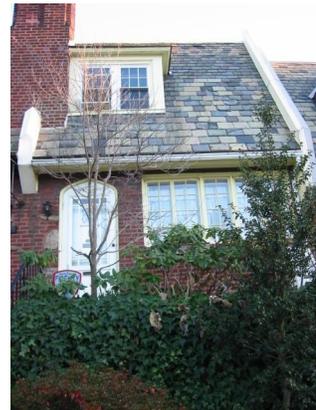
3456 Penn

Exterior Physical Condition: Good

Front - Storm/Screen Door: Replaced with wood storm door

Parapet: Aluminum clad

Miscellaneous: Muntin removed in second floor center casement for air conditioner (air conditioner not currently in place)

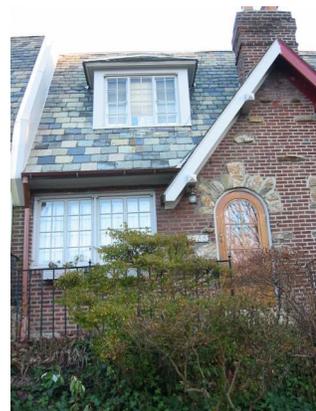
3458 Penn

Exterior Physical Condition: Good

Front - Door Leaded Glass Pane: Leaded facsimile or original

Front - Storm/Screen Door: Replaced with wood storm door

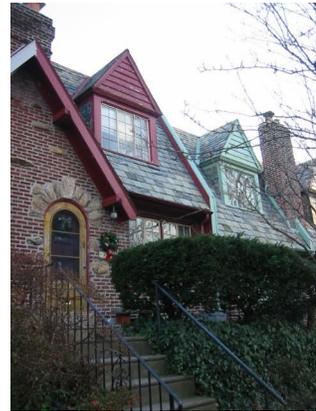
3460 Penn

Exterior Physical Condition: Good

Front - Lamp: Glass missing

Front - Door Leaded Glass Pane: Leaded facsimile or original

Front - Storm/Screen Door: Replaced with wood screen door

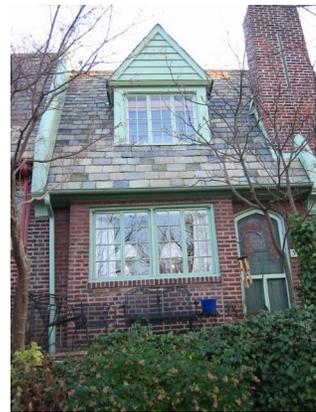
3462 Penn

Exterior Physical Condition: Good

Front - Lamp: Replaced

Front - Door Leaded Glass Pane: Leaded facsimile or original

Style Irregularity: Second-Floor Steel Casement window in dormer has leaded diamond-pane leaves rather than eight-light leaves (one of two houses of style A to have irregularity)

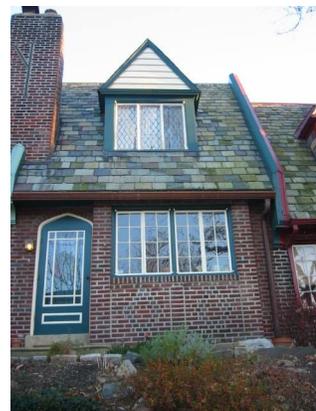
3464 Penn

Exterior Physical Condition: Good

Front - Second-Floor Steel Casement: Replaced with two casement leaves, center solid wood panel added with air conditioner

Front - Storm/Screen Door: Replaced with wood storm door

Front - Dormer: Aluminum clad appears to be added to dormer face

Miscellaneous: Second floor window air conditioning unit added through window

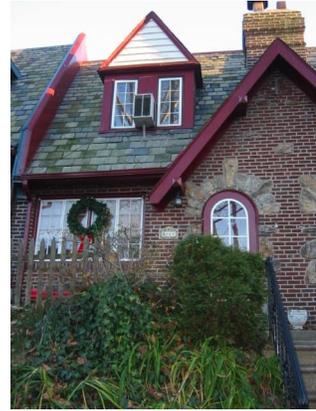
3466 Penn

Exterior Physical Condition: Good

Front - Lamp: Replaced

Front - Storm/Screen Door: Replaced with wood storm door
