5. INVENTORY

MIDVALE AVENUE

MIDVALE – ODD-NUMBERED SIDE

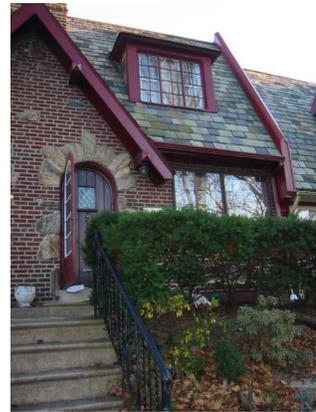
Front - Door Leaded Glass Pane: Leaded facsimile or original

Front - Storm/Screen Door: Replaced with wood storm door

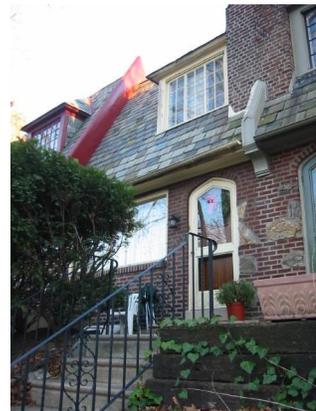
3468 Penn

Exterior Physical Condition: Good

Front - Door Leaded Glass Pane: Leaded facsimile or original

Front - Storm/Screen Door: Replaced with wood storm door

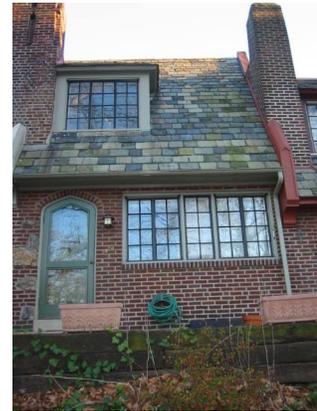
3470 Penn

Exterior Physical Condition: Good

Front - Lamp: Replaced

Front - Door Leaded Glass Pane: Leaded facsimile or original

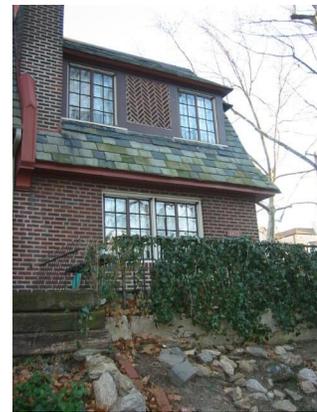
3472 Penn

Exterior Physical Condition: Good

Front - Lamp: Replaced

Style Irregularity: Slate mansard cap/skirt around perimeter of garage. Railing over garage for roof deck.* Roof deck and porch have awning, likely removable.*

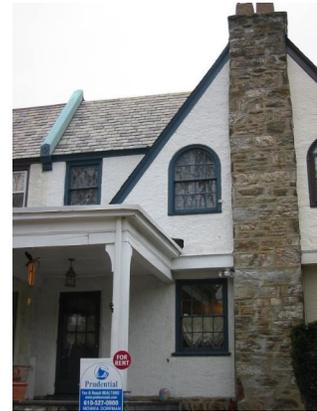
3403 Queen

Exterior Physical Condition: Good

Front - Lamp: Replaced

Front - Storm/Screen Door: Replaced with aluminum storm door

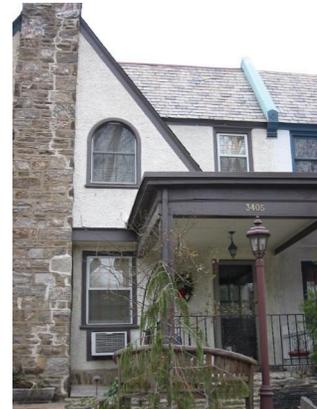
3405 Queen

Exterior Physical Condition: Good

Front - Porch: Wood balustrade removed except for common portion, replaced with steel; ceiling covered by what appears to be fiberboard

Front - Lamp: Replaced

Front - 1st Floor Wood, D/H Window: Replaced with one/one double-hung, artificial divided lights

Front - Second Floor, D/H Window: Leaded double-hung replaced with one/one double-hung with artificial divided lights; Arched double-hung replaced with one/one double-hung with artificial divided lights

Front - Storm/Screen Door: Replaced with aluminum storm door

Miscellaneous: Air conditioning unit through first level stucco front

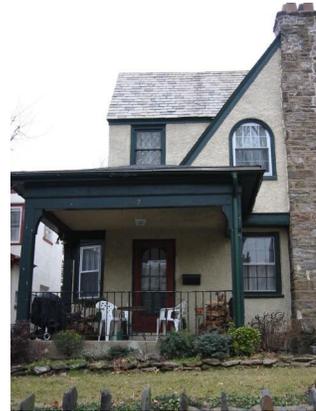
3407 Queen

Exterior Physical Condition: Good

Roof - Slate: Porch slate replaced by asphalt shingles

Front - Porch: Wood balustrade removed, replaced with steel

Front - Lamp: Replaced

Front - Second Floor, D/H Window: Arched double-hung replaced with one/one double-hung with artificial divided lights

Front - Storm/Screen Door: Replaced with wood storm door

Side Elevation - Windows: Forward side first floor bay windows replace by one/one double hungs, forward side second floor window replaced by louver window. Exterior storms also added to several side elevation windows

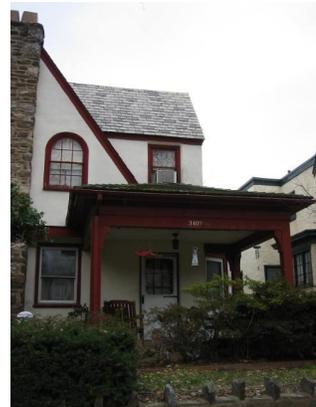
3409 Queen

Exterior Physical Condition: Good

Roof - Slate: Porch slate replaced by wood shingles

Front - Lamp: Replaced

Front - 1st Floor Wood, D/H Window: Replaced with one/one double-hung

Front - Second Floor, D/H Window: Replaced by vinyl one/one double-hung, artificial divided light*

Front - Storm/Screen Door: Replaced with aluminum storm door

Side Elevation - Windows: One replace with fixed light, two replaced with single pane triple-hung, others with one/one double-hungs

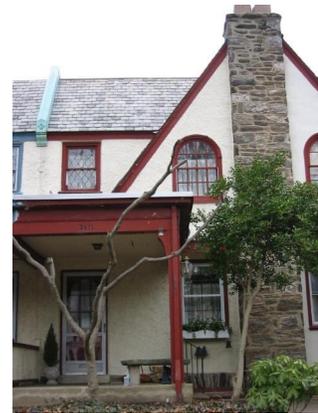
3411 Queen

Exterior Physical Condition: Good

Front - Porch: Wooden plank ceiling; missing brackets*

Front - Lamp: Replaced

Front - Storm/Screen Door: Replaced with aluminum storm door

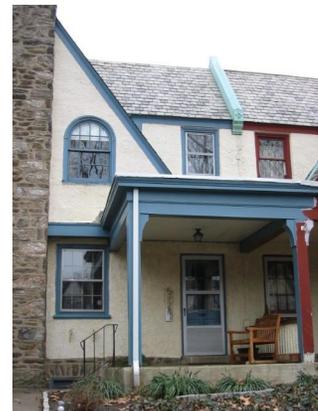
3413 Queen

Exterior Physical Condition: Good

Front - Lamp: Replaced

Front - Second Floor, D/H Window: Exterior storm added over leaded glass double-hung

Front - Storm/Screen Door: Replaced with aluminum storm door

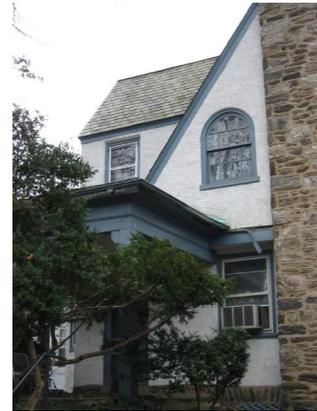
3415 Queen

Exterior Physical Condition: Good

Roof - Slate: Porch slate replaced by asphalt shingles

Front - Storm/Screen Door: Replaced with wood screen door

Side Elevation - Windows: Exterior storms added

Side Elevation - Window Surrounds: Clad sill

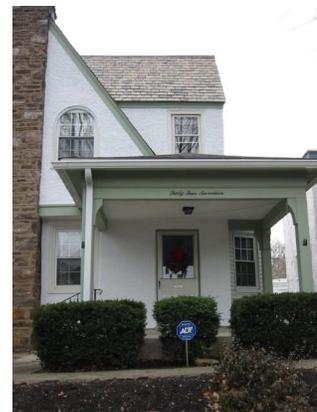
3417 Queen

Exterior Physical Condition: Good

Roof - Slate: Porch slate replaced by asphalt shingles

Front - Lamp: Replaced

Front - 1st Floor Wood, D/H Window: Replaced with one/one double-hung, artificial divided lights

Front - Second Floor, D/H Window: Both replaced with one/one double-hungs, artificial divided lights

Front - Storm/Screen Door: Replaced with aluminum storm door

Side Elevation - Window Surrounds: Clad

Miscellaneous: Side bay has vinyl clad

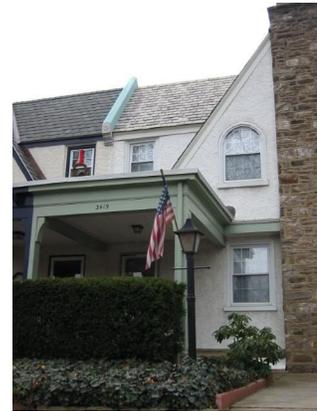
3419 Queen

Exterior Physical Condition: Good

Front - Lamp: Replaced

Front - 1st Floor Wood, D/H Window: Replaced with one/one double-hung, artificial divided lights

Front - Second Floor, D/H Window: Both replaced with one/one double-hungs, artificial divided lights

Front - Storm/Screen Door: Replaced with aluminum storm door

Front - Rake Molding: Aluminum clad

Front - Second Floor Six/Six D/H Surround: Aluminum clad

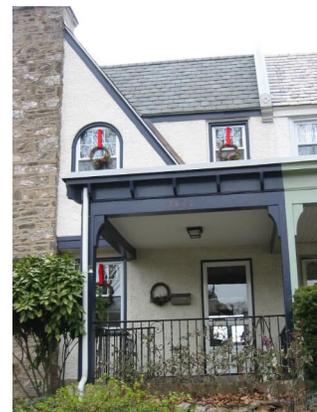
3421 Queen

Exterior Physical Condition: Good

Roof - Slate: Slate removed and replaced with asphalt shingles

Front - Porch: Wood balustrade removed, replaced with steel; ceiling appears covered by dry board

Front - Lamp: Replaced

Front - 1st Floor Wood, D/H Window: Replaced with one/one double-hung, artificial divided lights

Front - Second Floor, D/H Window: Both replaced with one/one double-hungs, artificial divided lights

Front - Storm/Screen Door: Replaced with aluminum storm door

Miscellaneous: False rafter ends added to porch

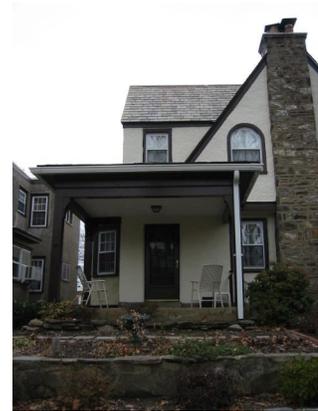
3423 Queen

Exterior Physical Condition: Good

Front - Lamp: Replaced

Front - 1st Floor Wood, D/H Window: Replaced with one/one double-hung, artificial divided lights

Front - Second Floor, D/H Window: Both replaced with one/one double-hungs, artificial divided lights

Front - Storm/Screen Door: Replaced with aluminum storm door

Front - Second Floor Six/Six D/H Surround: Aluminum clad

Side Elevation - Windows: All windows replaced with mix of double-hungs, casements and sliders

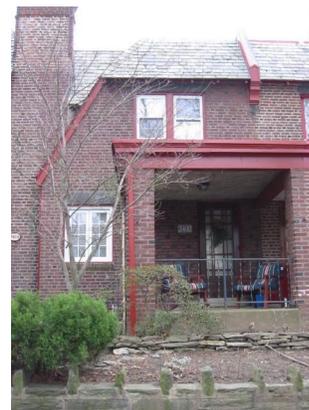
3402 Queen

Exterior Physical Condition: Good

Front - Lamp: Replaced

Front - Second-Floor Steel Casement: Replaced with one/one double-hungs, artificial divided lights

Front - First Floor Casement Surround: Partially aluminum clad

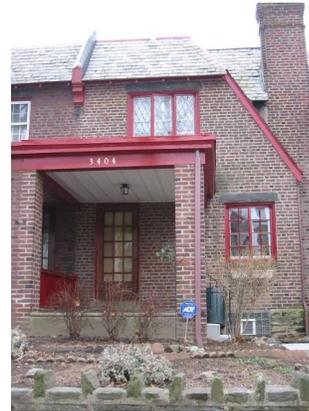
3404 Queen

Exterior Physical Condition: Good

Front - Lamp: Replaced

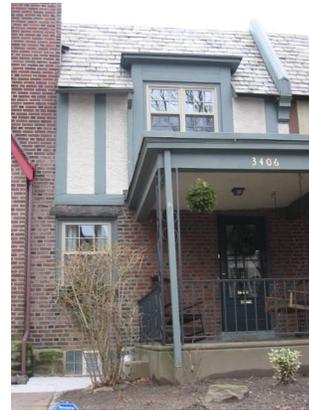
3406 Queen

Exterior Physical Condition: Good

Front - Porch: Common wood balustrade removed, replaced with steel

Front - Lamp: Replaced

Front - Second-Floor Steel Casement: Replaced with one/one double-hungs, artificial divided lights

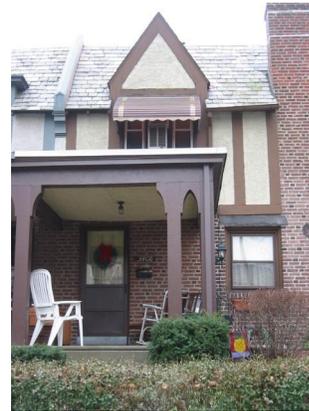
3408 Queen

Exterior Physical Condition: Good

Front - Lamp: Replaced

Front - Second-Floor Steel Casement: Replaced with three double hungs

Front - Storm/Screen Door: Replaced with aluminum storm door

Miscellaneous: Air conditioning unit in center of second floor front window

Miscellaneous: Awning added to second floor dormer

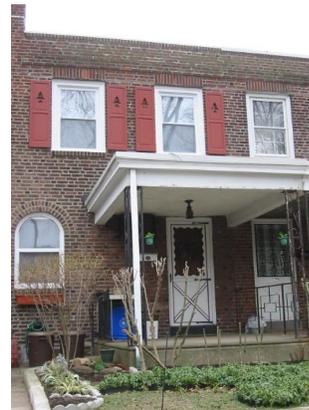
3410 Queen

Exterior Physical Condition: Good

Front - Porch: Wood balustrade replaced with steel; wood pillars replaced by forged steel supports

Front - 1st Floor Wood, D/H Window: Replaced with one/one double-hung

Front - Second Floor, D/H Window: Replaced by two double-hungs

Front - Storm/Screen Door: Replaced with aluminum storm door

Miscellaneous: False shutters added to second floor front windows

Miscellaneous: Air conditioning unit through first floor brick façade

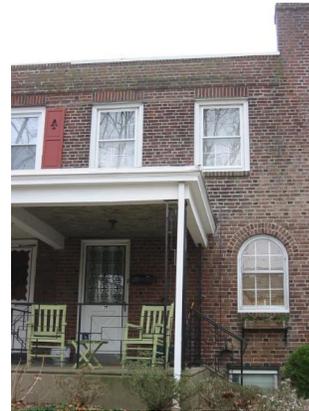
3412 Queen

Exterior Physical Condition: Good

Front - Porch: Wood balustrade replaced with steel; wood pillars replaced by forged steel supports

Front - Lamp: Replaced

Front - 1st Floor Wood, D/H Window: Replaced with one/one double-hung, artificial divided lights

Front - Second Floor, D/H Window: Replaced by two double-hungs, artificial divided lights

Front - Storm/Screen Door: Replaced with aluminum storm door

Front - Second Floor Casement Surround: Aluminum clad

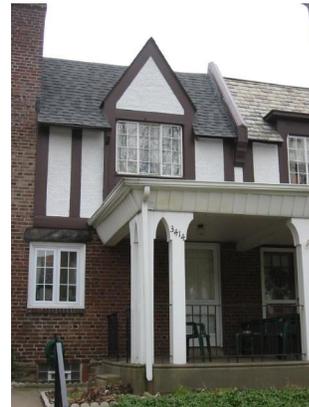
3414 Queen

Exterior Physical Condition: Good

Roof - Slate: Slate removed and replaced with asphalt shingles

Front - Lamp: Replaced

Front - Flat head Door: Twelve light door replaced with solid door

Front - Storm/Screen Door: Replaced with aluminum storm door

Front - Porch Siding: Aluminum cladding on eave and soffit of porch

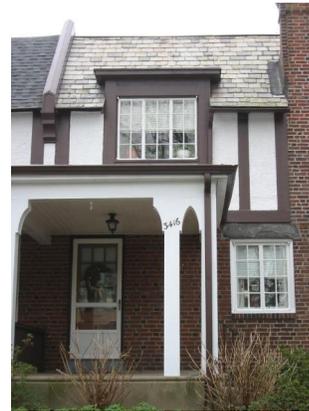
3416 Queen

Exterior Physical Condition: Good

Front - Lamp: Replaced

Front - Storm/Screen Door: Replaced with aluminum storm door

Front - First Floor Casement Surround: Aluminum clad

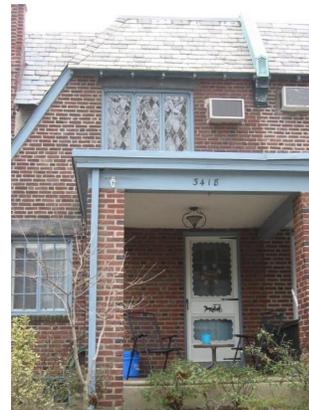
3418 Queen

Exterior Physical Condition: Good

Front - Lamp: Replaced

Front - Storm/Screen Door: Replaced with aluminum storm door

Miscellaneous: Air conditioning unit through brick in second floor front

Style Irregularity: Flat-head door with six-lights, lights forming arch at head and two vertically oriented panels; rather than, twelve-light door.

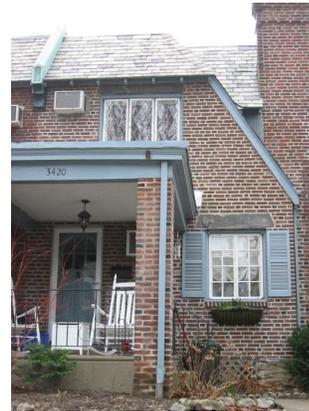
3420 Queen

Exterior Physical Condition: Good

Front - Lamp: Replaced

Front - Storm/Screen Door: Replaced with aluminum storm door

Miscellaneous: Air conditioning unit through brick in first and second floor front

Miscellaneous: False shutters added to first floor front window

Style Irregularity: Flat-head door with six-lights, lights forming arch at head and two vertically oriented panels; rather than, twelve-light door.

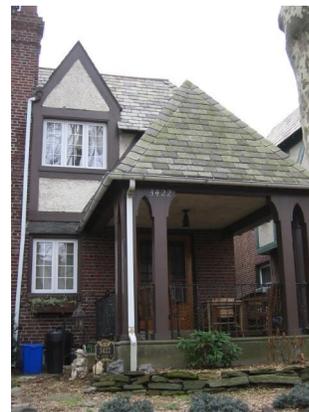
3422 Queen

Exterior Physical Condition: Good

Front - Second-Floor Steel Casement: Replaced with casement leaves, artificial divided light

Front - Storm/Screen Door: Replaced with wood storm door

Side Elevation - Windows: Replaced with mix of one/one double-hungs, and casements, artificial divided lights

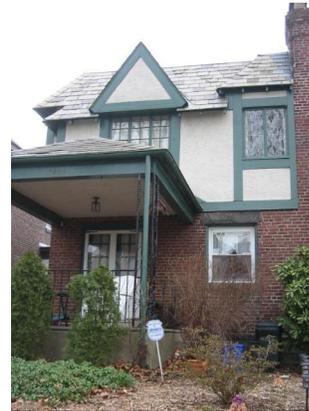
3424 Queen

Exterior Physical Condition: Good

Front - Porch: Wood balustrade replaced with steel

Front - Lamp: Replaced

Front - Storm/Screen Door: Replaced with aluminum storm door

Side Elevation - Windows: Several replaced with double-hungs; exterior storms added

Miscellaneous: Side elevation rearward bay aluminum clad

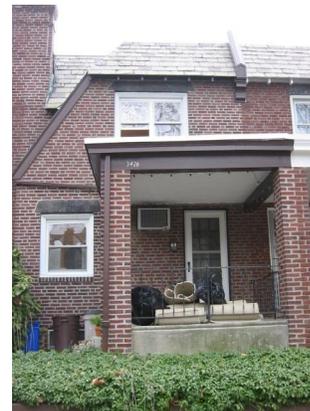
3426 Queen

Exterior Physical Condition: Good

Front - Porch: Wood balustrade replaced with steel

Front - Lamp: Removed from porch ceiling, replacement affixed to façade

Front - All Windows: Replaced with vinyl casement; surrounds aluminum or vinyl clad.*

Front - Storm/Screen Door: Replaced with aluminum storm door

Miscellaneous: Air conditioning unit through brick in first floor front

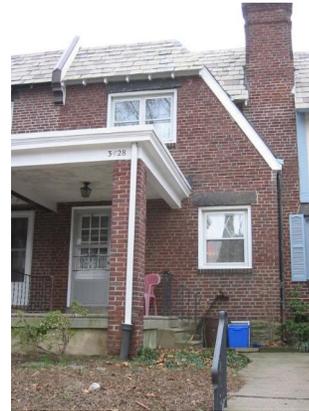
3428 Queen

Exterior Physical Condition: Good

Front - Lamp: Replaced

Front - Second-Floor Steel Casement: Replaced with one/one double-hungs

Front - Storm/Screen Door: Replaced with aluminum storm door

Front - Second Floor Casement Surround: Aluminum clad

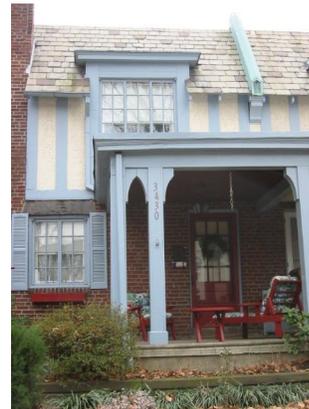
3430 Queen

Exterior Physical Condition: Good

Front - Lamp: Replaced

Front - Storm/Screen Door: Replaced with aluminum storm door

Front - All Windows: Replaced with vinyl casement; surrounds aluminum or vinyl clad.*

Miscellaneous: False shutters added to first floor front window

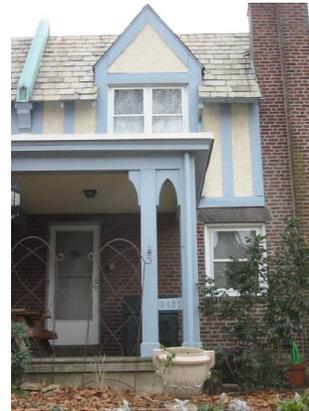
3432 Queen

Exterior Physical Condition: Good

Front - Lamp: Replaced

Front - Second-Floor Steel Casement: Replaced with one/one double-hungs

Front - Flat head Door: Twelve light door replaced with solid door

Front - Storm/Screen Door: Replaced with aluminum storm door

Front - First Floor Window: Replaced with vinyl D/H window with vinyl or aluminum surrounds.*

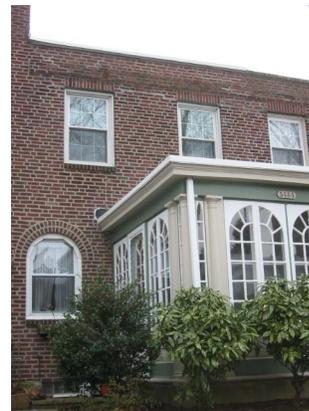
3434 Queen

Exterior Physical Condition: Good

Front - Porch: Square pillars replaced by Tuscan columns; wood balustrade removed; porch enclosed with casement windows, true divided light

Front - Lamp: Replaced

Front - 1st Floor Wood, D/H Window: Replaced with one/one double-hung

Front - Second Floor, D/H Window: Replaced with one/one double-hungs, artificial divided lights

Front - Second Floor Six/Six D/H Surround: Aluminum clad

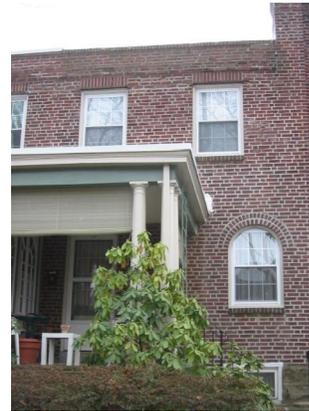
3436 Queen

Exterior Physical Condition: Good

Front - Porch: Square pillars replaced by Tuscan columns;
wood balustrade removed

Front - Lamp: Replaced

Front - 1st Floor Wood, D/H Window: Replaced with
one/one double-hung, artificial divided lights

Front - Second Floor, D/H Window: Replaced with one/one
double-hungs, artificial divided lights

Front - Storm/Screen Door: Porch door added along with
aluminum storm door

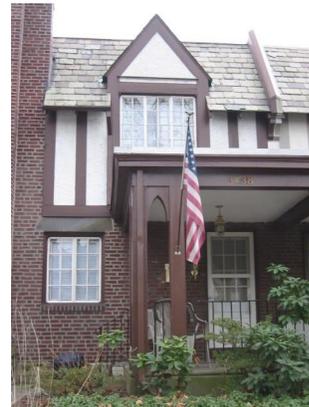
3438 Queen

Exterior Physical Condition: Good

Front - Porch: Wood balustrade replaced with steel

Front - Lamp: Replaced; additional lamp affixed to façade

Front - Storm/Screen Door: Replaced with aluminum storm
door

Front - First Floor Window: Replaced with vinyl casement.*

Front - Second Floor Window: Replaced with two one/one
D/H vinyl windows.*

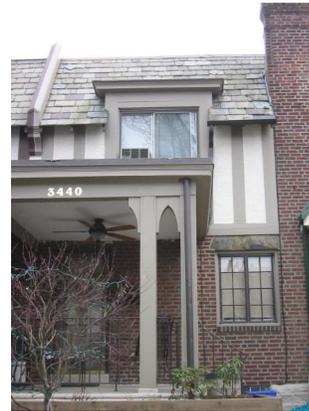
3440 Queen

Exterior Physical Condition: Good

Front - Porch: Wood balustrade replaced with steel

Front - Lamp: Replace by ceiling fan with light, porch hung

Front - Second-Floor Steel Casement: Replaced with two light casemnt window*

Front - Storm/Screen Door: Replaced with aluminum storm door

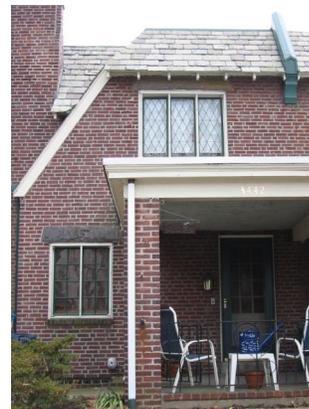
3442 Queen

Exterior Physical Condition: Good

Front - Lamp: Removed from porch ceiling, replacement affixed to façade

Front - All Windows: Replaced with vinyl casement; surrounds aluminum or vinyl clad.*

Front - Storm/Screen Door: Replaced with aluminum storm door

Miscellaneous: Single brick course added to porch's forward concrete edge

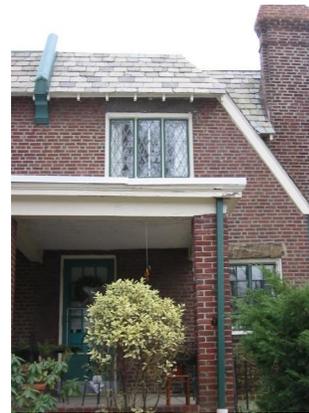
3444 Queen

Exterior Physical Condition: Good

Front - Lamp: Removed from porch ceiling, replacement affixed to façade

Front - Storm/Screen Door: Replaced with aluminum storm door

Miscellaneous: Single brick course added to porch's forward concrete edge

Miscellaneous: Several courses of brick at chimney head replaced

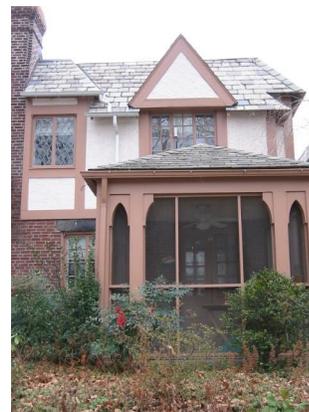
3446 Queen

Exterior Physical Condition: Good

Front - Lamp: Replace by ceiling fan with light, porch hung

Front - All Windows: Replaced with vinyl casement; surrounds aluminum or vinyl clad.*

Miscellaneous: Several courses of brick at chimney head replaced

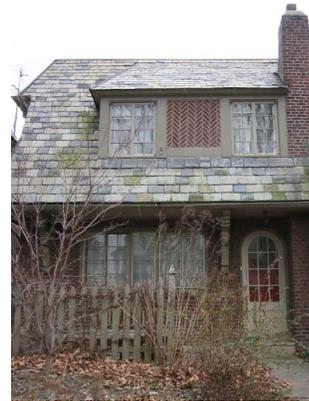
3448 Queen

Exterior Physical Condition: Good

Front - Lamp: Replaced

Front - All Windows: Replaced with vinyl casement; surrounds aluminum or vinyl clad.*

Side Elevation - Windows: One first floor rearward window replaced with casement; first floor exterior storms added

Miscellaneous: Air conditioning unit through brick in second floor forward side elevation

Style Irregularity: Has timber brackets supporting first floor eave; round-arched door rather than Tudor-arched door; lamp affixed to eave rather than façade; chimney not common; and rearward side elevation does not have brick bay.

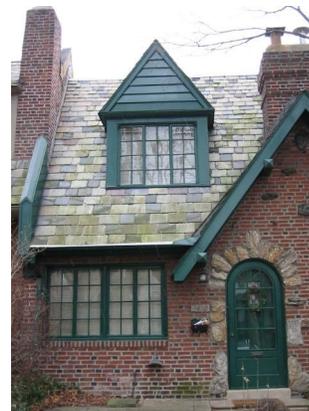
3450 Queen

Exterior Physical Condition: Good

Front - All Windows: Replaced with double-hung, artificial divided light. First- and second-floor double-hung surround covered in aluminum or vinyl clad.*

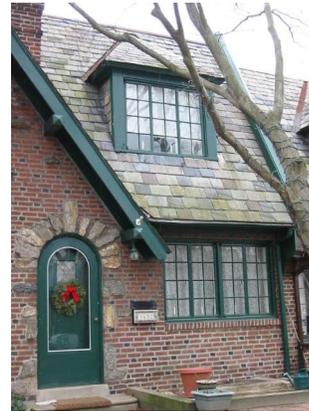
3452 Queen

Exterior Physical Condition: Good

Front - Storm/Screen Door: Replaced with aluminum storm door

Front - First Floor Window: Replaced with vinyl slider window with artificial diamond lights*

Front - Second Floor Window: Replaced with vinyl slider window with aluminum or vinyl cladding on surrounds*

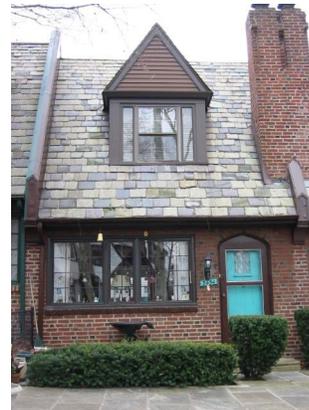
3454 Queen

Exterior Physical Condition: Good

Front - Lamp: Replaced

Front - Second-Floor Steel Casement: Replaced with one/one double-hungs w/ two flanking panes, artificial divided lights

Front - Storm/Screen Door: Replaced with aluminum storm door

Miscellaneous: First floor brick window sill painted

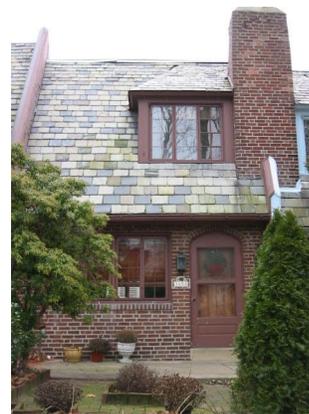
3458 Queen

Front - First Floor Window: Storm windows over individual leaves*

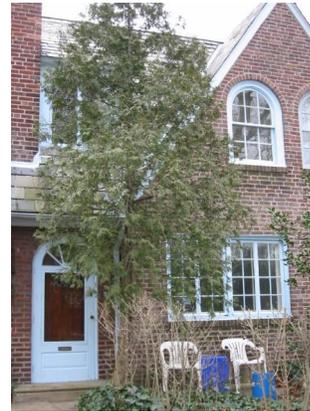
3460 Queen

Front - Door Leaded Glass Pane: Leaded facsimile or original

Front - Storm/Screen Door: Replaced with wood storm door

Style Irregularity: Round-arched door rather than Tudor-arched door

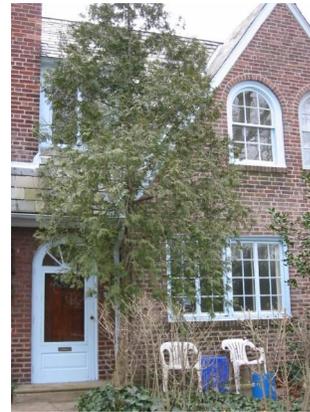
3462 Queen

Front - Door Leaded Glass Pane: Leaded facsimile or original

Front - Storm/Screen Door: Replaced with wood storm door

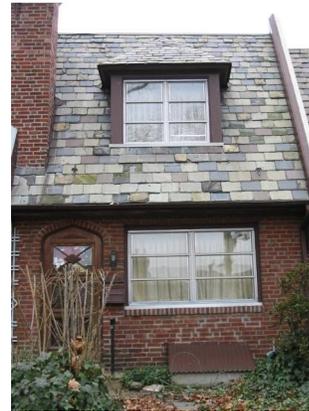
3464 Queen

Front - First Floor Casement Surround: Aluminum clad sill

Front - Second Floor Casement Surround: Aluminum clad sill

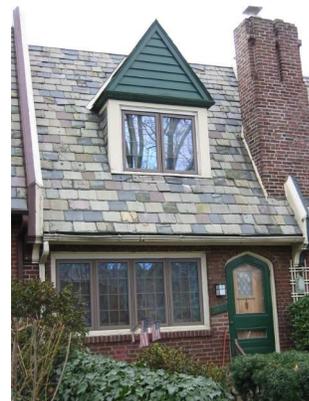
3466 Queen

Front - Second Floor Casement Surround: Aluminum clad

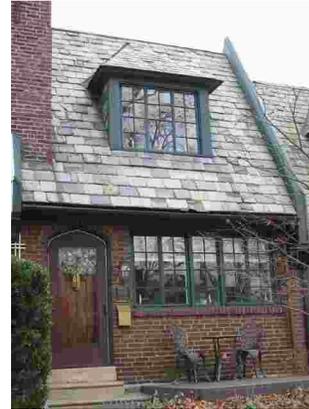
3468 Queen

Front - Dormer: Completely aluminum clad

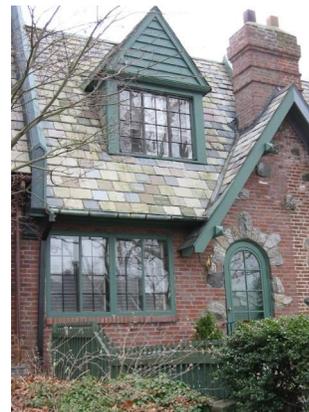
3470 Queen

Front - Lamp: Replaced and attached to façade rather than gable support

Front - Door Leaded Glass Pane: Leaded facsimile or original

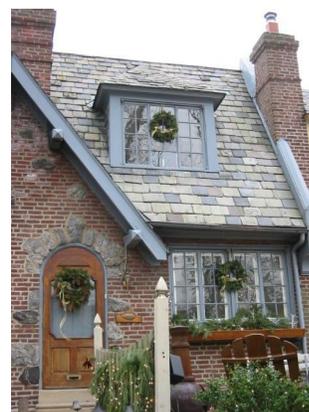
3472 Queen

Front - Door Leaded Glass Pane: Leaded facsimile or original

Front - Storm/Screen Door: Replaced with wood storm door

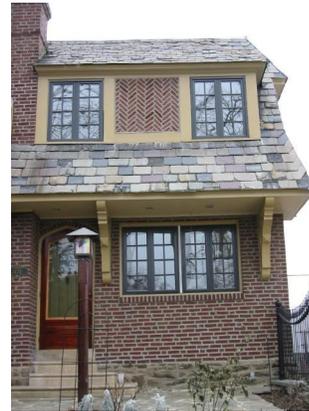
3474 Queen

Miscellaneous: High hat lighting added to front first floor soffit

Style Irregularity: Has timber brackets supporting first floor eave; lamp affixed to eave rather than façade; chimney not common; garage incorporated in basement with entry from Conrad Street; side elevation basement level is of fieldstone.
