ADDRESS: 107 CHESTNUT ST

Proposal: Complete demolition of Unsafe building

Structural Condition Assessment 107 Chestnut Street, Philadelphia, PA

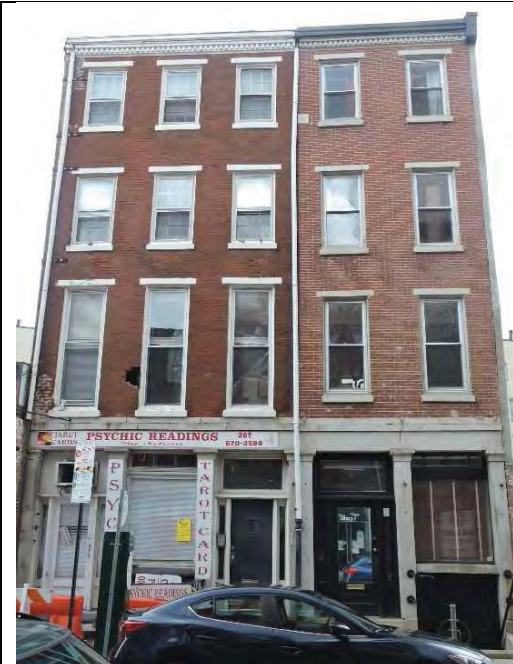
107 (left) and 105 Chestnut, looking north at frontage. Note the hole next to the 2nd Fl. window

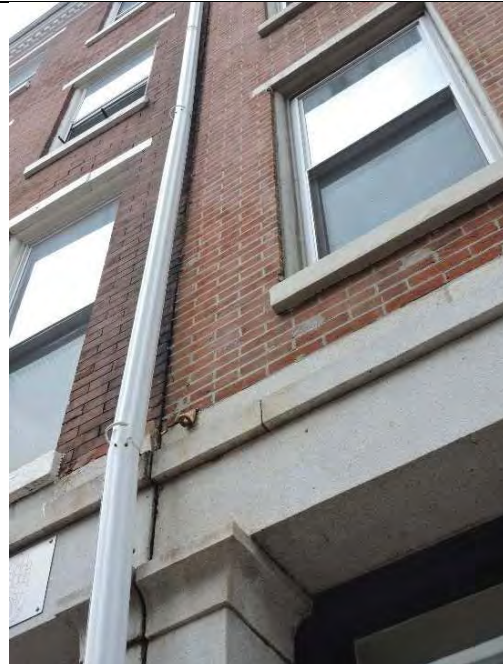
Full height joint between the facades.

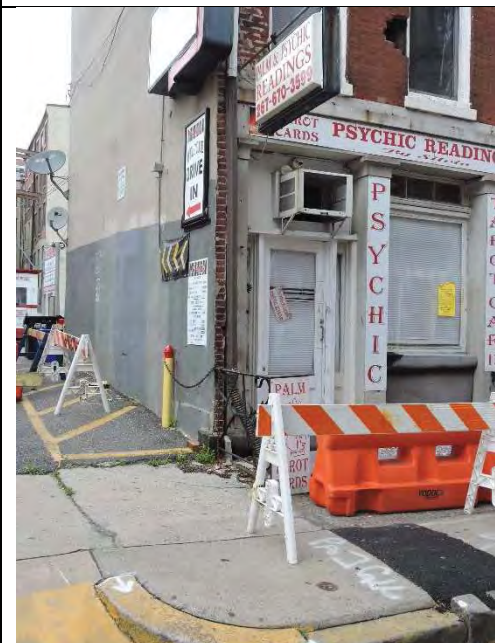
Southwest corner overview.

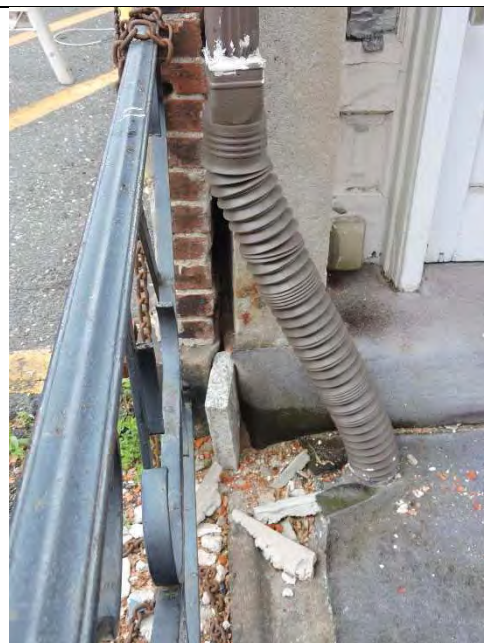
The combined observations of the increasing gap between the wythes of the west wall, and that the first floor joists have fallen out of their bearing pockets, seems to indicate that the foundation of the west wall is moving westward (see diagram on p. 6). The upper floor joists restrain this movement, creating bowing stresses in the wall that further distort the lower portion. This condition places the bearing wall in peril.

Gap between the 109 wythe and 107 wythe (behind the granite column) of the west wall.

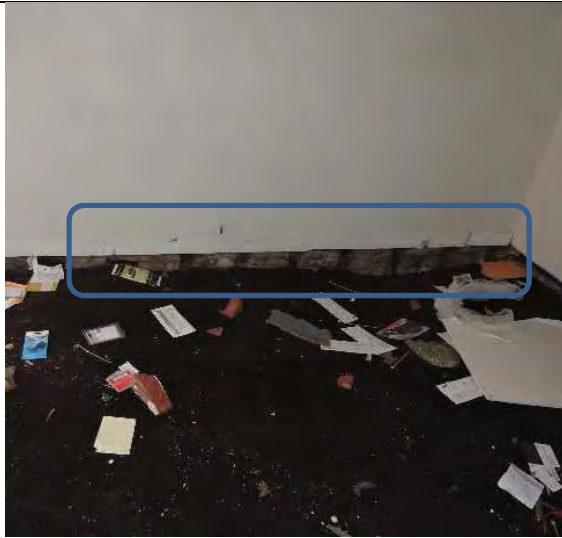
First floor joists have fallen out of the bearing pockets.

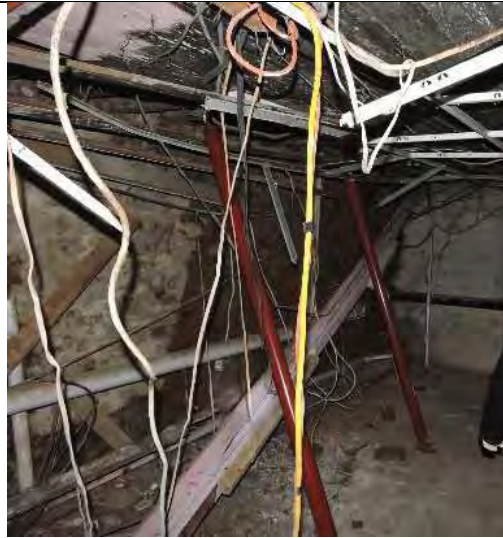
Screw jacks under the unsupported joists fell over recently.

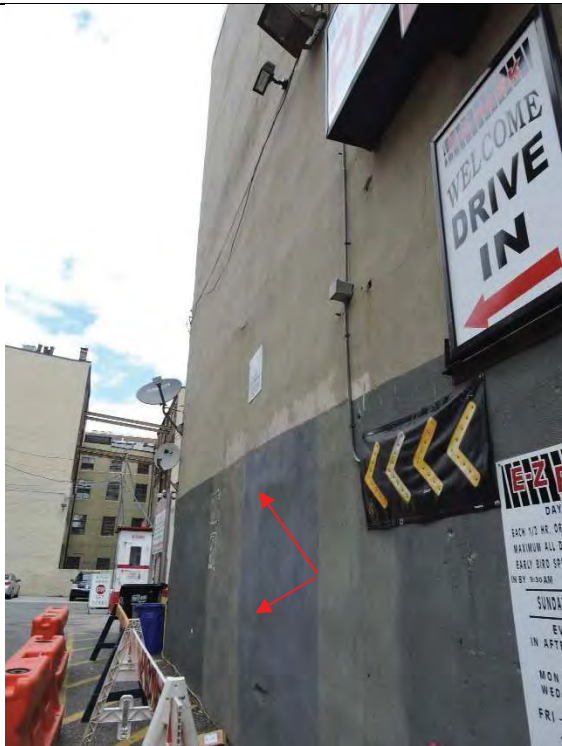
Stucco and wall are buckling.

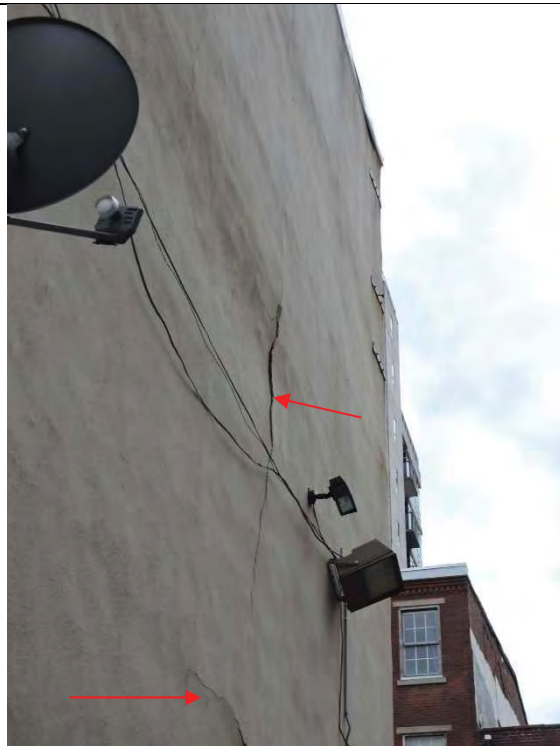
Stucco is delaminating.

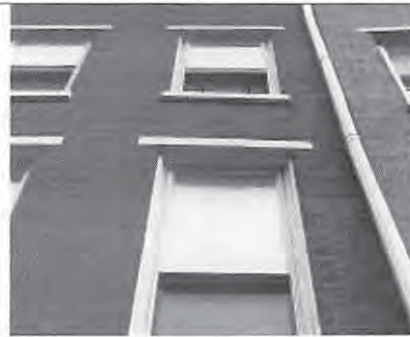
1. The front brick wall has moved laterally towards Chestnut Street. There is cracking and spalling, or pieces of it are breaking off, of the front wall at the third and second floor levels. This movement results in the load no longer being applied concentrically at the center of the wall. The eccentric load also furnishes a driving moment which will result in further movement of the wall outwards. Due to the movement the capacity of the wall is reduced. This condition is not repairable unless the wall is reconstructed. As such, the historical nature, aspects and/or fabric of the building would be altered.

The picture above shows movement below the window. The brick joints are open. This reduces the ability of the brick to transfer load due the reduced surface area. The walls are deteriorated. The picture to right shows a opening that has failed at the second floor. This opening is approximately 12 inches wide by 18 inches tall. This results in a reduced capacity of the pier to carry load. This condition is not repairable without complete reconstruction. Thus, the historical nature, aspects and/or fabric of the building would be altered.

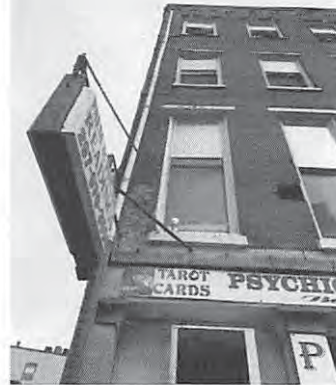
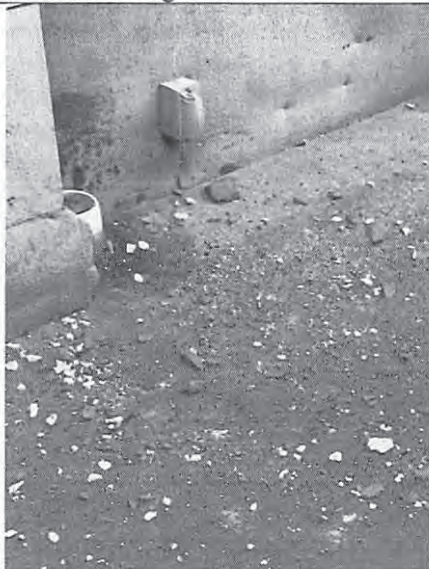
2. A portion of the front brick wall has fallen as shown in item #1. This opening is approximately 12 inches wide by 18 inches tall. This condition reduces the cross sectional area that the wall can use to support the loading. As such, the load carrying capacity of the wall is reduced. At my original inspection, the masonry was intact and no holes existed. This condition worsened over time. This condition is not repairable without complete reconstruction. Thus, the historical nature, aspects and/or fabric of the building would be altered.

The picture to the left shows the fallen debris on the ground on the front sidewalk of the structure. At the time of my original inspection, the hole and fallen debris did not exist. This condition is not repairable without complete reconstruction. Thus, the historical nature, aspects and/or fabric of the building would be altered.

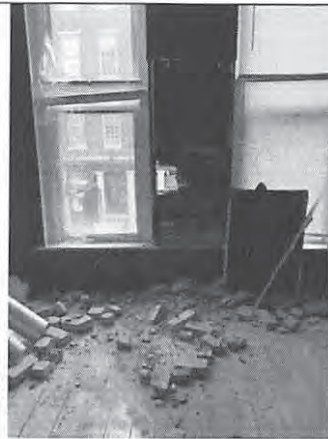
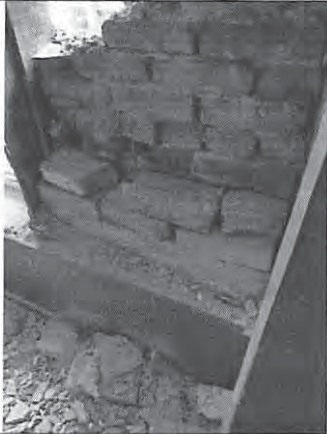
3. The front pier that has collapsed onto the side walk has deteriorated. This is a picture taken from within the second floor. The bricks have collapsed onto the second floor. The bricks are loose and easily removed by hand. They are no longer mortared together. They are a stack of cards and cannot carry load. The mortar has completely deteriorated. This pier is no longer carry loading. In order to repair this condition, the loading above would have to be shored and the pier completely removed and reconstructed. This would negatively impact the historical nature, aspects and/or fabric of the building.

This condition was not present at the time of my initial inspection.

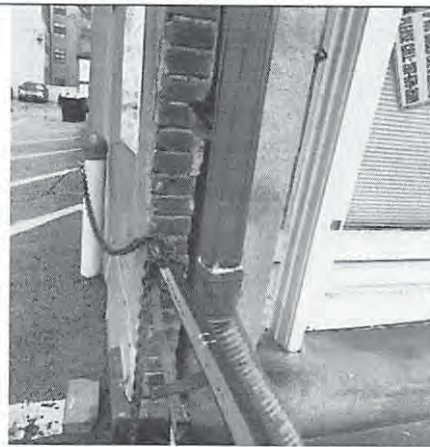
4. There is a large vertical crack that has widened on the front Southwest corner. The crack extends vertically up the entire height of the wall. It has been repaired on at least two occasions. This crack varies in width. It is approximately $\frac{3}{4}$ of an inch wide. The movement of these walls will only continue to worsen as water can now freeze in the crack. This condition shows that the walls have delaminated. In effect, the walls are two 4 inch thick walls rather than one 8 inch thick wall. The second portion of the wall is behind the downspout. This results in reduced load capacity of the wall. The crack has widened over the course of my inspections. This condition is not repairable without complete reconstruction. Thus, the historical nature, aspects and/or fabric of the building would be altered.

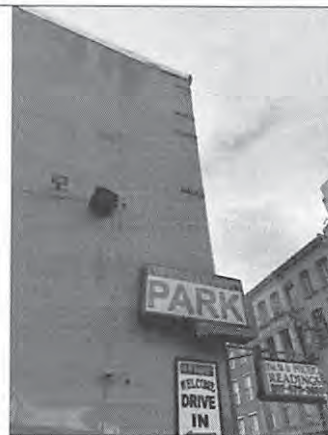
5. There is steel strapping present at the top of the front west corner. These straps indicate a previous repair completed at the top of the wall. The repair is approximately 10 years old. There are four straps that appear to be 3 inches wide by 3 feet long. The repair indicates that the building corner was moving and is no longer in its original condition. The masonry is not properly integrated together. While the strapping is working, it is unattractive and negatively impacts the historical nature, aspects and/or fabric of the building.

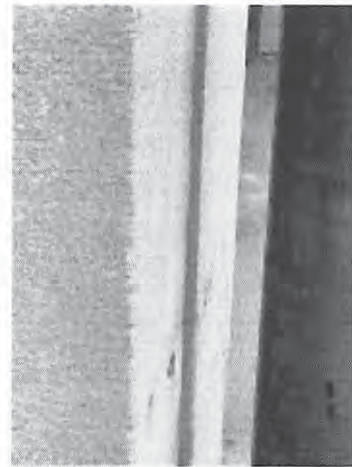
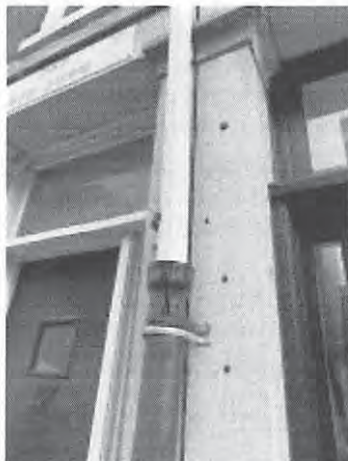
6. The front wall where it adjoins the building to the east also shows separation, shifting and lateral movement. The movement indicates that the building has sifted relative to the neighboring east building and has gotten larger over the time of my inspections. The movement noted is approximately $\frac{3}{8}$ of an inch. The joint exists for the full height of the structure along the east side. Due to movement, the loading above is now eccentric to the wall. This results in the wall continuing to laterally move and the condition to worsen over time. In order to repair this condition, the wall would have to be removed, reconstructed and properly secured to the floors behind. This would negatively impact the historical nature, aspects and/or fabric of the building.

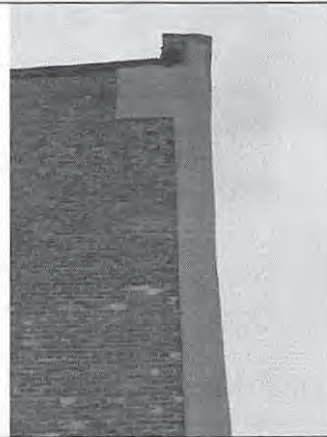
7. The upper parapets are not water protected. There is no cap flashing and the top of the wall is water stained. As such, water is entering into the wall resulting in further movement. The water infiltration is visible on the upper parapet of the structure.

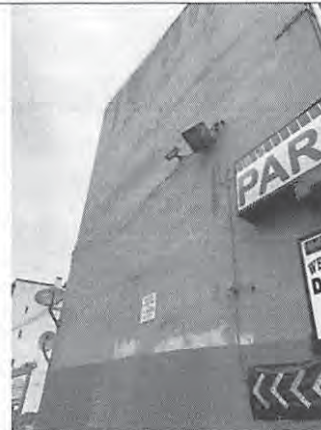
8. The west wall is pulling away from the building to the west. This is indicated by the cracking and spalling of the stucco. Please note that the wall has bulged and rolled. This movement results in the load no longer being applied concentrically at the center of the wall. The eccentric load also furnishes a driving moment which will result in further movement of the wall outwards. Due to the movement the capacity of the wall is reduced. The joists are dislodged from their original bearing condition. With the floor removed, the wall becomes more slender and longer. The load carrying capacity of the wall is reduced. This condition is not repairable without complete reconstruction. Thus, the historical nature, aspects and/or fabric of the building would be altered.

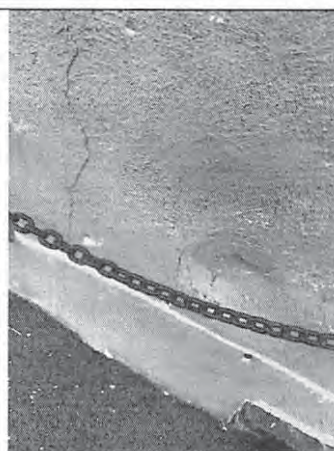
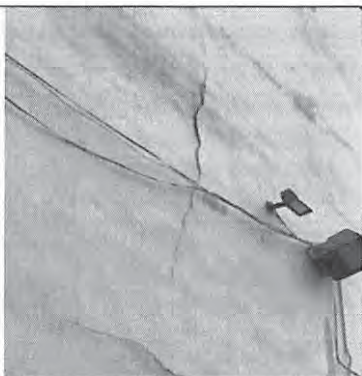
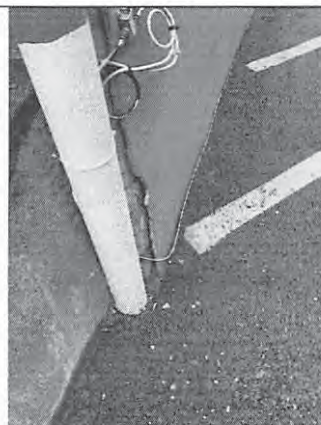
9. There are numerous areas where the stucco coating has delaminated and moved away from the exterior walls. The stucco is cracked and bulging. The cracks vary in thickness from 1/8 to 3/8 of an inch in width. Some cracks are small other are over 8 feet in length. The impact on the picture to the right shows that the stucco has delaminated over 3 inches away from the face. The movement also is visible at the ends of the stucco where it adjoins the brick face. This is visible within the lower right picture. The stucco presents a dangerous condition because pieces are falling to the ground. These conditions have worsened over the time of my inspections. This condition is not repairable without complete removal and reconstruction of the stucco. Thus, the historical nature, aspects and/or fabric of the building would be altered.

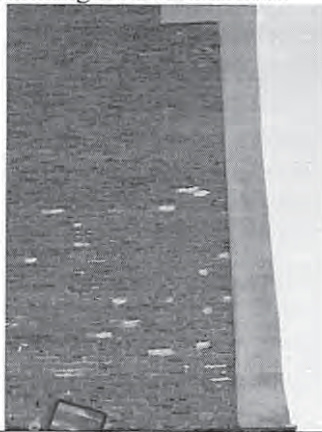
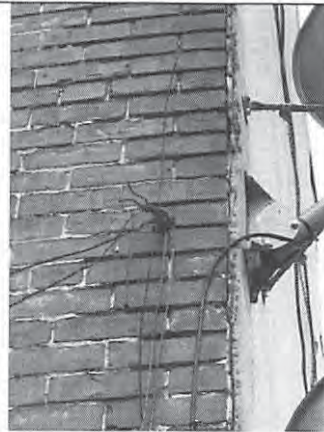
10. Several bricks are missing or have been infilled on the rear east corner. This is indicated by the holes in the picture below. The infilled bricks are white. The bricks have further deteriorated over the time of my inspections. Additional brick faces have spalled or deteriorated. This condition is indicative of deterioration of the brick and reduced load carrying capacity of the wall. This condition is not repairable without removal and replacement of the damaged brick. Thus, the historical nature, aspects and/or fabric of the building would be altered.

This picture shows missing mortar within the brick joints. This missing mortar indicates that the wall has deteriorated. This results in a reduced load carrying capacity of the wall. The mortar joints have deteriorated further over the time my inspections. This condition is not repairable without replacement of the mortar. The mortar composition and color would not match the original construction. Thus, the historical nature, aspect and/or fabric of the building would be altered.

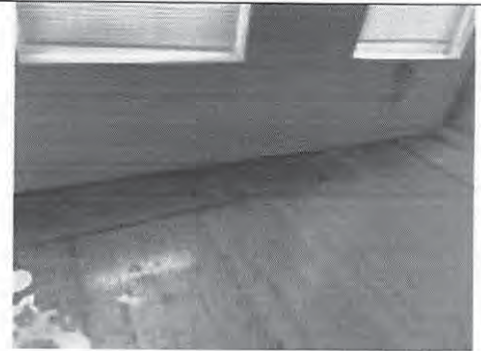
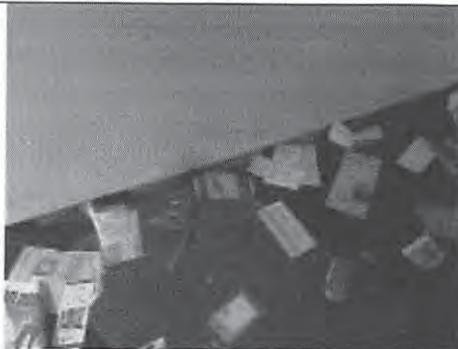
11. All floors are loose and not level. The picture to the right shows an increased gap between the baseboard and the floor. The gap is over $\frac{1}{2}$ of inch wide. The gap on the left side is larger than the gap on the right. This indicates that the front wall has moved laterally forward. This condition has worsened over the time of my inspections. In order to level the floor, the floor boards would have to be removed. Thus, the historical nature, aspects and/or fabric of the building would be altered

This picture to the left shows the movement downward on the first floor. The floor was originally at the bottom of the white wall. The movement downwards is a maximum of 4 inches. This indicates that the joists are not laterally supporting the wall and that the wall will continue to move. The floor joists have deteriorated and require complete replacement. Thus, the historical nature, aspects and/or fabric of the building would be altered. This condition has worsened over the time of my inspections.

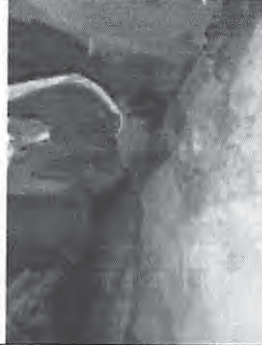
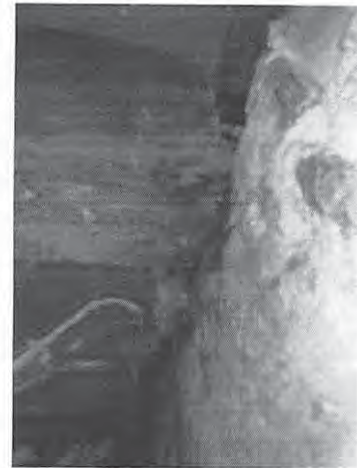
12. The west end of the joists are almost completely out their pockets on the first floor. This condition had and will continue to worsen. The joists have moved further out of the pockets and floor has moved downwards. There is no bearing contact of the joist to a minimal 1 inch bearing contact of the joist to the wall. The joist ends are rotted. The load carrying capacities of these members are compromised. The first floor is unstable and potentially can collapse. The floor no longer provides lateral support for the wall.

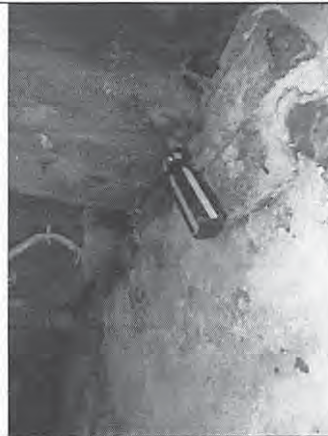
13. The first floor joists on both the east and west ends are rotted. These members are easily penetrated by a screw driver under normal hand pressure. This condition has worsened over the time of my inspections. The deterioration indicates that the member is structurally compromised and can no longer sustain its required loading without removal or repair. This would result in negatively impacting the historical nature, aspects and/or fabric of the building.

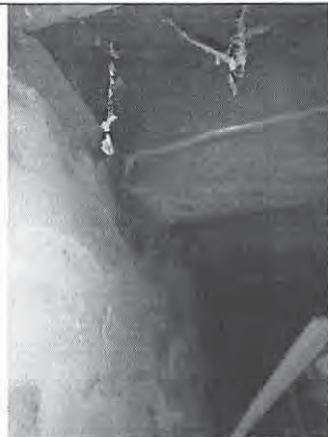
14. There are cracked joists within the first floor visible on the east end. The crack is approximately $\frac{1}{4}$ of an inch in width and extend 6 feet long. The crack reduces the member available to carry loading. Its load carrying capacity is reduced. The deterioration indicates that the member is structurally compromised and can no longer sustain its required loading without removal or repair. This would result in negatively impacting the historical nature, aspects and/or fabric of the building.

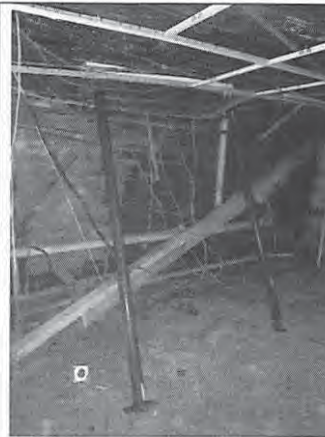
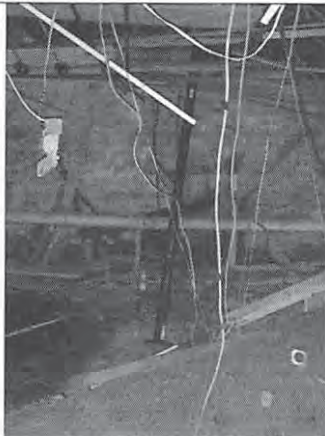
15. The temporary supports for the first floor joists have shifted. The supports are no longer plumb or supporting. During my original inspection these members were plumb. The shifting indicates that the floor has moved downwards and outwards. It indicates that the building is continuing to move. In order to repair this condition, the entire floor and wall have to be reconstructed. The joists immediately must be removed and replaced. The wall has to be reconstructed to eliminate the water infiltration.

Any repair/reconstruction would result in negatively impacting the historical nature, aspects and/or fabric of the building.

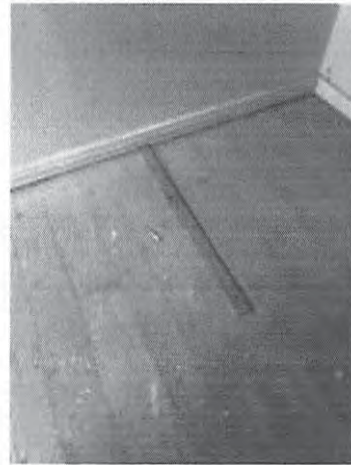
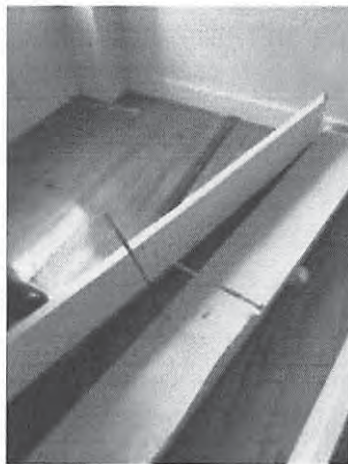
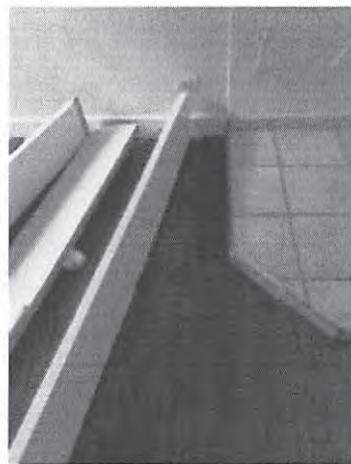
16. There is steel strapping present at the second and third floor level that attaches the floor to the rear wall. This indicates a prior repair. This repair is over 10 years old. The repair indicates that the building was moving. While the strapping is working, it is unattractive and negatively impacts the historical nature, aspects and/or fabric of the building.

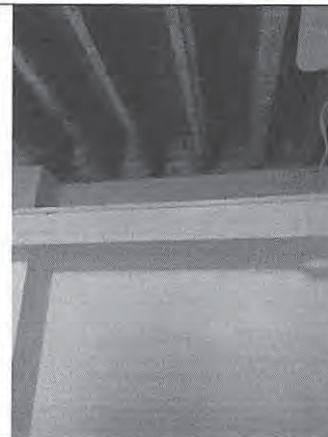
17. Several joists are loose in the joist pockets on the upper levels. This is evidence by the creaking and movement when walking on the floors above. These joists are no longer secured in the pocket due to deterioration of the brick and the mortar. This picture shows the condition of the brick and pockets at the third floor. There is missing mortar within the brick joints in the picture at the left.

The picture to the left shows deteriorated brick dust on the insulation. This indicates that the bricks are crumbling due to water infiltration within the building. This reduces the load carrying capacity of the brick. In order to repair this condition, the bricks would require removal and replacement. This would negatively impact the historical nature, aspects and/or fabric of the building.

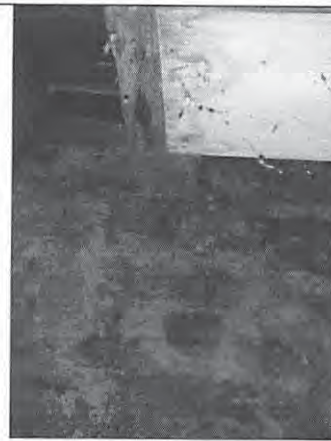
18. The basement is damp and wet. This condition has been present on all inspections. There is standing water present. There is mold present. Water infiltration is due to the site drainage, the lack of parapet flashing, and through the wall itself resulting in deterioration of wood member and the stone walls. The water causes further deterioration and reduced capacity of the members to carry load. In order to eliminate the water, the wall above requires removal and replacement. The site drainage should be set to drain water away from the foundation. Further, damproofing and drainage systems would be required. This would negatively impact the historical nature, aspects and/or fabric of the building.

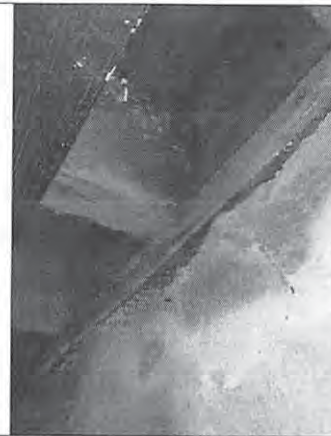
19. There is evidence of a past fire within the basement area. The ceiling and some members show substantial charring and smoke damage. A fire indicates that the building has suffered past trauma. It is no longer constructed in its original condition. Due to the presence of a past fire, I recommend that all members to inspected to assure a proper repair was completed and no damaged members exist.
