#### ADDRESS: 1600-06 E BERKS ST

Proposal: Demolish building owing to necessity in the public interest Review Requested: Final Approval Owner: 1600 Berks LLC Applicant: Matt McClure, Esq., Ballard Spahr History: 1885-90, St. Laurentius Church, Edwin Forest Durang, architect Individual Designation: 7/10/2015 District Designation: None Staff Contact: Jon Farnham, jon.farnham@phila.gov

### STRUCTURAL CONDITION APPRAISAL

ST. LAURENTIUS CHURCH 1608 EAST BERKS STREET PHILADELPHIA, PA

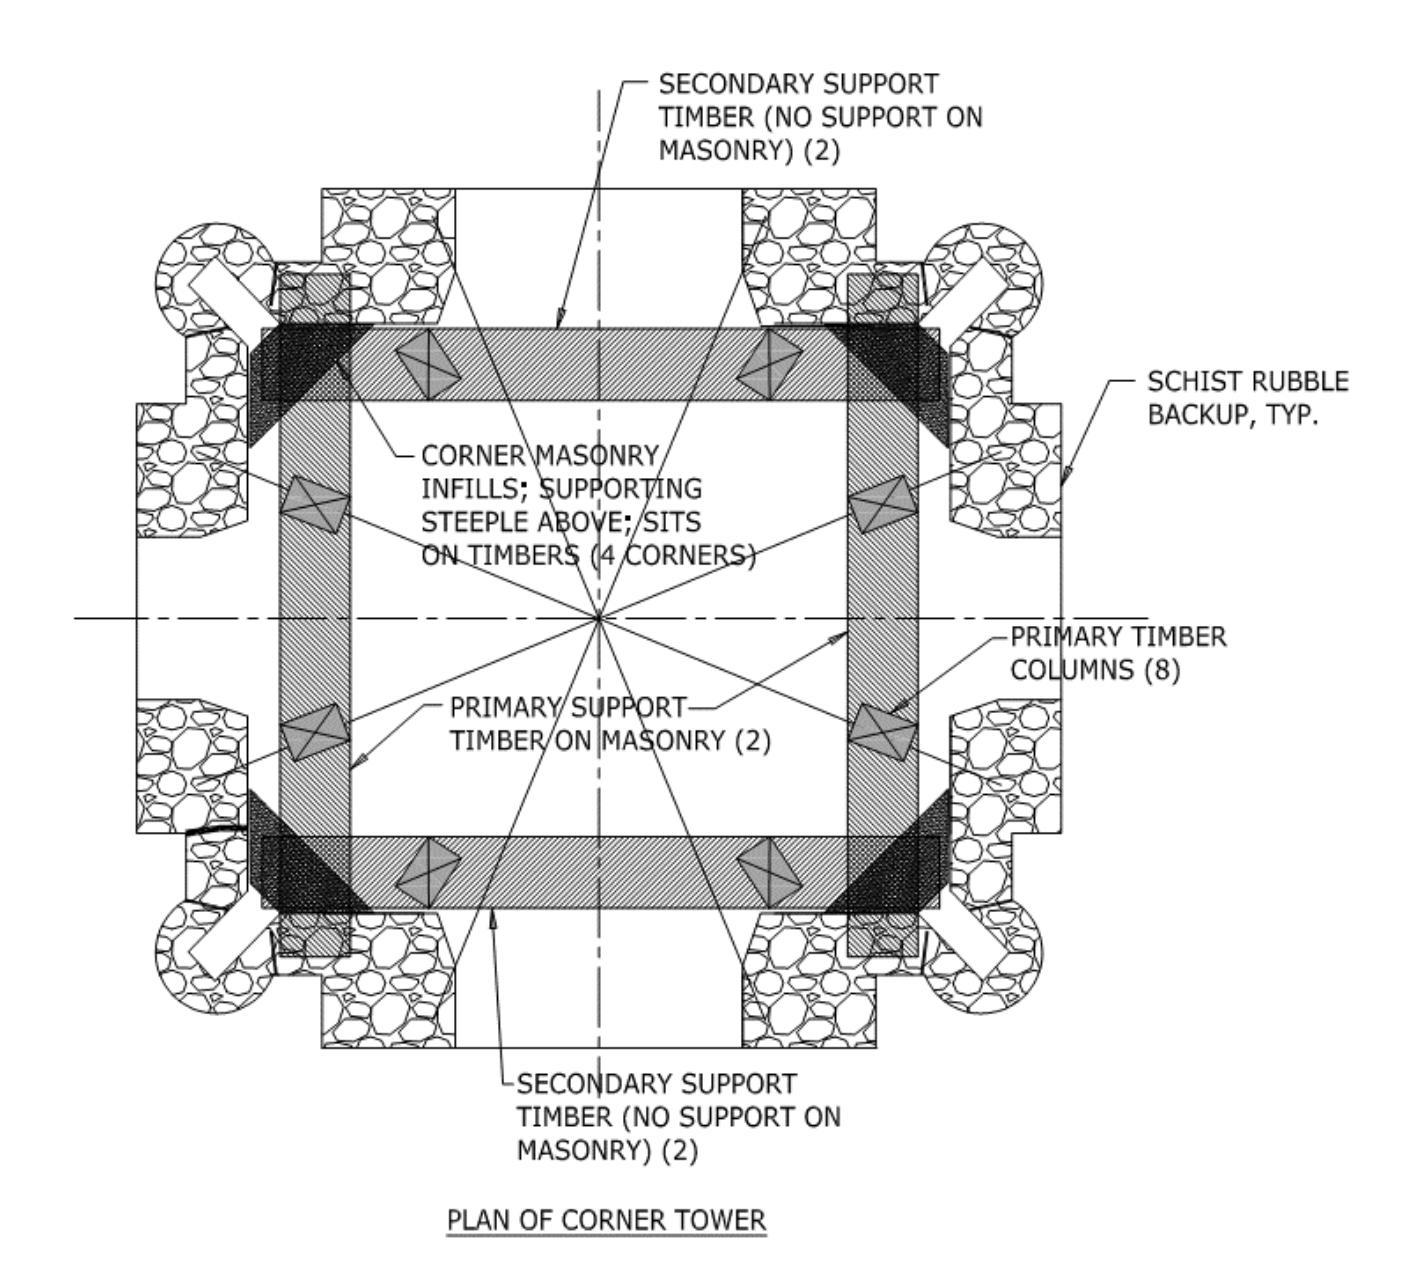
Below is the framing plan for the main platform at the Lower Bell (see elevation page 4).

All timber above the Lower Bell that frames out the platforms (Upper Bell, Upper Platform and the steeple above) are supported by the girders at this Lower Bell Platform. There are no other ties between the timber and the masonry above. The main timbers that span to the northern and southern walls are supported by the masonry walls. The secondary timbers spanning east west are supported by the north south girders but do not tie into the masonry walls.

The method of framing the towers means that it the tower masonry above the water table (where the masonry projects out) is entirely dependent on the integrity of the corners for its stability.
