**Philadelphia (PA) Fire Department
Health and Safety Office
After Action Review**

**Line of Duty Death
Lieutenant Matthew LeTourneau
January 06, 2018**

2240 N. Colorado Street
Box 7743: 18th Street and Dauphin Street

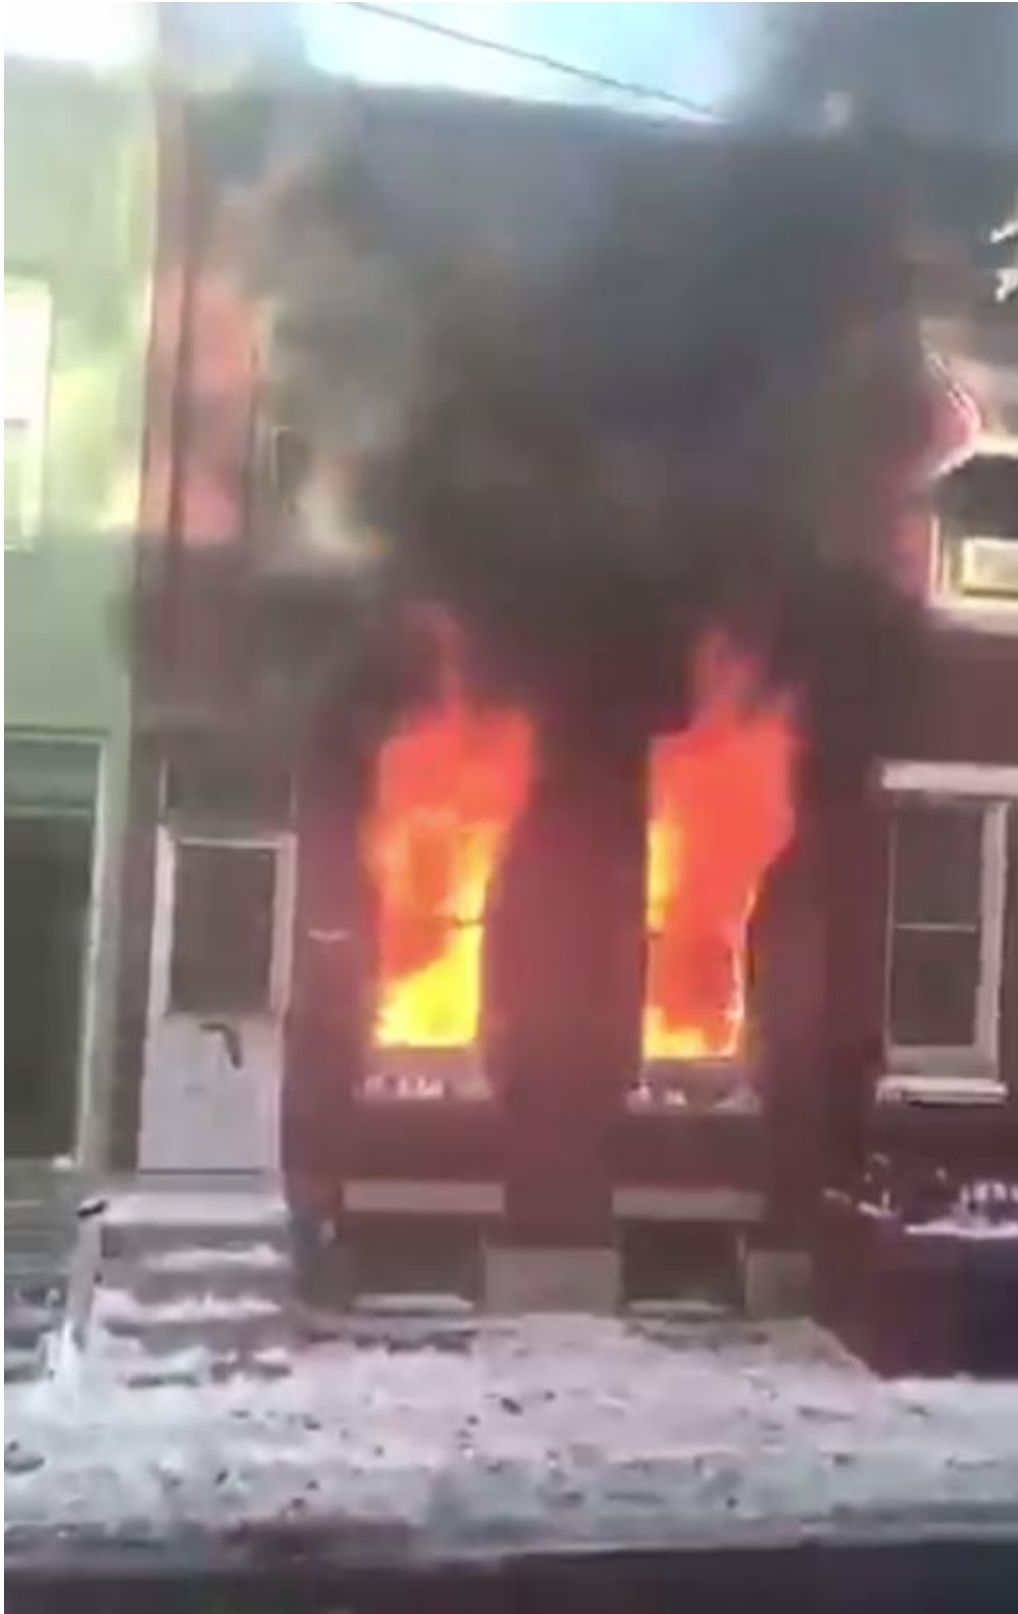
6: Civilian video of pre-arrival conditions in the Alpha Division (08:52:59 Hrs.)

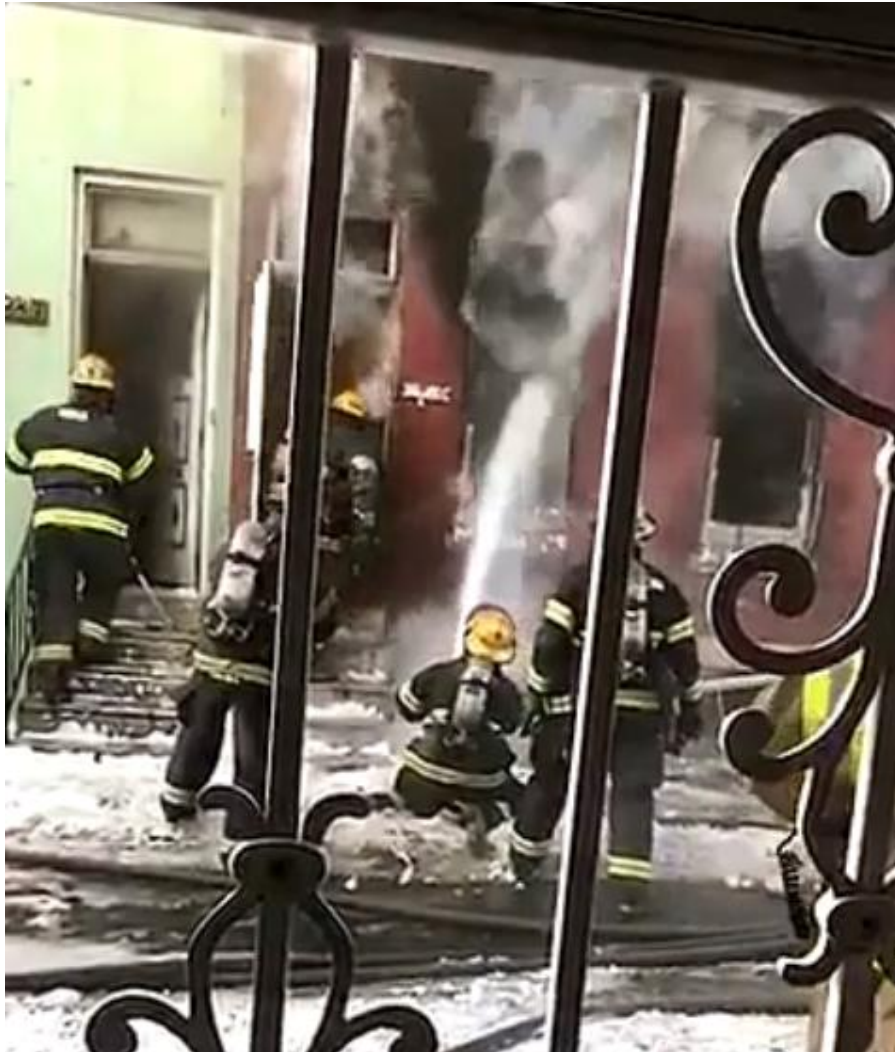
10: Initial fire attack from the exterior in the Alpha Division while firefighters made forcible entry. Firefighters are also entering the Bravo Exposure. (08:57:49 Hrs.)

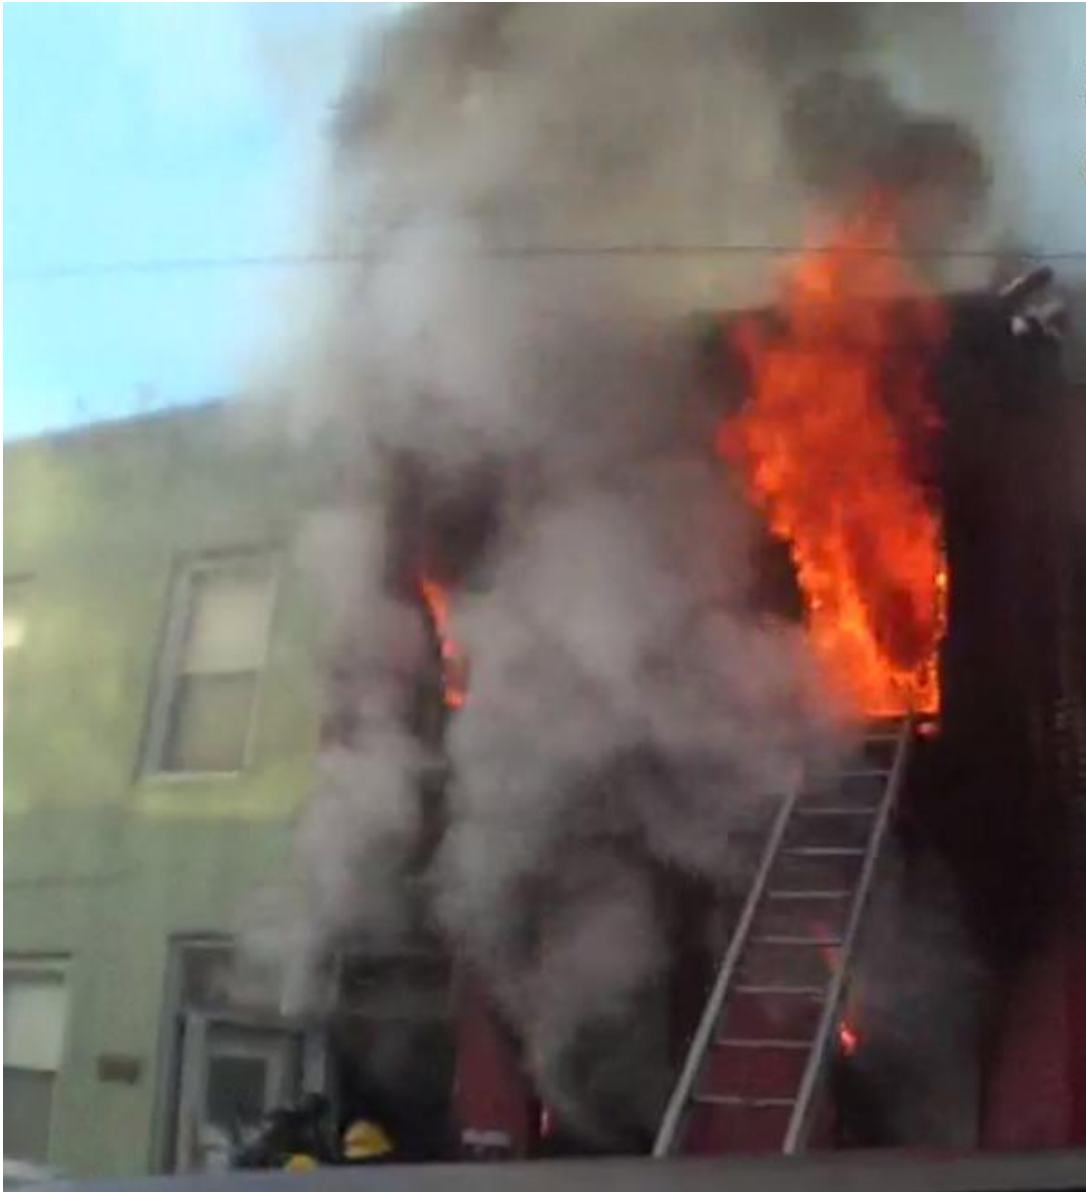
11: Fire showing on the 2nd floor in the Alpha Division. (09:05:16 Hrs.)

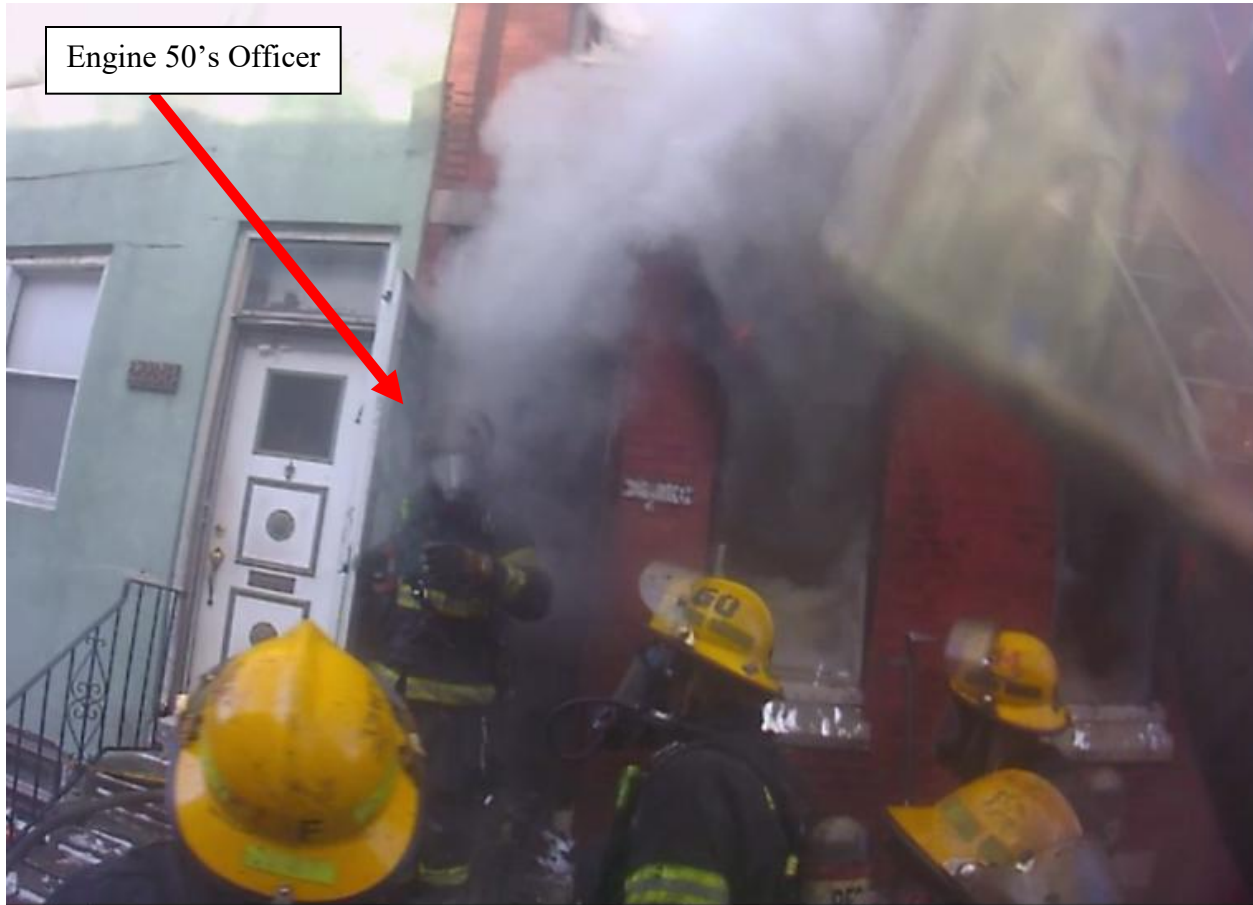
14: The last member exits the dwelling while transitioning to an exterior attack. (09:09:59 Hrs.)

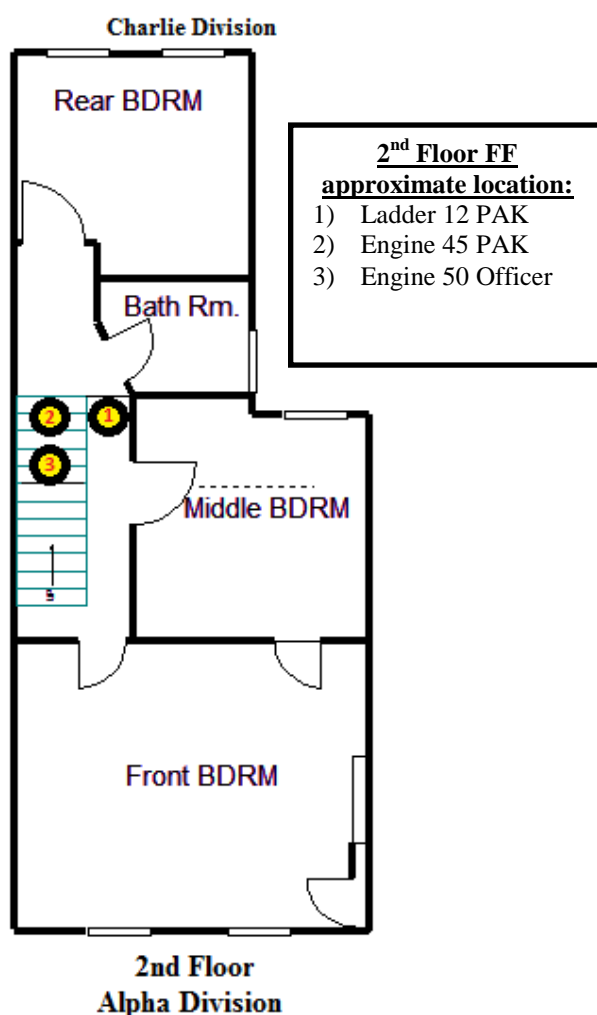
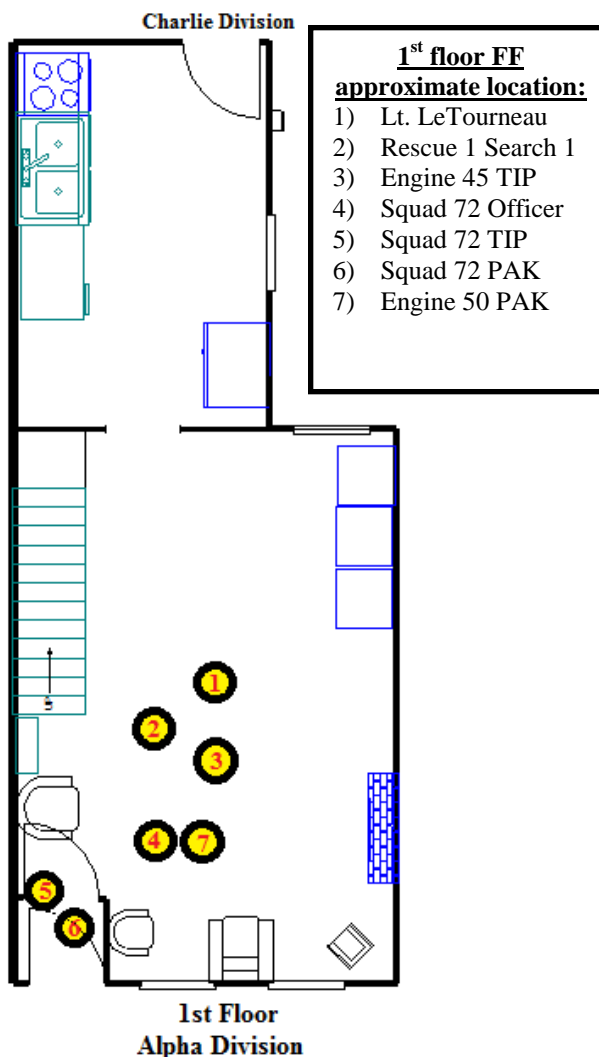
At some point, Ladder 12's PAK Firefighter yelled to the members on the steps that he felt the second floor "drop". This report prompted Engine 50's Officer to order him off the second floor; however, before Ladder 12's PAK Firefighter could get to the steps, the second floor collapsed beneath his feet.⁴¹ The approximate location of fire personnel at the time of the collapse is believed to be depicted in the following diagrams:

⁴¹ This occurs at approximately 09:33:18 Hrs.

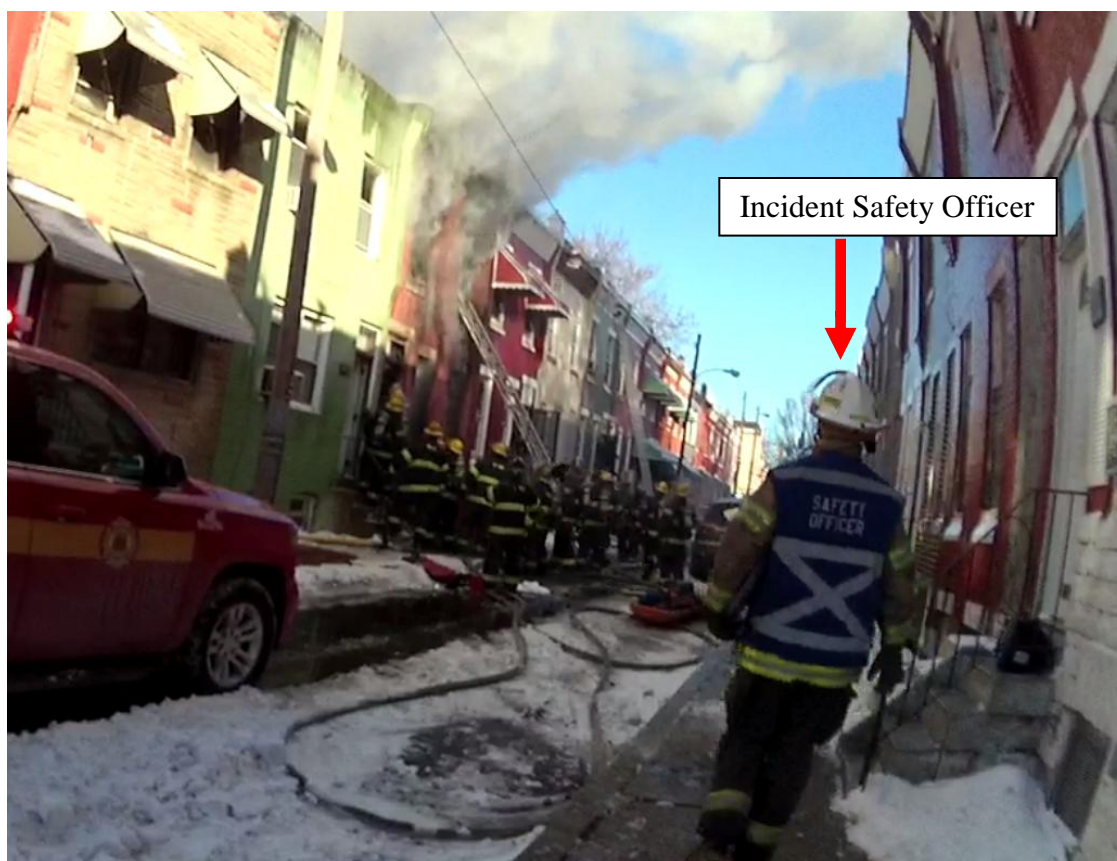
21: The Incident Safety Officer arrives in the Alpha Division after having just responded from another assignment in the city. (09:35:44 Hrs.)

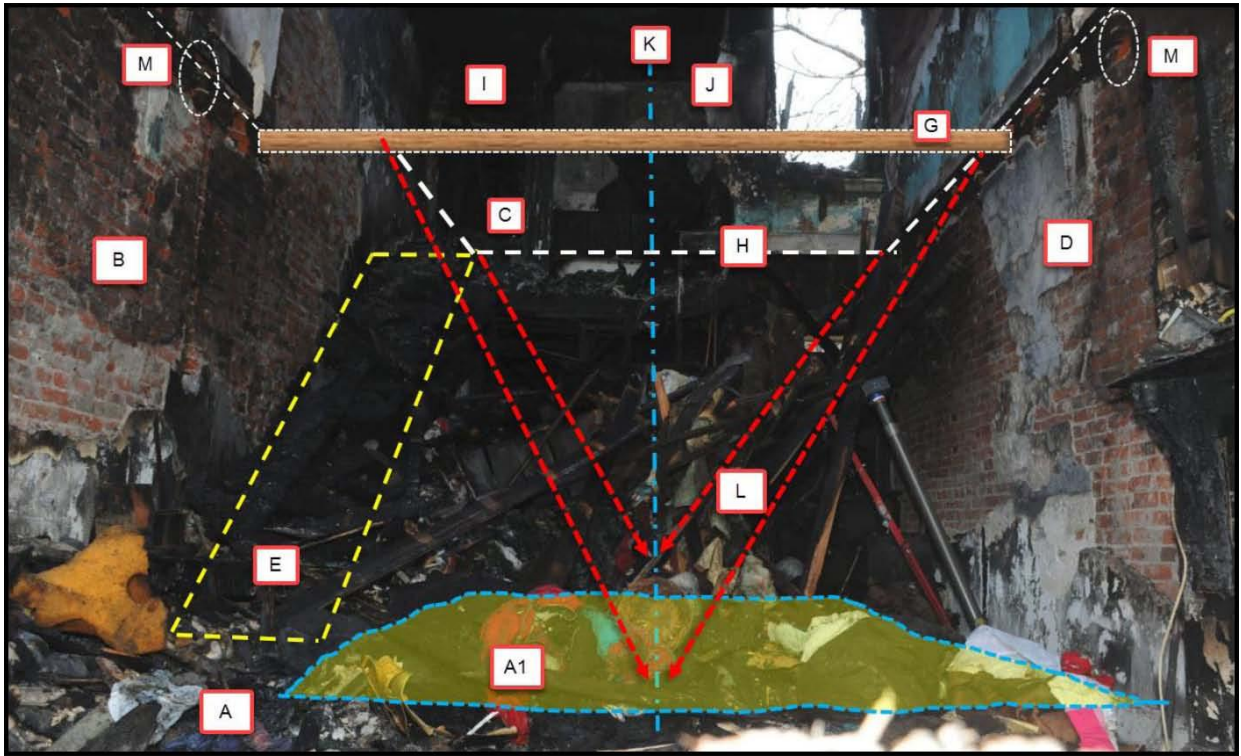
Post Collapse and after debris removal from both First and Second areas

- A. First Floor Front Living Room Area
- A1. Primary Collapse Zone under the area of the Middle Second Floor bedroom above. This area had the predominate level of collapse severity and catastrophic level of building materials and debris pile from the V-Floor collapse profile. This collapse area consisted of both building materials, structural components and heavy content (Hording material) furnishing, etc. that created a significant matrix of materials, loads and mass.

- J. Second Floor Bathroom
- K. Approximate Centerline of the Rowhouse floor-span & approx. CL of the Second Floor V-Collapse Profile
- L. Depiction of the directional movement of the second-floor assembly and floor diaphragm failing approx. mid-span resulting in a V- Collapse profile

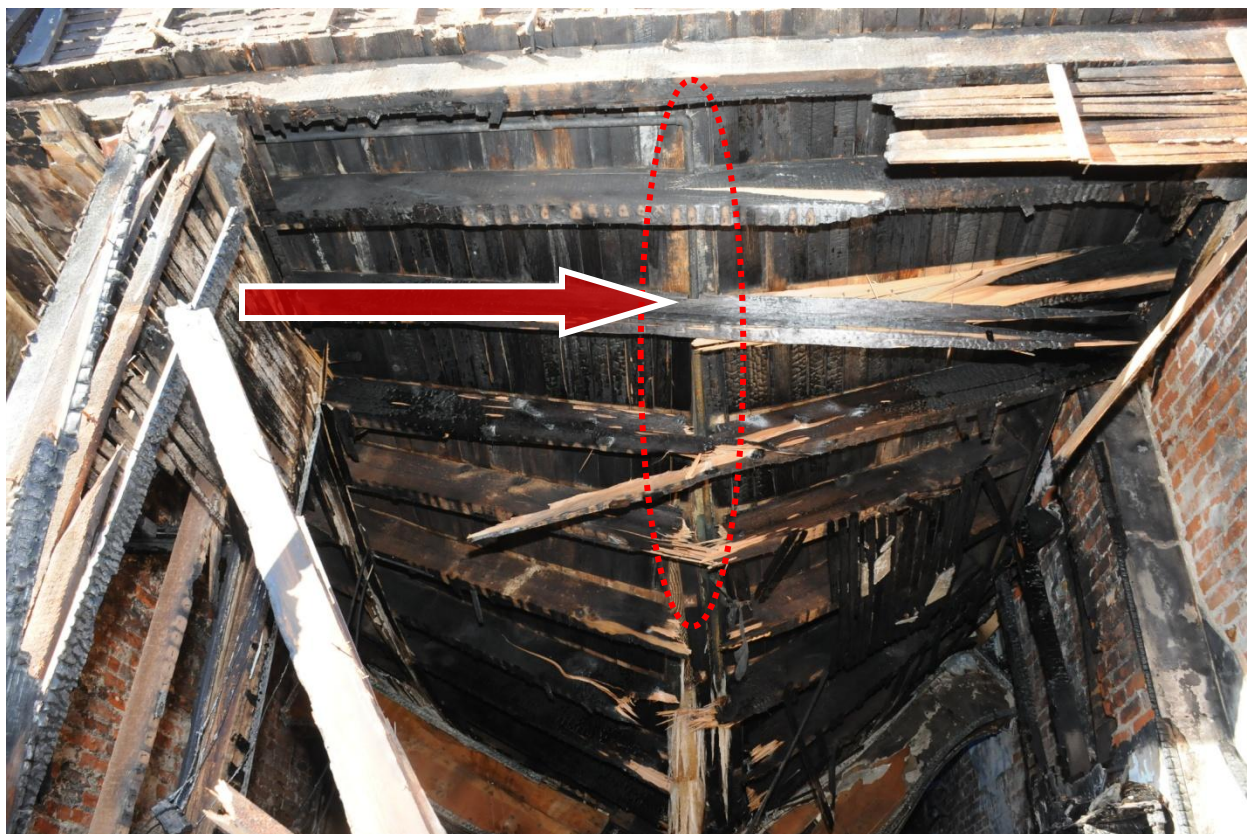
Photograph #6

The circle indicates where the pipe was located on the top of the second-floor joist. The arrow indicates an area where the floor joists were notched to allow for the pipe. The picture was taken from the sidewalk in the Alpha Division on the exterior of the dwelling looking up toward the second floor.

In addition to the previously documented condition of the home (see section, The Fire Dwelling: 2240 North Colorado Street) it was also discovered during post fire investigations that the top of several joists for the second floor were notched approximately 1” by 1” in the center of the dwelling to allow a channel for a pipe (see Post Fire Photograph #6). Some post fire photographs show the “V” shaped collapse occurred along the line where that pipe was situated (see Post Fire Photograph #5).

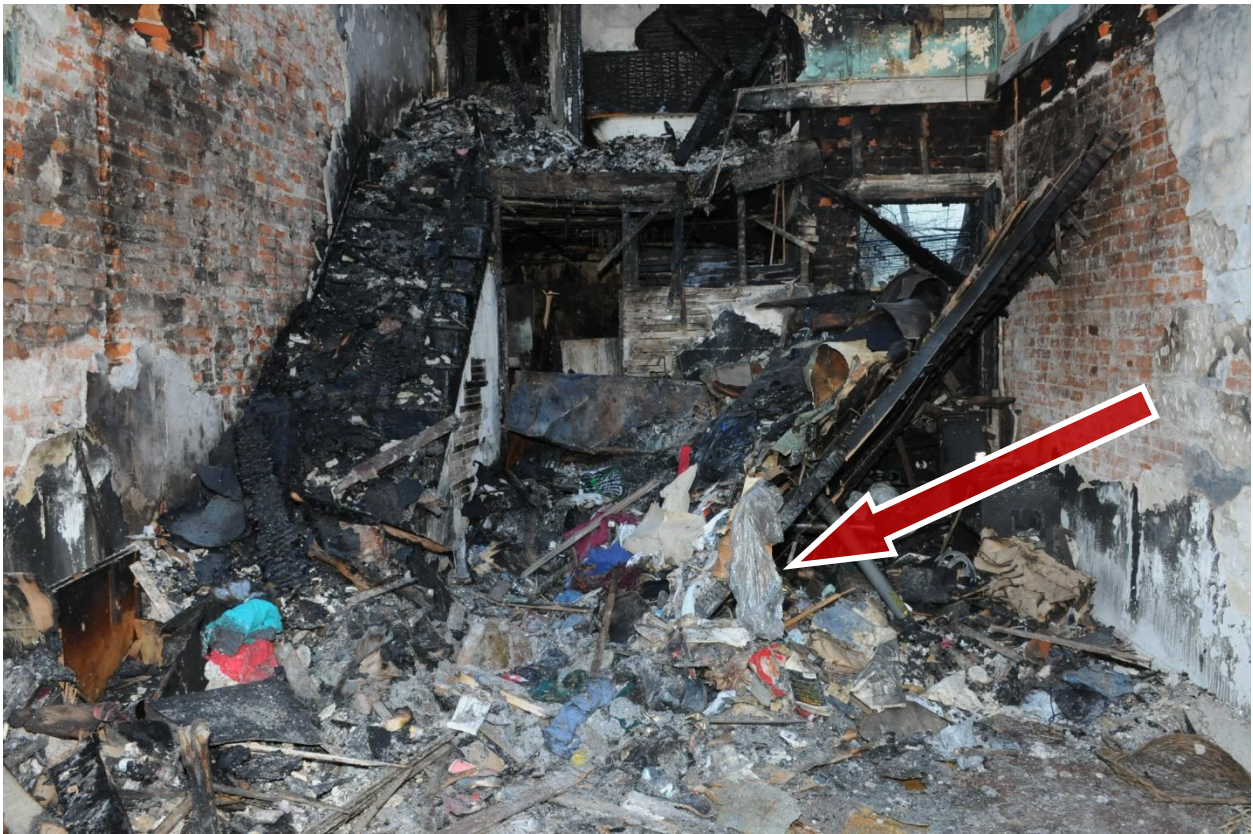
Photograph #7

This picture is taken from near the Alpha wall looking towards the Charlie wall. Lt. LeTourneau was located under the debris approximately where the arrow points. The steps to the second floor are to the far left of the picture.

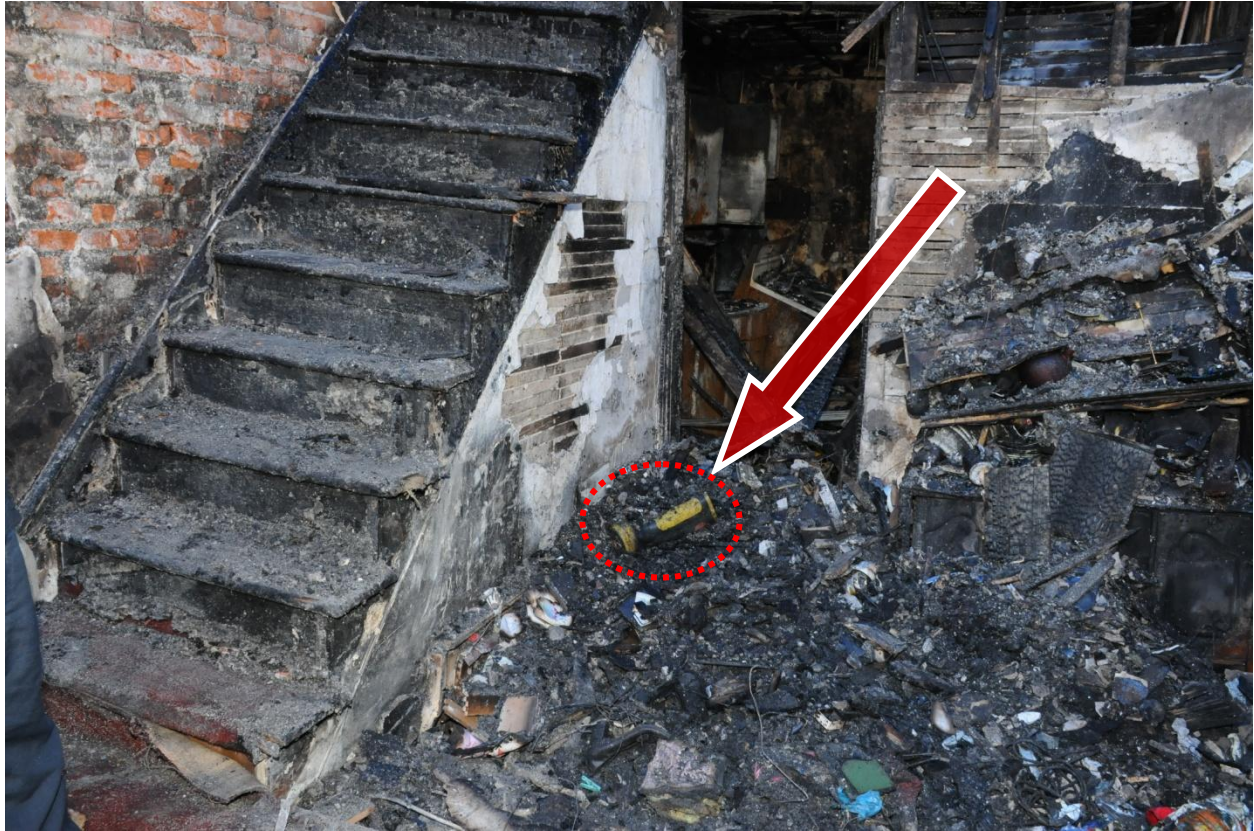
Photograph #8

This picture is taken from near the middle of the living space looking towards the Charlie wall.

The arrow and circle indicate the approximate location where Ladder 12's PAK Firefighter landed when he fell from the second floor. Ladder 12's PAK Firefighters boot was located by the Investigative Team under debris at this approximate location.

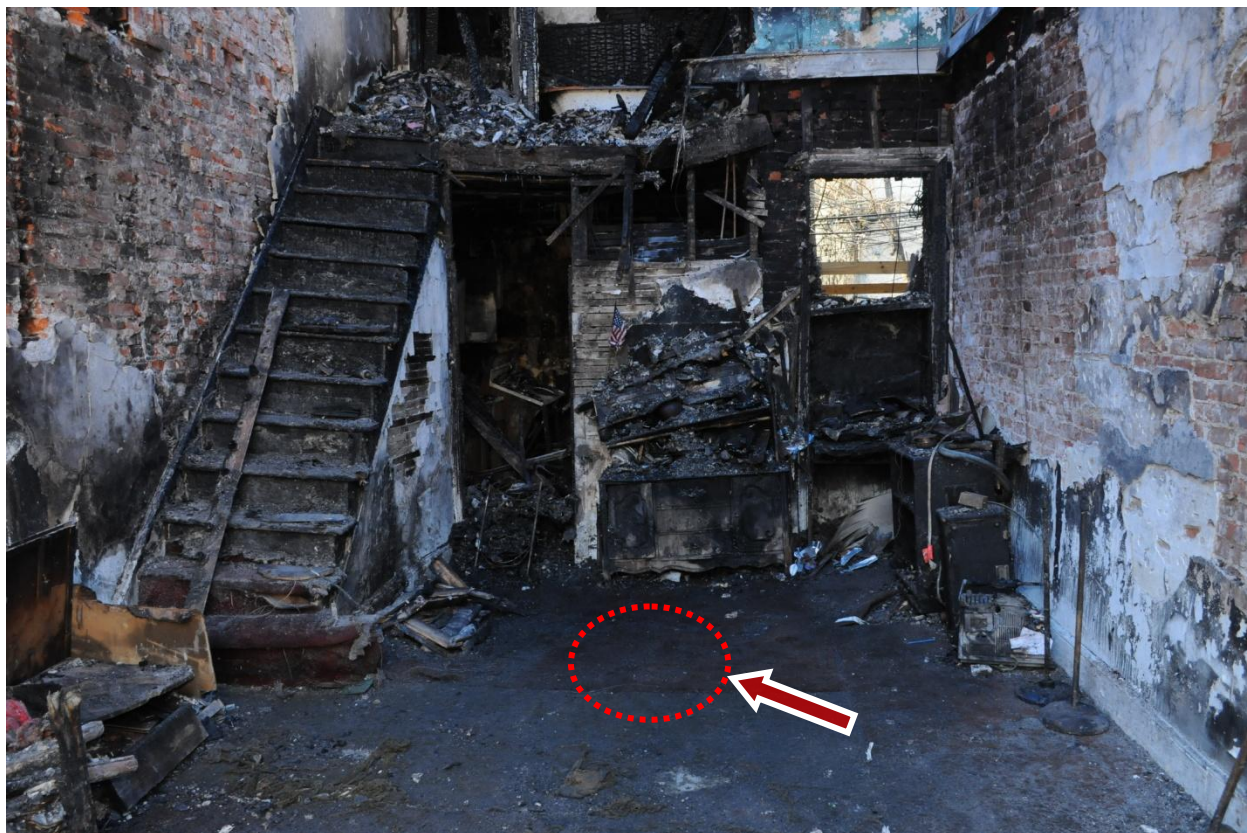
Photograph #9

This picture is taken from near the Alpha wall looking towards the Charlie wall. Lt. LeTourneau was located approximately where the circle and arrow indicate.

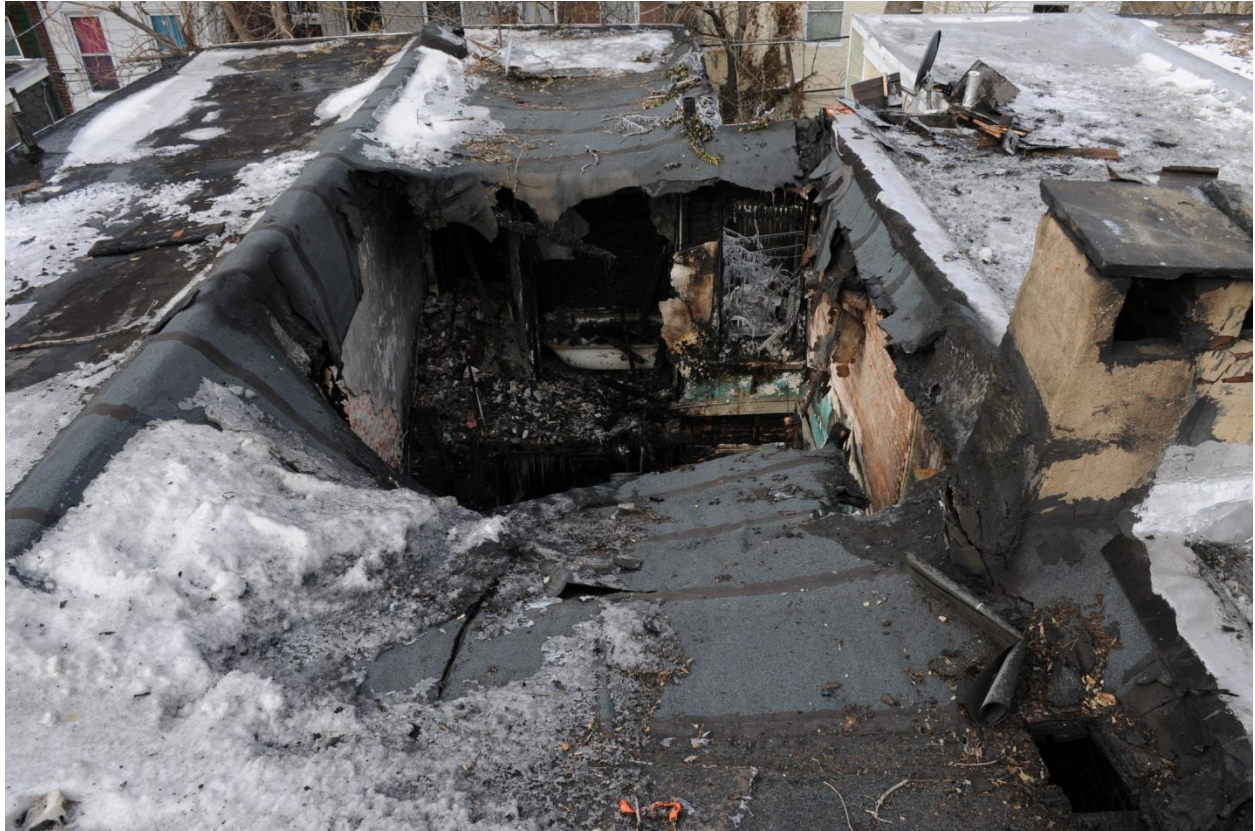
Photograph #10

View of the roof looking from near the Alpha wall towards the Charlie wall.

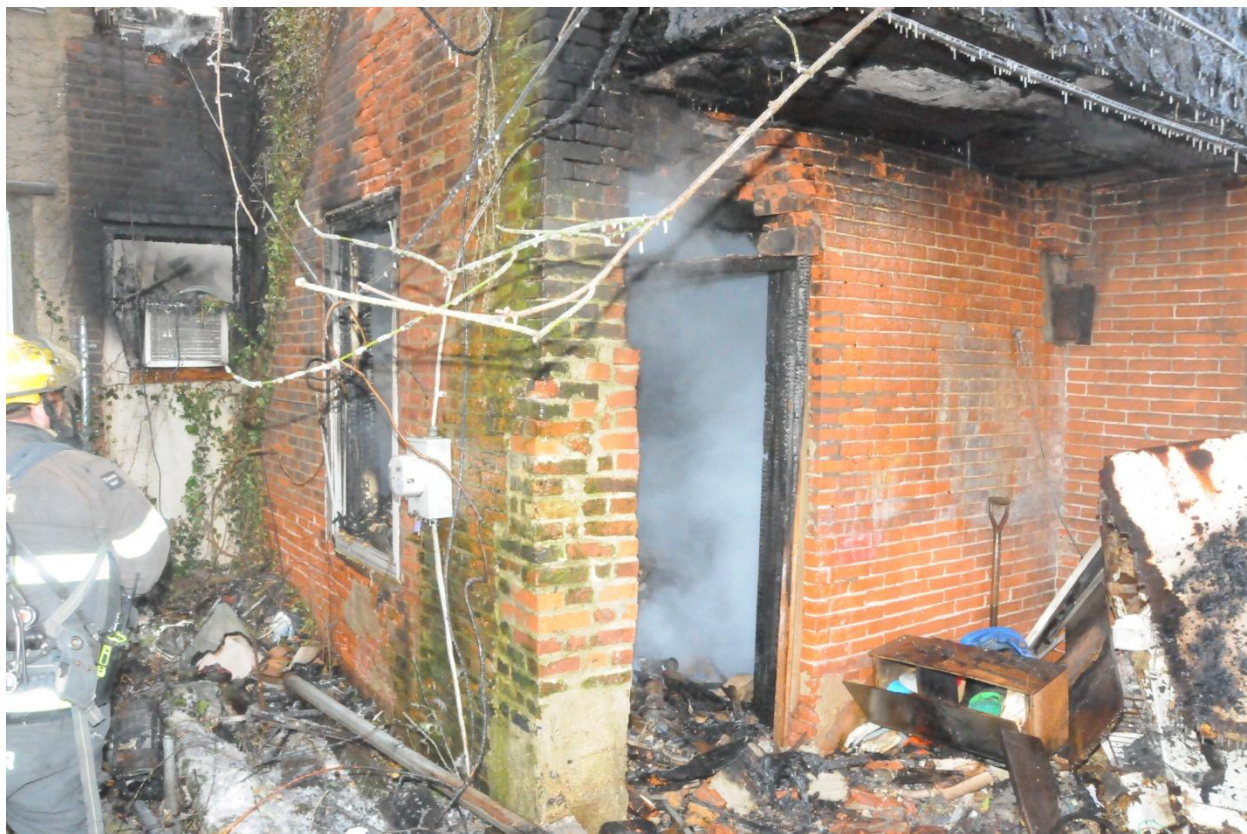
Photograph #11

View of the rear of the dwelling. Ladder 12's PAK Firefighter was located by firefighters operating in the Charlie Division just inside the doorway after he self-rescued.

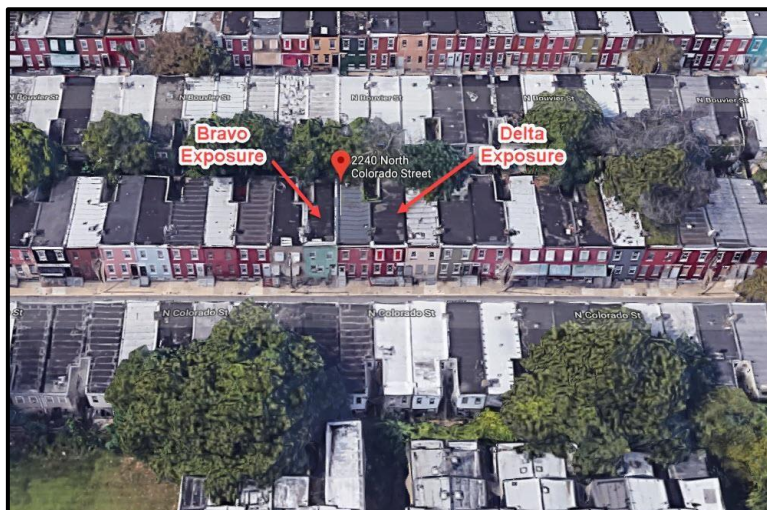
Map 1 | Photo 1 Aerial View of 2240 North Colorado Street

The rowhouse was found to have evidence of physical, material and maintenance neglect and progressive physical building and structure deterioration. The building did not have an operable fixed heating system¹, had roofing and perimeter wall deterioration and had direct open areas to the environment with direct exposure and susceptibility to seasonal environmental cycles and conditions.

There was evidence that significant hoarding conditions of materials and a significant degree of clutter was present throughout the rooms and floors of the structure that imposed critical operations impediments and highly suggest it affected the structure during the early development stages of the fire within the room compartments and within concealed and exposed area of the building structural components, systems, assemblies and materials. These hoarding, heavy content and clutter conditions also had significant contributions towards building compromise, collapse and concurrent and subsequent Fire Department fire suppression operations, mitigation efforts and resulting fire service personnel extrication and rescue effort resulting from the structural floor collapse. ^{1, 17}
