CENTRAL MOUNT AIRY COMMERCIAL HISTORIC DISTRICT

Proposed Action: Designation

NOMINATION OF HISTORIC DISTRICT
PHILADELPHIA REGISTER OF HISTORIC PLACES
PHILADELPHIA HISTORICAL COMMISSION

Central Mount Airy Commercial Historic District

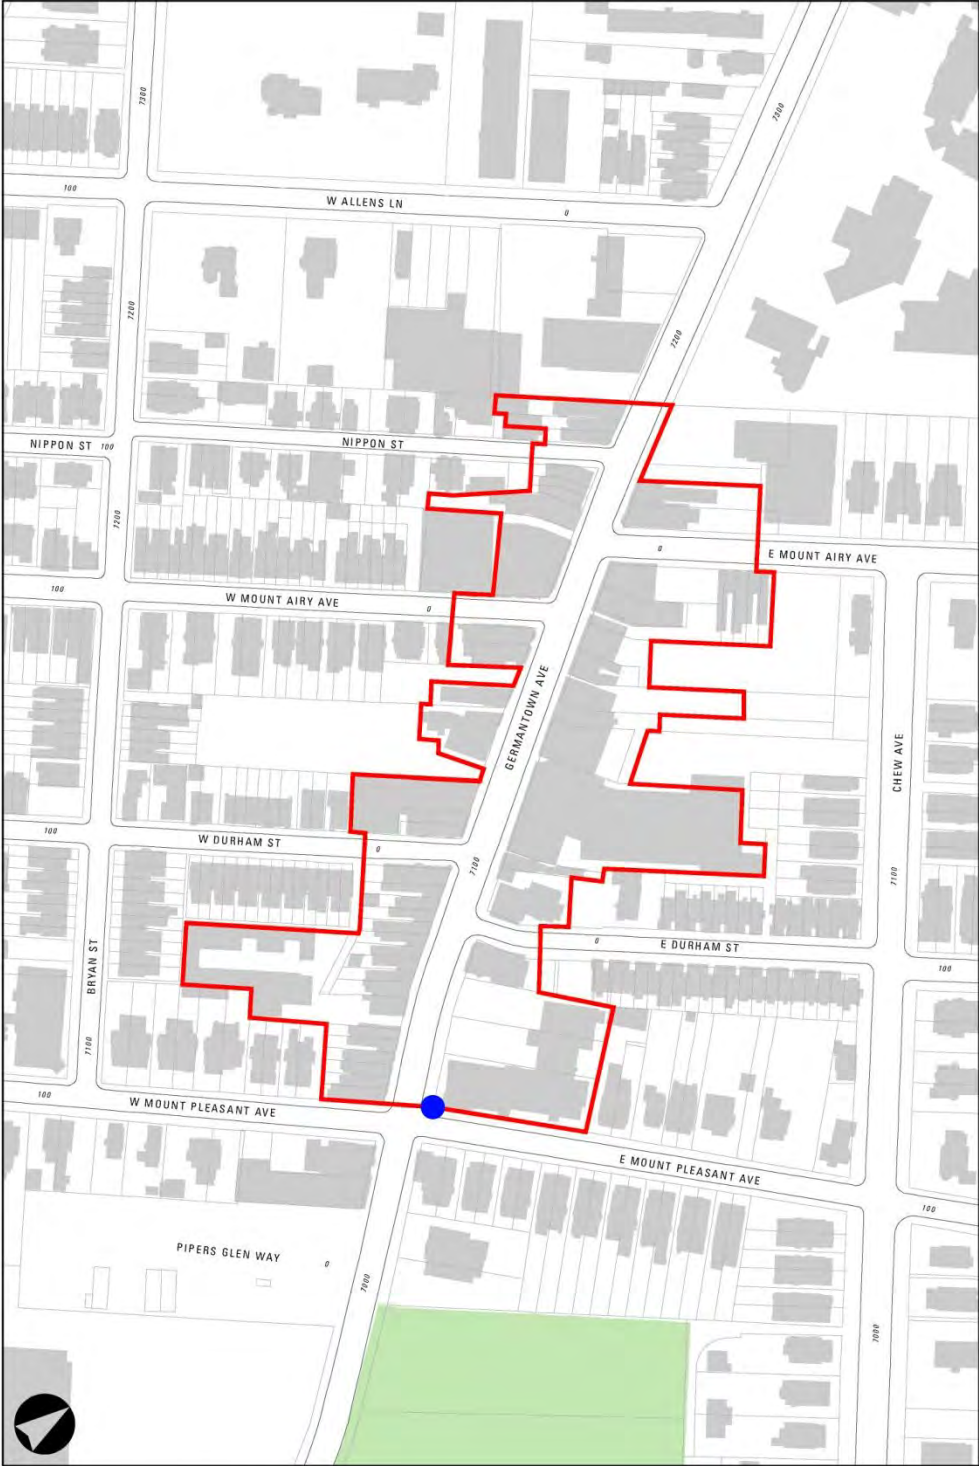
3. BOUNDARY DESCRIPTION

Beginning at a point at the intersection formed by the Northeast side of Germantown Avenue (Sixty feet wide) with the Northwest side of Mount Pleasant Avenue (fifty feet wide) (blue dot) being the southernmost point of the parcel containing the Mt. Airy Presbyterian Church, 7111-13 Germantown Avenue; thence extending northeasterly along E Mount Pleasant Avenue the distance of approximately 200 feet to a point; thence extending northwesterly along the rear lot line of 7111-13 Germantown Avenue approximately 165 feet to a point; thence extending southwesterly approximately 98 feet to a point; thence extending northwesterly approximately 86 feet, along the rear lot line of 7117 Germantown Avenue, crossing E Durham Street, to a point on the northwest side of East Durham Street; thence extending northeasterly approximately 35 feet to a point; thence extending northwesterly, along the rear lot line of 7127 Germantown Avenue, approximately 64 feet to a point; thence extending northeasterly approximately 40 feet to a point; thence extending northwesterly approximately 16 feet to a point; thence extending northeasterly approximately 206 feet along the southeast lot line of 7133-43 Germantown Avenue to a point; thence extending northwesterly, along the rear lot line of 7133-43 Germantown Avenue approximately 40 feet; thence extending southwesterly approximately 32 feet to a point; thence extending northwesterly approximately 69 feet; thence extending southwesterly along the northwest lot line of 7133-43 Germantown Avenue approximately 145 feet; thence extending northwesterly, along the rear lot line of 7145-47 Germantown Avenue, approximately 72 feet; thence extending northeasterly along the southeast lot line of 7149 Germantown Avenue approximately 21 feet; thence extending northwesterly along the rear lot line of 7149 Germantown Avenue approximately 21 feet; thence extending northeasterly along the southeast lot line of 7151 Germantown Avenue approximately 108 feet; thence extending northwesterly along the rear lot line of 7151 Germantown Avenue approximately 34 feet; thence extending southwesterly along the northwest lot line of 7151 Germantown Avenue approximately 123 feet; thence extending northwesterly, along the rear lot line of 7157-59 Germantown Avenue, approximately 60 feet; thence extending northeasterly, along the southeast lot line of 7161 Germantown Avenue and the rear lot lines of 20 through 26 E Mount Airy Avenue, approximately 154 feet; thence extending northwesterly, along the northeast lot line of 26 E Mount Airy Avenue, approximately 95 feet; thence extending southwesterly, along southeast side of E Mount Airy Avenue, approximately 22 feet to a point; thence extending northwesterly, across East Mount Airy Avenue and along the rear lot lines of 7201 and 7205 Germantown Avenue, approximately 111 feet to a point; thence extending southwesterly the distance of approximately 156 feet to a point on the northeast side of Germantown Avenue; thence extending northwesterly along Germantown Avenue approximately 108 feet to a point; thence extending southwesterly approximately 229 feet across Germantown Avenue, following the northwest lot line of 7224 Germantown Avenue to a point; thence extending southeasterly of approximately 24 feet along the rear lot line of 7224 Germantown Avenue to a point; thence extending northeasterly of approximately 15 feet to a point; thence extending southeasterly along the rear lot line of 7222 Germantown approximately 16 feet to a point; thence extending northeasterly approximately 52 feet to a point; thence extending southeasterly along the rear lot line of 7220 Germantown Avenue approximately 16 feet to a point; thence extending southwesterly approximately 15 feet along the northwest side of Nippon Street to a point; thence extending southeasterly

approximately 68 feet, crossing Nippon Street and along the rear lot lines of 7212 through 7216 Germantown Avenue, to a point; thence extending southwesterly, along the northwest lot line of 7208-10 Germantown Avenue, approximately 130 feet to a point; thence extending southeasterly along the rear lot line of 7208-10 Germantown Avenue approximately 20 feet to a point; thence extending northeasterly approximately 95 feet along the southeast lot line of 7208-10 Germantown Avenue to a point; thence extending southeasterly along the rear lot line of 7200-06 Germantown Avenue approximately 105 feet; thence extending southwesterly approximately 53 feet along the northwest side of W Mount Airy Avenue to a point; thence extending southeasterly approximately 93 feet, crossing W Mount Airy Avenue and along the rear lot line of 7174 Germantown Avenue, to a point; thence extending northeasterly, along the southeast lot lines of 7170 and 7174 Germantown Avenue, approximately 94 feet to a point; thence extending southeasterly, along the southwest side of Germantown Avenue, approximately 25 feet to a point; thence extending southwesterly, along the northwest lot line of 7152 Germantown Avenue, approximately 107 feet to a point; thence extending southeasterly, approximately 29 feet to a point; thence extending southwesterly the distance of approximately 12 feet to a point; thence extending southeasterly, along the rear and lot line of 7146-50 Germantown Avenue, approximately 45 feet to a point; thence extending northeasterly approximately 25 feet to a point; thence extending southeasterly approximately 15 feet to a point; thence extending northeasterly approximately 64 feet to a point on Germantown Avenue; thence extending southeasterly, along Germantown Avenue, approximately 17 feet to a point; thence extending southwesterly, along the northwest lot line of 7140 Germantown Avenue, approximately 164 feet to a point; thence extending southeasterly, along the rear lot line of 7140 Germantown Avenue, approximately 75 feet to a point on W Durham Street; thence extending northeasterly along West Durham Street approximately 17 feet to a point; thence extending southeasterly across W Durham Street and along the rear lot lines of 2 W Durham Street and 7126 through 7132 Germantown Avenue, approximately 127 feet to a point; thence extending southwesterly, along the side lot line of 7112-14 Germantown Avenue , approximately 225 feet to a point; thence extending southeasterly along the rear lot line of 7112-14 Germantown Avenue, approximately 79 feet to a point; thence northeasterly approximately 88 feet to a point; thence southeasterly approximately 37 feet to a point; thence extending northeasterly approximately 100 feet to a point; thence extending southeasterly, along the rear lot lines of 7100 through 7110 Germantown Avenue, approximately 99 feet to a point on the northwest side of W Mount Pleasant Avenue; thence extending northeasterly along W Mount Pleasant Avenue, approximately 146 feet to the place of beginning.

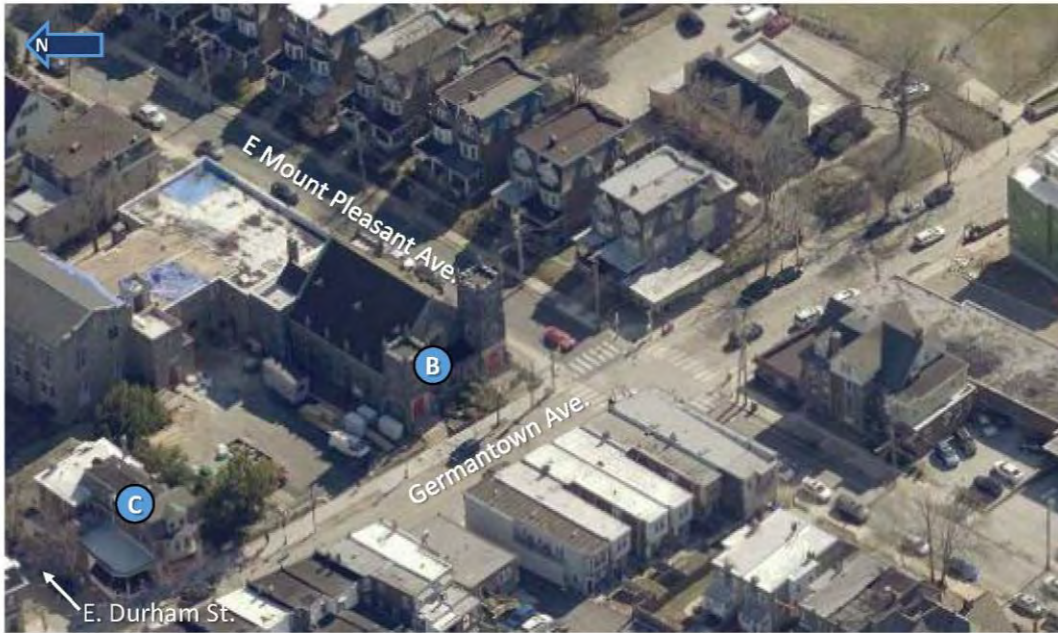
East Mount Pleasant Ave. to East Durham St. (odd)

- B** 7111-13 Germantown Ave.
- C** 7117-19 Germantown Ave.

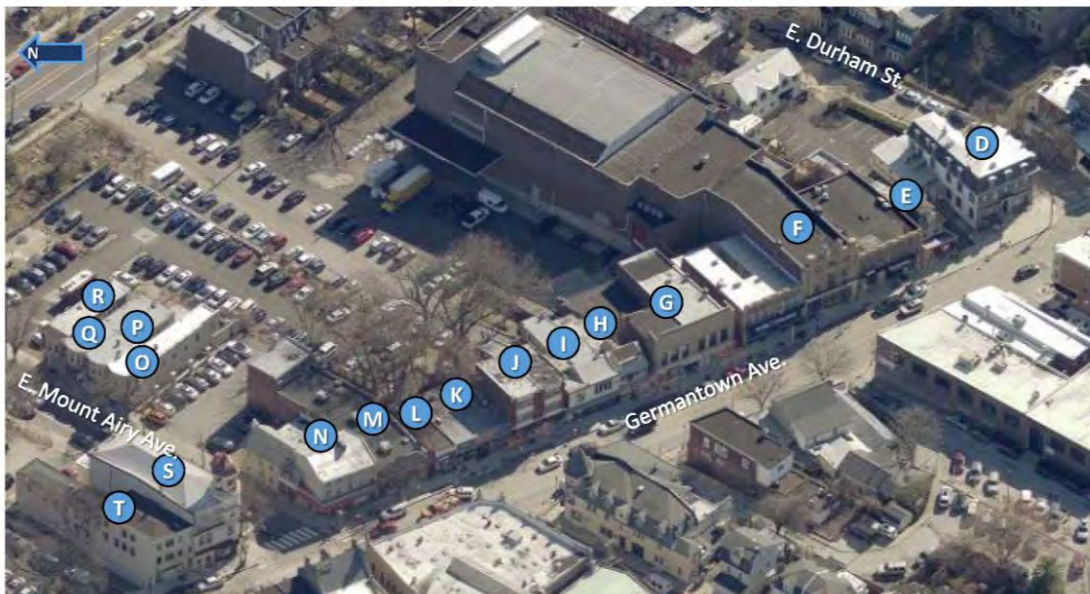
East Durham St. to East Mount Airy Ave. (odd)

| D 7127 Germantown Ave. | I 7151 Germantown Ave. | M 7165 Germantown Ave. | Q 24 E. Mount Airy Ave. |

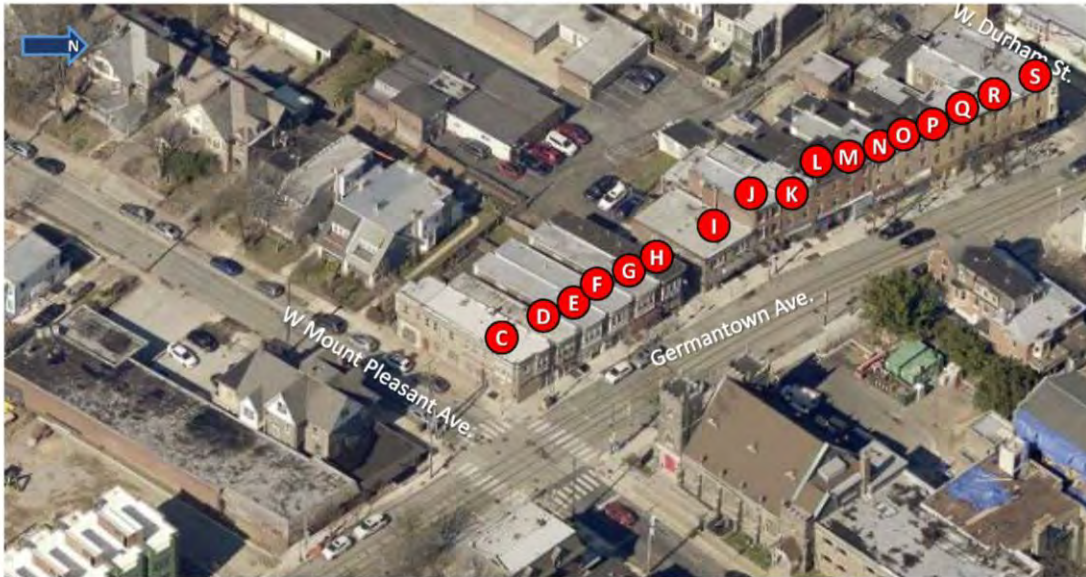
W. Mount Pleasant Ave. to W. Durham St. (even)

| C 7100 Germantown Ave. | F 7106 Germantown Ave. | K 7118 Germantown Ave. | P 7128 Germantown Ave. |

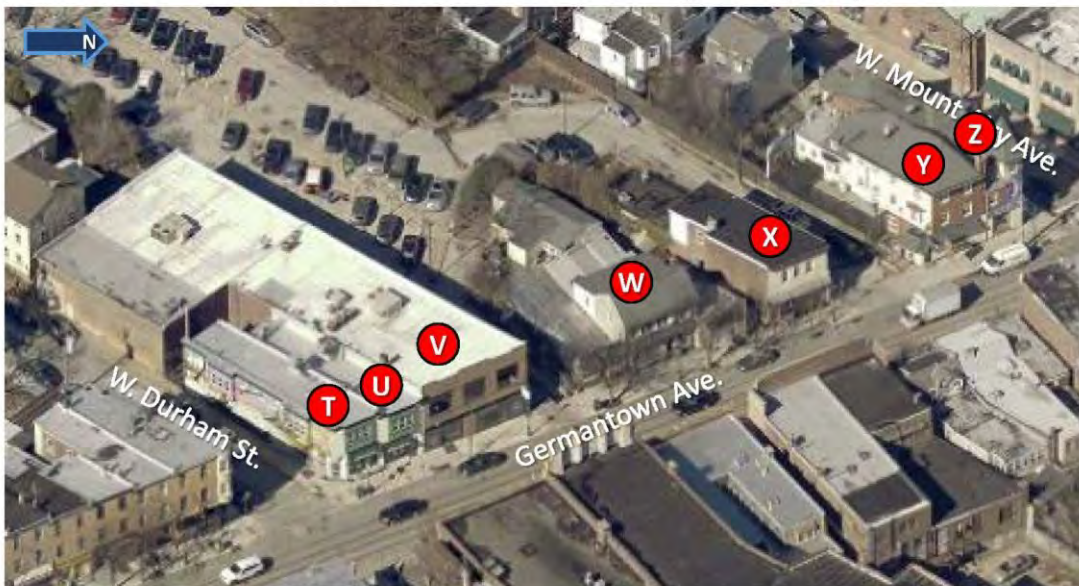
W. Durham St. to West Mount Airy Ave. (even)

| T 7136 Germantown Ave. | W 7146-50 Germantown Ave. | Y 7170 Germantown Ave. |

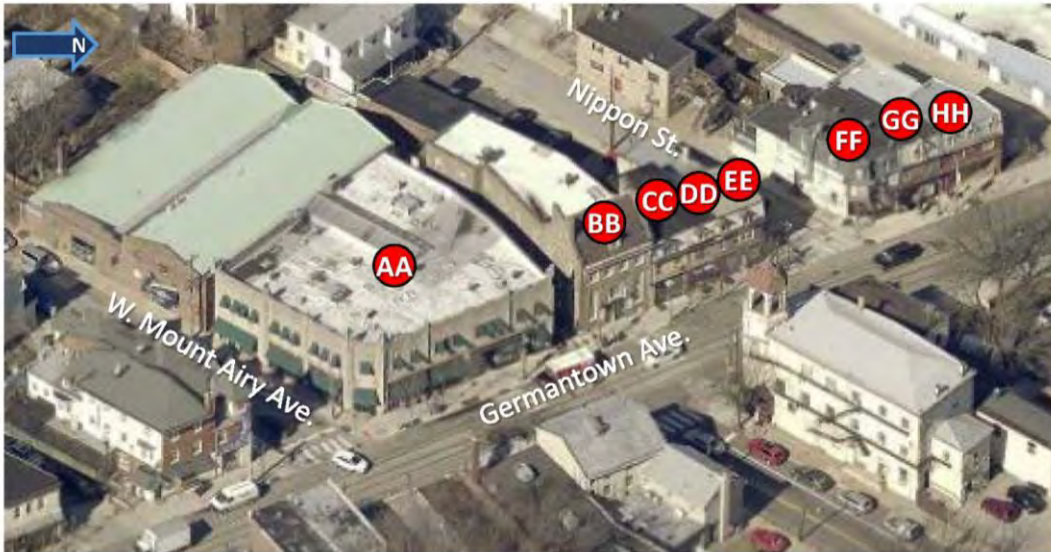
W. Mount Airy Ave. to Nippon St. (even)

| AA 7200-06 Germantown Ave. | DD 7214 Germantown Ave. | GG 7222 Germantown Ave. |

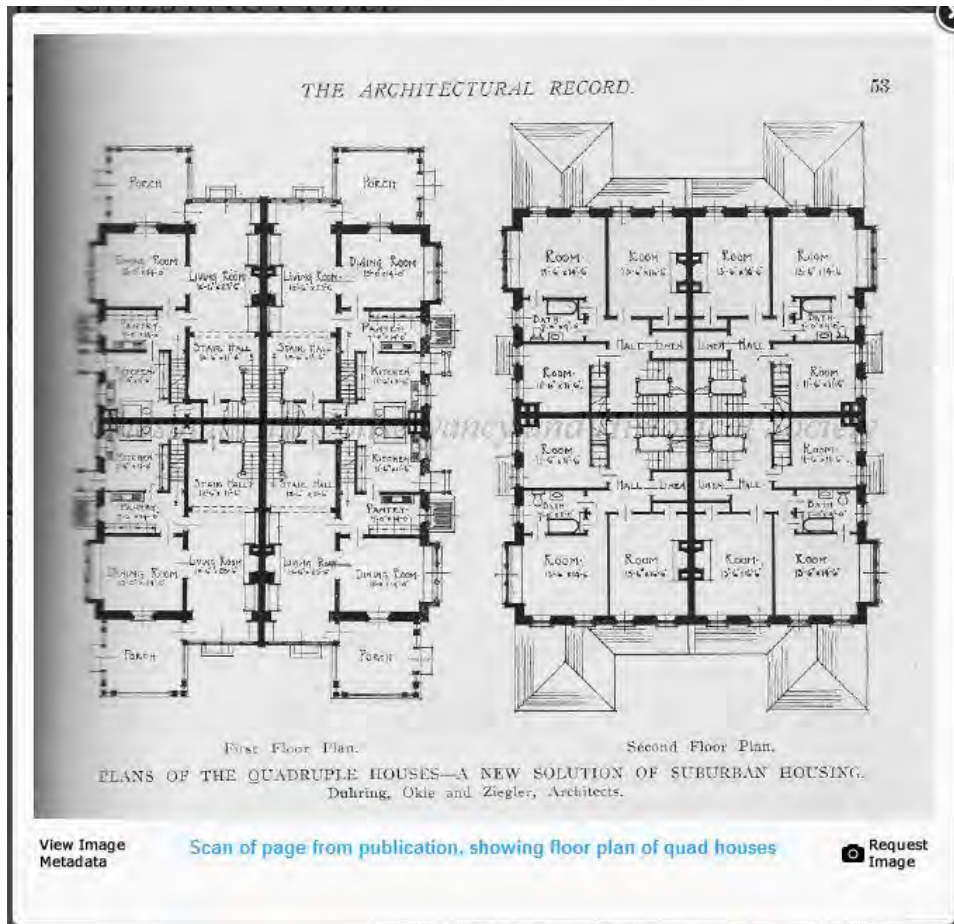
Figure 6. Plans for Woodward's Quad Houses (*The Architectural Record*, July 1913, New York)

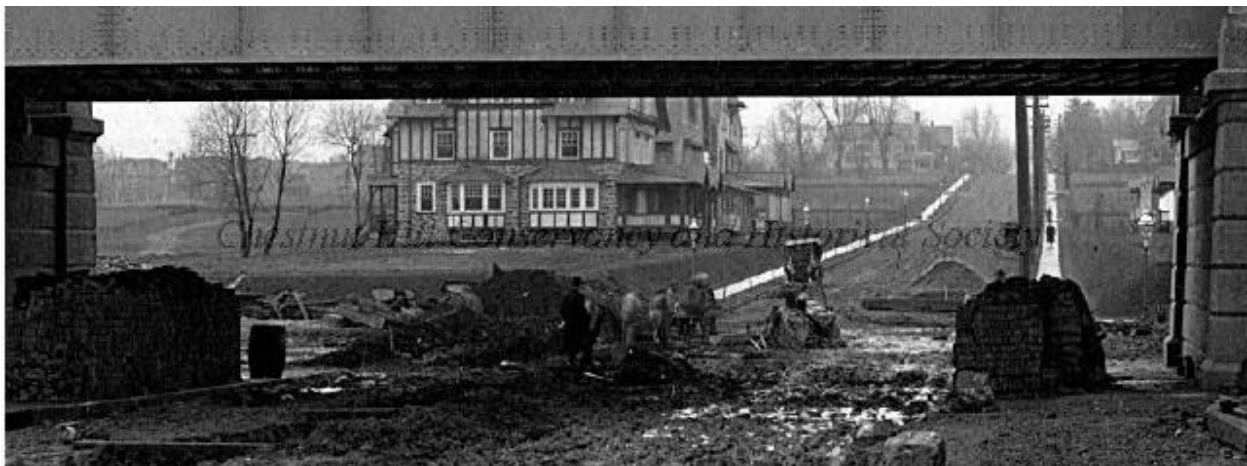
Figure 7. This 1909 photo looks west under the tracks of the Mount Pleasant Station to the still sparsely developed east Mount Airy. The newly built Tudor-style houses at 224 and 222 East Sedgwick sit alone in a field. (Chestnut Hill Conservancy)

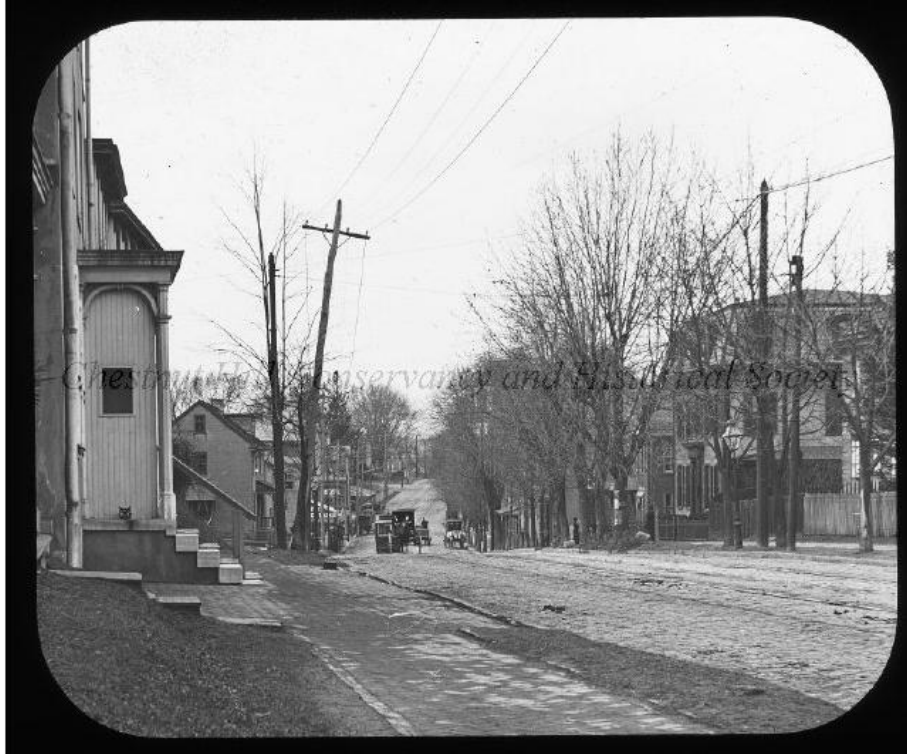
Figure 8. Germantown Avenue around 1900, looking north near the intersection with Mount Airy Avenue. The bell tower of the International Order of Odd Fellows Hall, is in the center behind the trees. The first house on the right is 7127 Germantown Avenue. The porches of the Mount Pleasant Inn are on the left. (Chestnut Hill Conservancy)

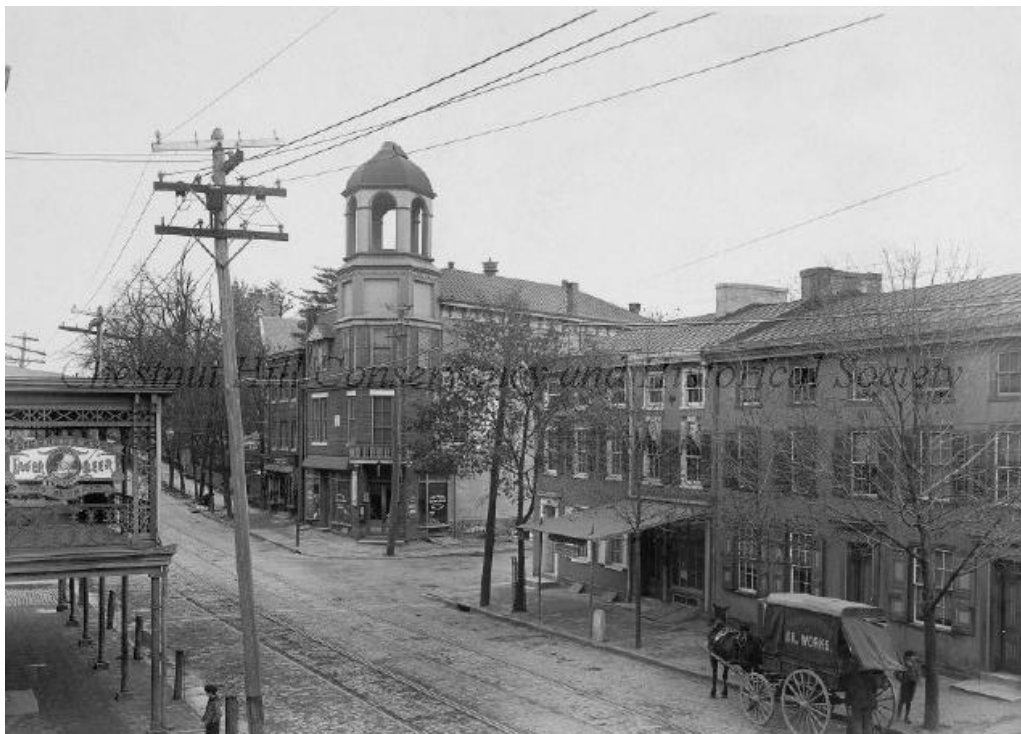
Figure 9. Germantown Ave. looking north toward East Mount Airy Avenue, ca. 1905. Taken from an upper window at Engard's Bakery. The porches of the White Swan Hotel are on the left. The Haas residence on the right is gone, replaced by 7165 Germantown Ave.

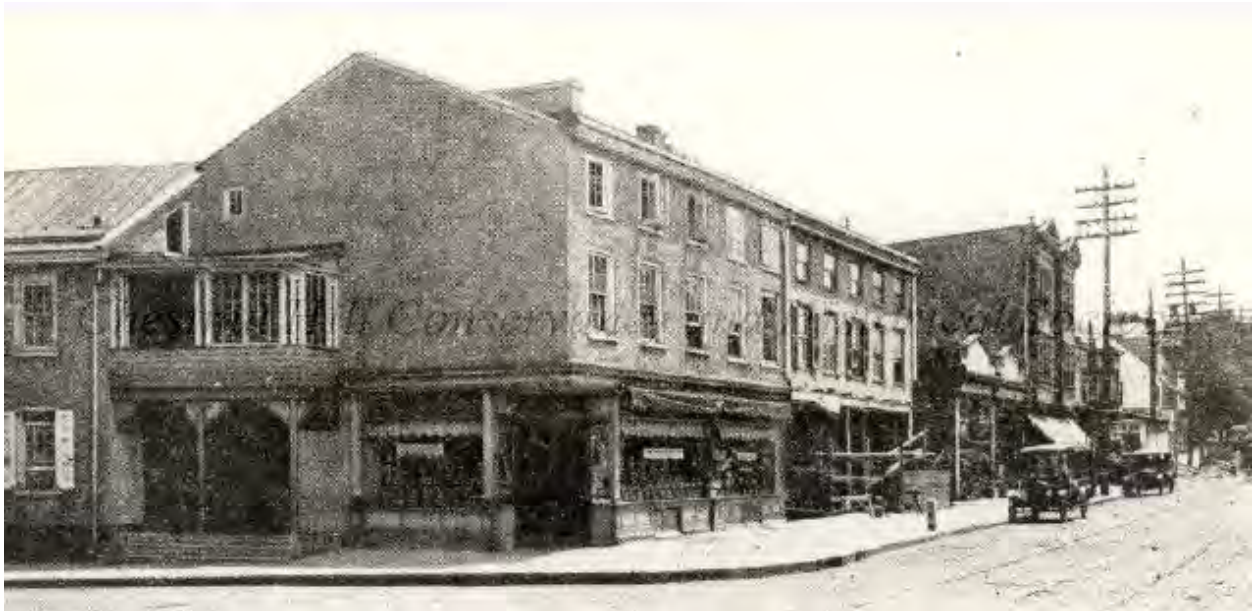
Figure 10. East side of Germantown Ave. looking south from the intersection of Mt. Airy Ave. The Shermer House (7169) is on the corner at the center, the Haas house at 7165 to its right, and then the three-story 7153-55. The photo is undated, but the presence of 7153-55 places it after 1915. (Chestnut Hill Conservancy)

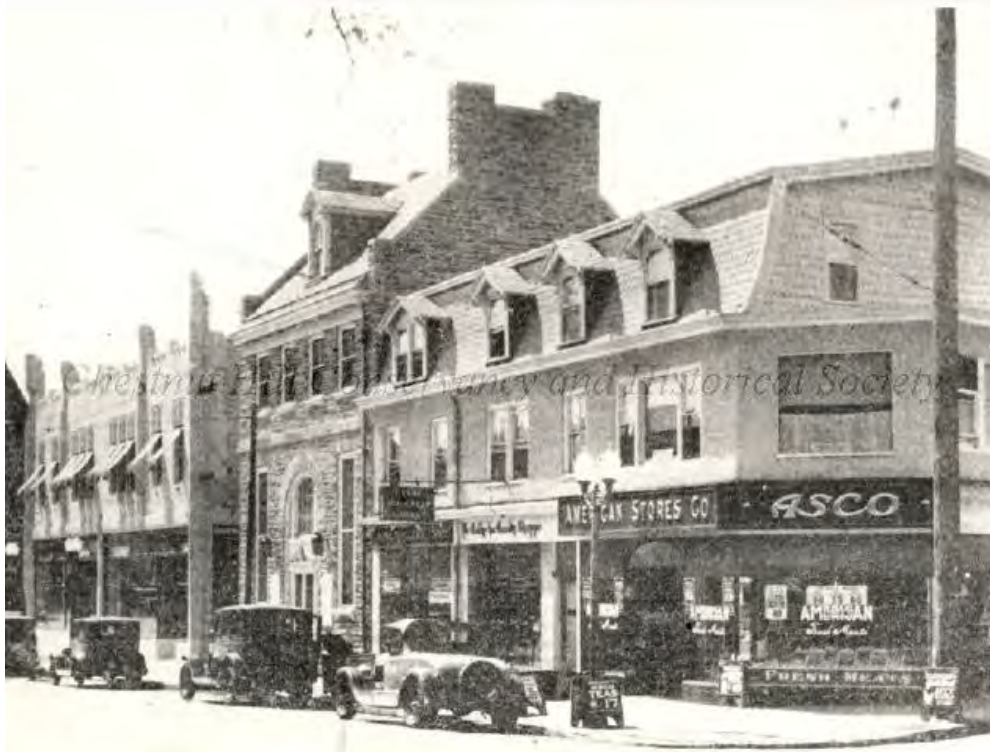
Figure 11. The west side of Germantown Ave., looking south at Mt. Airy Ave. the ASCO building is 7212-7216 Germantown Ave. The photo is undated, but the presence of the Tourison Building (left) places it after 1929. (Chestnut Hill Conservancy)

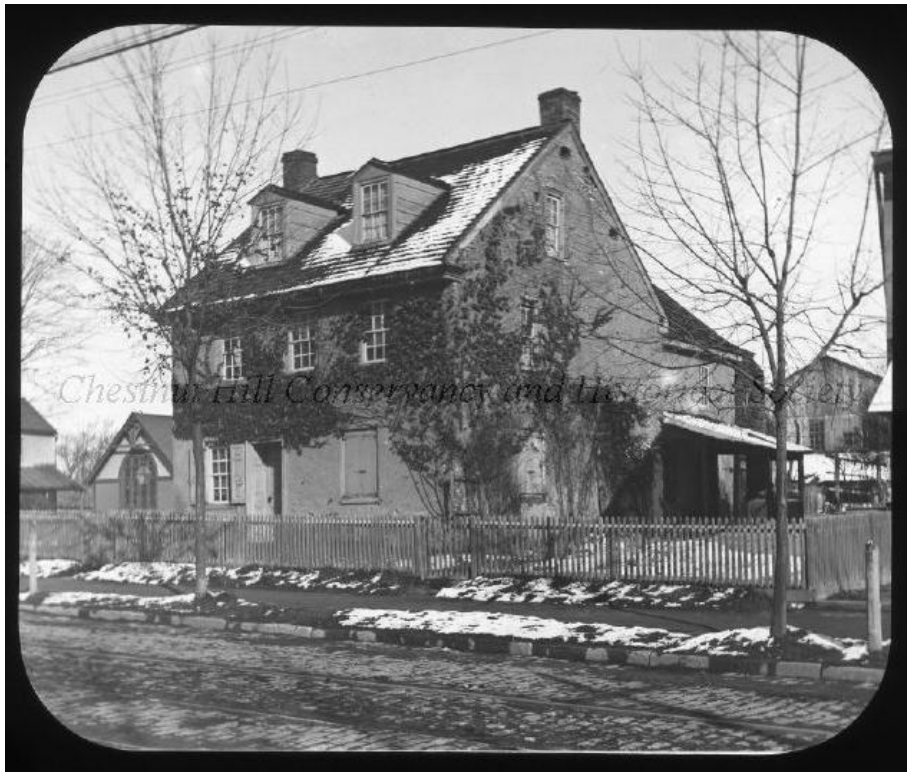
Figure 12. In 1824, Jacob Derr purchased this property at the southeast corner of Germantown and Mount Pleasant Avenues and ran a carriage-making, wheelwright, and blacksmith's shop in the rear. His sons George and Charles continued running the shop through most of the nineteenth century. The Mount Airy Presbyterian Church chapel can be seen to the left in this photo taken between 1894 and 1901. (Chestnut Hill Conservancy)

As mentioned above, in 1906, Jacob Derr sold his carriage-making, wheel-wright and blacksmith shop at the corner of Mt. Pleasant and Germantown Avenues to A. B. and C. F. Millett. They replaced Derr’s house (Figure 12) and large yard with two rows of twin houses in a mix of architectural styles noted above. Three-story rowhouses with mixed commercial and residential uses appeared on Germantown Avenue, (7116 to 7134 and 7220 to 7224), as did a three-story mixed-used apartment building (7205), between 1895 and 1910. These rowhouses had a ground floor storefront, and two windows on the second and third floors with a metal cornice above.

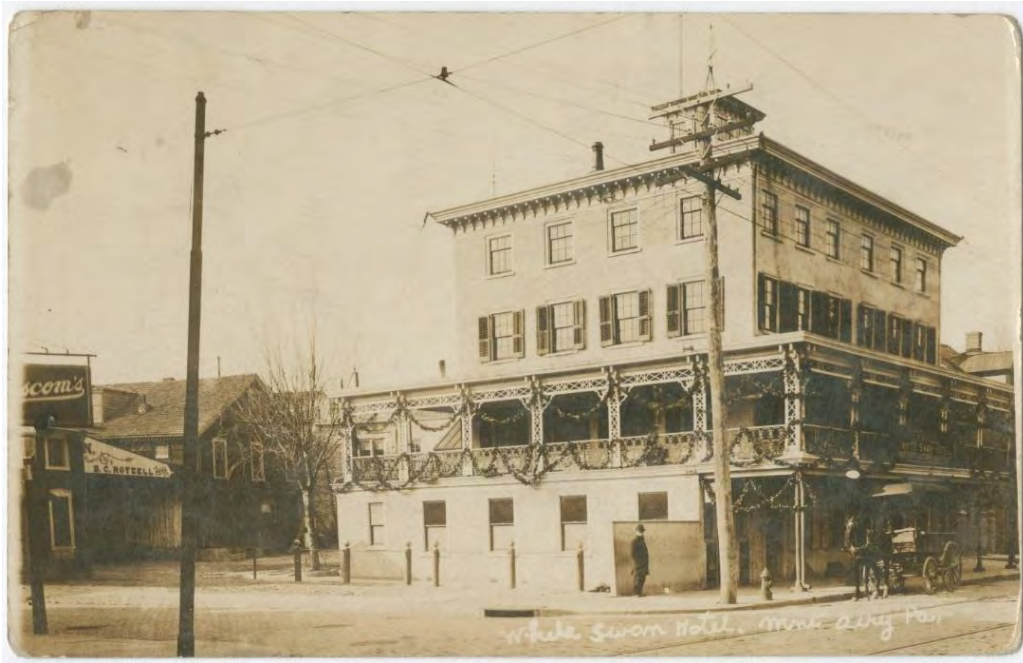
Figure 16. The White Swan Hotel, demolished for the Tourison Building (7200-06). (Germantown Historical Society)

Site was formerly home to the White Swan Hotel until replaced with the current structure as part of the Tourison brothers' commercial revitalization effort.

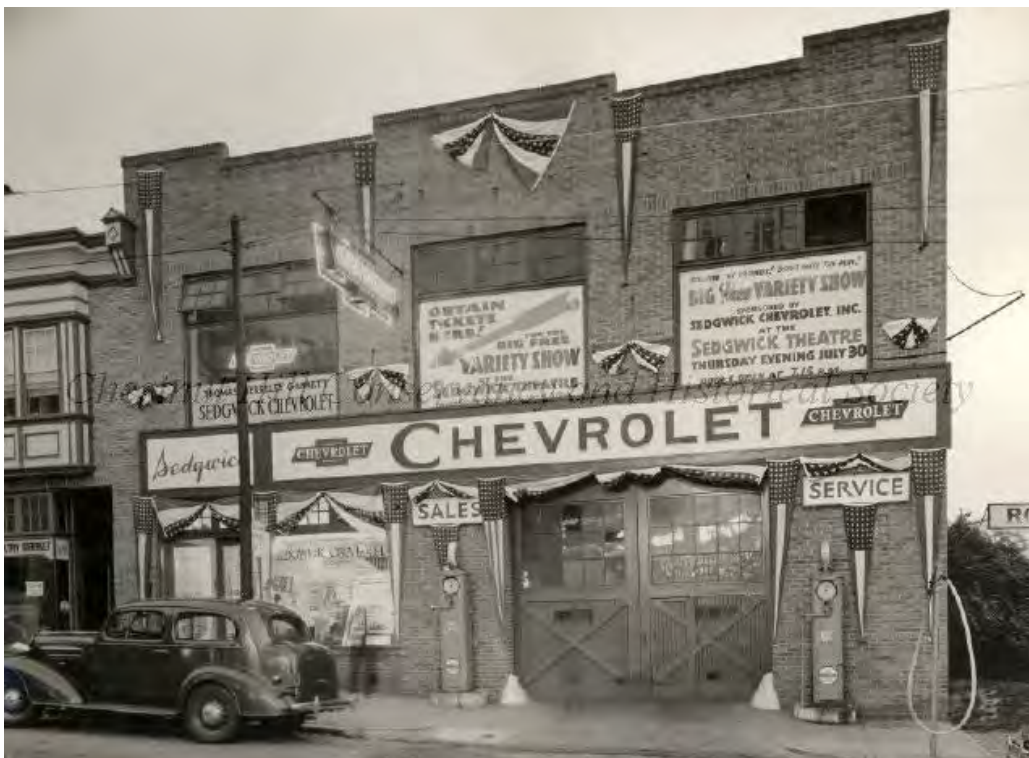
Figure 17. By 1939, 7140 Germantown Ave had become Thomas Berkeley Garrett's Chevrolet dealership. Note the gas pumps on the sidewalk, possibly dating to the building's previous life as the Sedgwick Garage. (Chestnut Hill Conservancy)

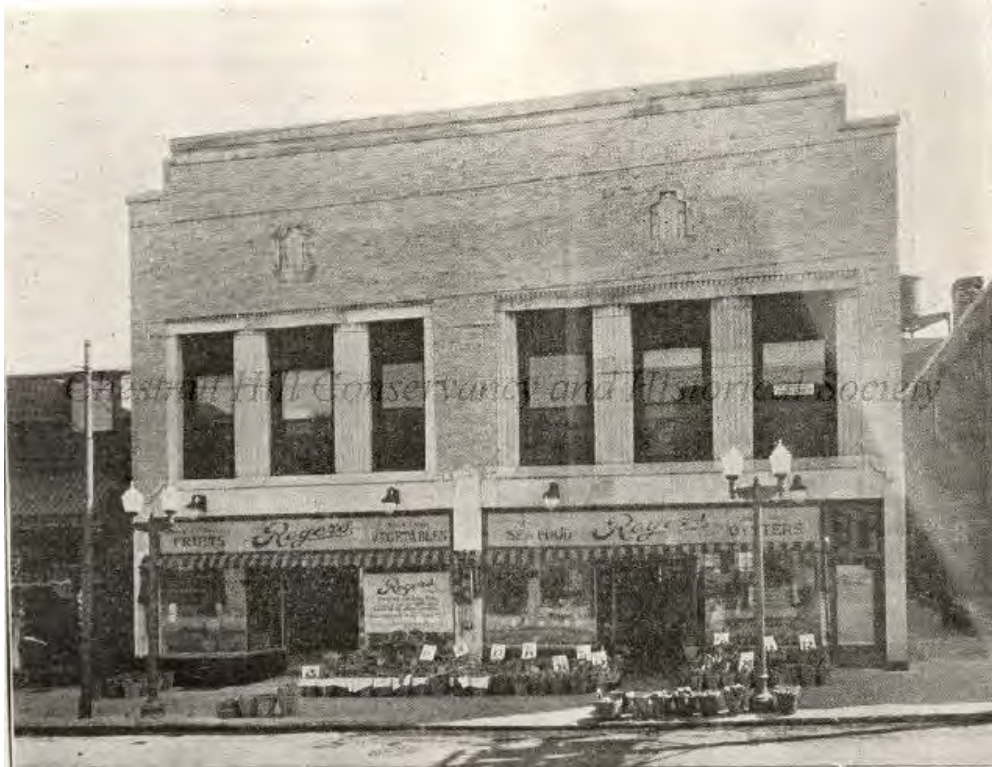
Figure 18. The Tourisons' Art Moderne building at 7145-7147 Germantown Ave. Photo from 1929, the opening of Roger's Grocery. (Chestnut Hill Conservancy)

The 1920s continued to be a period of change on this section of Germantown Avenue. In a further sign that it had become a destination, rather than a way to get to a destination, the Mt. Pleasant Inn which had been erected to serve vacationers and travelers on the turnpike was demolished in about 1923 and replaced by a row of two-story townhouses (7100 to 7110) to provide retail and residential space (Figure 13). These rowhouses had a ground floor storefront, a three-window metal bay on the second floor, and a metal cornice above. The Tourisons were engaged to convert the ground floors of four buildings (7117-19, 7127, 7205, 7212 to 7216) to commercial purposes or modify existing commercial spaces within them.²⁵ In addition to these modifications, after buying the Job Haas house at 7145-47, the Tourisons demolished it to build a two-story, six-rank Art Moderne commercial building (7145-47).²⁶

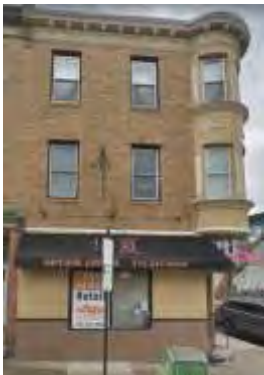
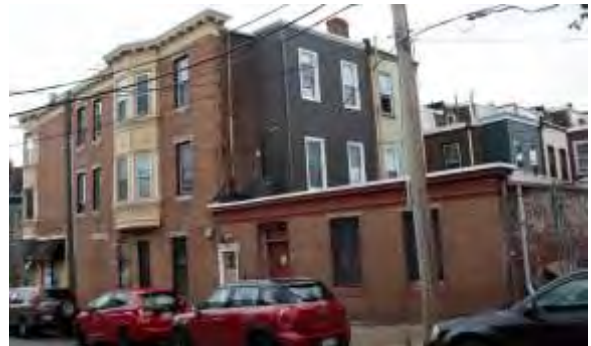
Storefront window on Germantown replaced with smaller window. Ceramic tile facing added.

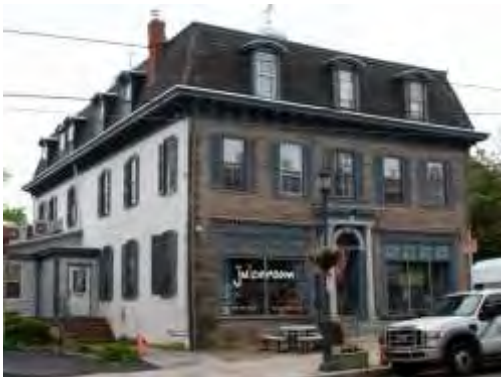
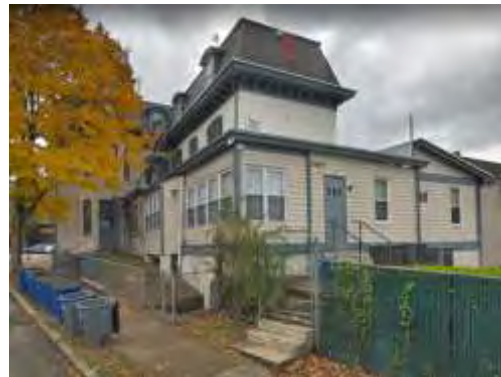
Address: 7127 GERMANTOWN AVE

Style: Federal/Second Empire
Stories: 2 **Bays:** 5
Foundation: Stone
Exterior Walls: Stone
Roof: Mansard; slate
Windows: Non-historic- wood
Doors: Non-historic- wood
Other Materials:

The alterations, including a mansard roof (c. 1860) and commercial windows on the ground floor (c. 1890) rest uneasily with the dressed stone front of the Georgian style house. In 1985 PHC approved the enclosure of a portion of the rear porch (c. 1900) which was not visible to the public. In 1993 the remainder of the porch was enclosed without PHC approval. PHC files indicate that the land was purchased in 1778 by William Allen and sold in 1797 by Andrew Allen, Jr.

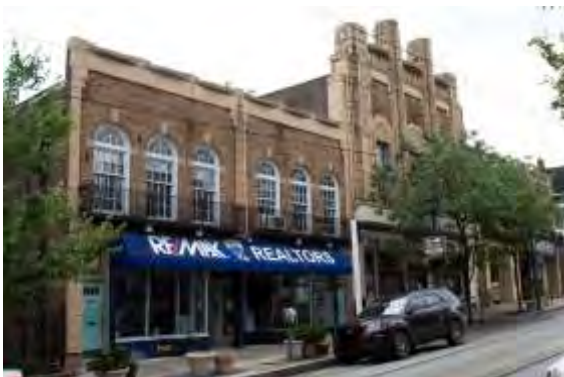
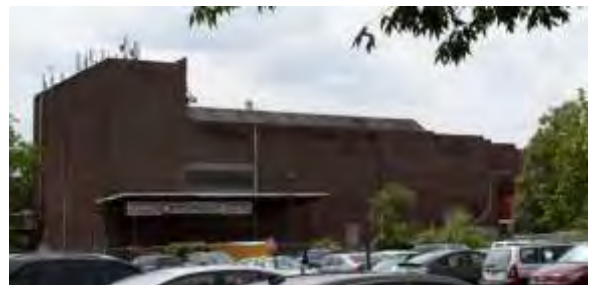
The original lobby is now used as a theater. The original theater is now used as a warehouse (below right). A 1945 photo (based on the release date of the movie shown on the marquee) shows terracotta facing similar to that on upper stories. A 1983 photo included in the PHRS Form shows ground floor store fronts replaced by red and white brick, wooden doors with broken pediment trim, and pent roofs with asphalt shingles. The current building shows efforts at restoration with doors and windows now resembling the 1945 versions, the pent roofs removed, and the red and white brick replaced by yellow brick. The second floor has remained original. The rear auditorium is considered non-contributing.

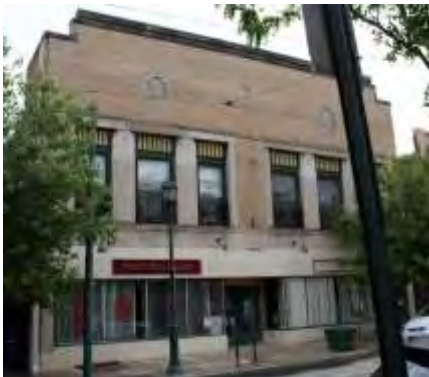
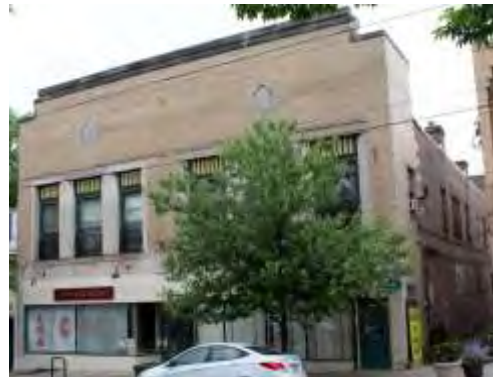
Address: 7145-47 GERMANTOWN AV

The 1935 and 1951 alterations were to ground floor, but are not further described. Current ground floor facing is tile; a 1983 PHRS form photo shows red brick below the display windows, the original was probably granite as on the second floor and right and left sides of first floor. The PHRS photos shows a large vertical sign on the second floor of 7145 advertising products for the appliance and computer stores in the building.

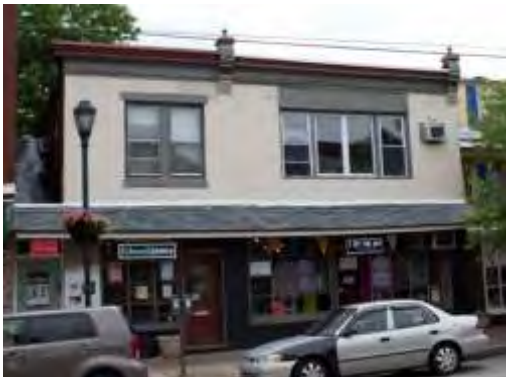
Building permits and other documents are unclear as to the origins of the building. One 1906 permit is for the interior alterations. Five months later, William Fleming acquired a permit for a new 2-story brick building using the existing foundations. In 1908, a 2-story brick addition measuring 20' wide was added; this is probably the right side of the present front. A rear bay window was installed in 1908. George S. Idell, architect, designed a 2-story brick side addition measuring 11'6" x 36' in 1913. Another side addition, measuring 12' x 26', was built in 1921. Idell returned in 1922 to design a series of garages. A boiler house was added to the garages at the end of that year. Finally Idell designed interior alterations and partitions and the present store windows were added in 1953.

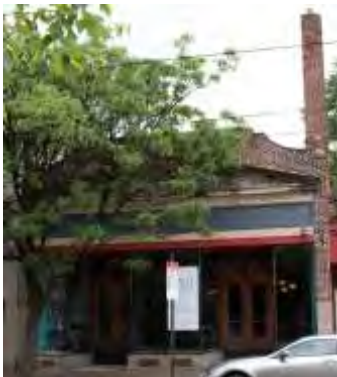
An example of Longstreth's Enframed Window Wall type of commercial building, which has been altered. A granite pediment spans the width of the façade, which also has limestone urns at the upper corners. Two additional bands of limestone run horizontally across the façade, divided by a wooden panel. Polished marble panels have been added to the lower part of the façade. White mosaics at entrances have red W within a diamond--the F.W. Woolworth's logo.

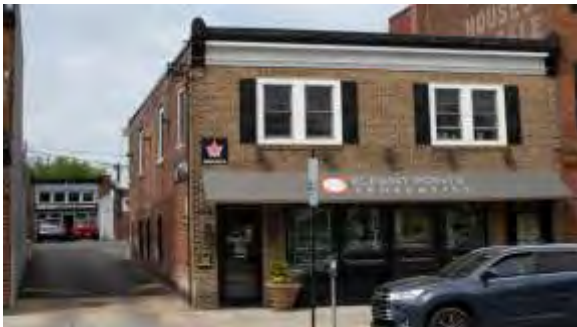
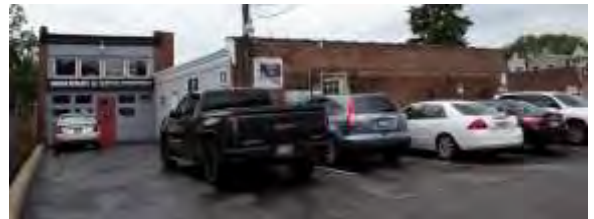
Property includes two additional businesses in garage/sheds at rear of lot, with access via driveway to left of structure (below left).

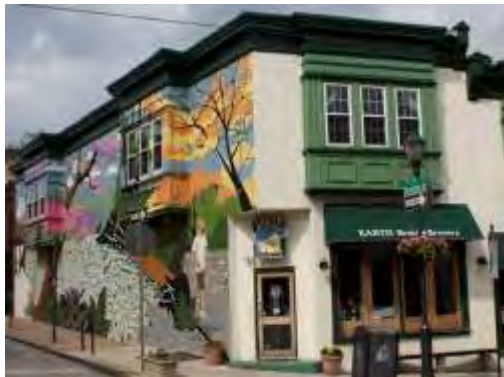
Was an upholstery shop in 1925. Pressed metal cornice and second-floor bays.

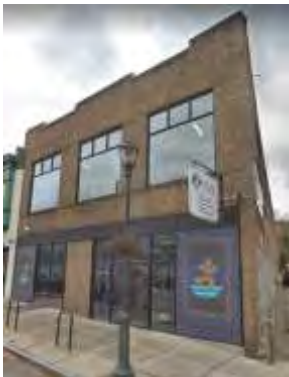
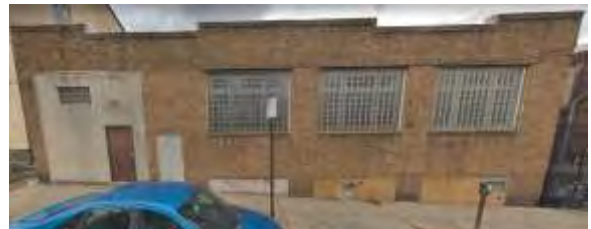
Front façade (below left) is on Germantown Ave, rear (below right) is on W. Durham St. The ground floor Germantown façade originally had two display windows centered between the left-most second story window, and a door for automobiles centered between the center and right-most second story windows. This was flanked by two sidewalk gas pumps. The second floor windows originally had one large pane below with three 2x3 light awning windows above (now one fixed pane each).

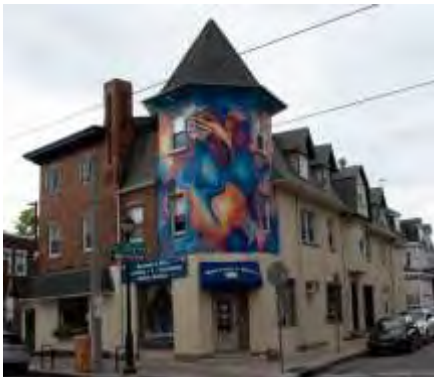
A gabled dormer window pierced the mansard on the Germantown Ave elevation but has since been removed. Most of the façade is now stuccoed. Building was constructed with 7170 (attached) and 2-6 West Mt. Airy Ave (adjacent).
