ADDRESS: 1823 DELANCEY PL

Proposal: Insert garage; remove additions; add roofdeck with pilot house

1823 Delancey Street
Schematic Design Presentation

Presented to Philadelphia Historical Commission
03.03.25

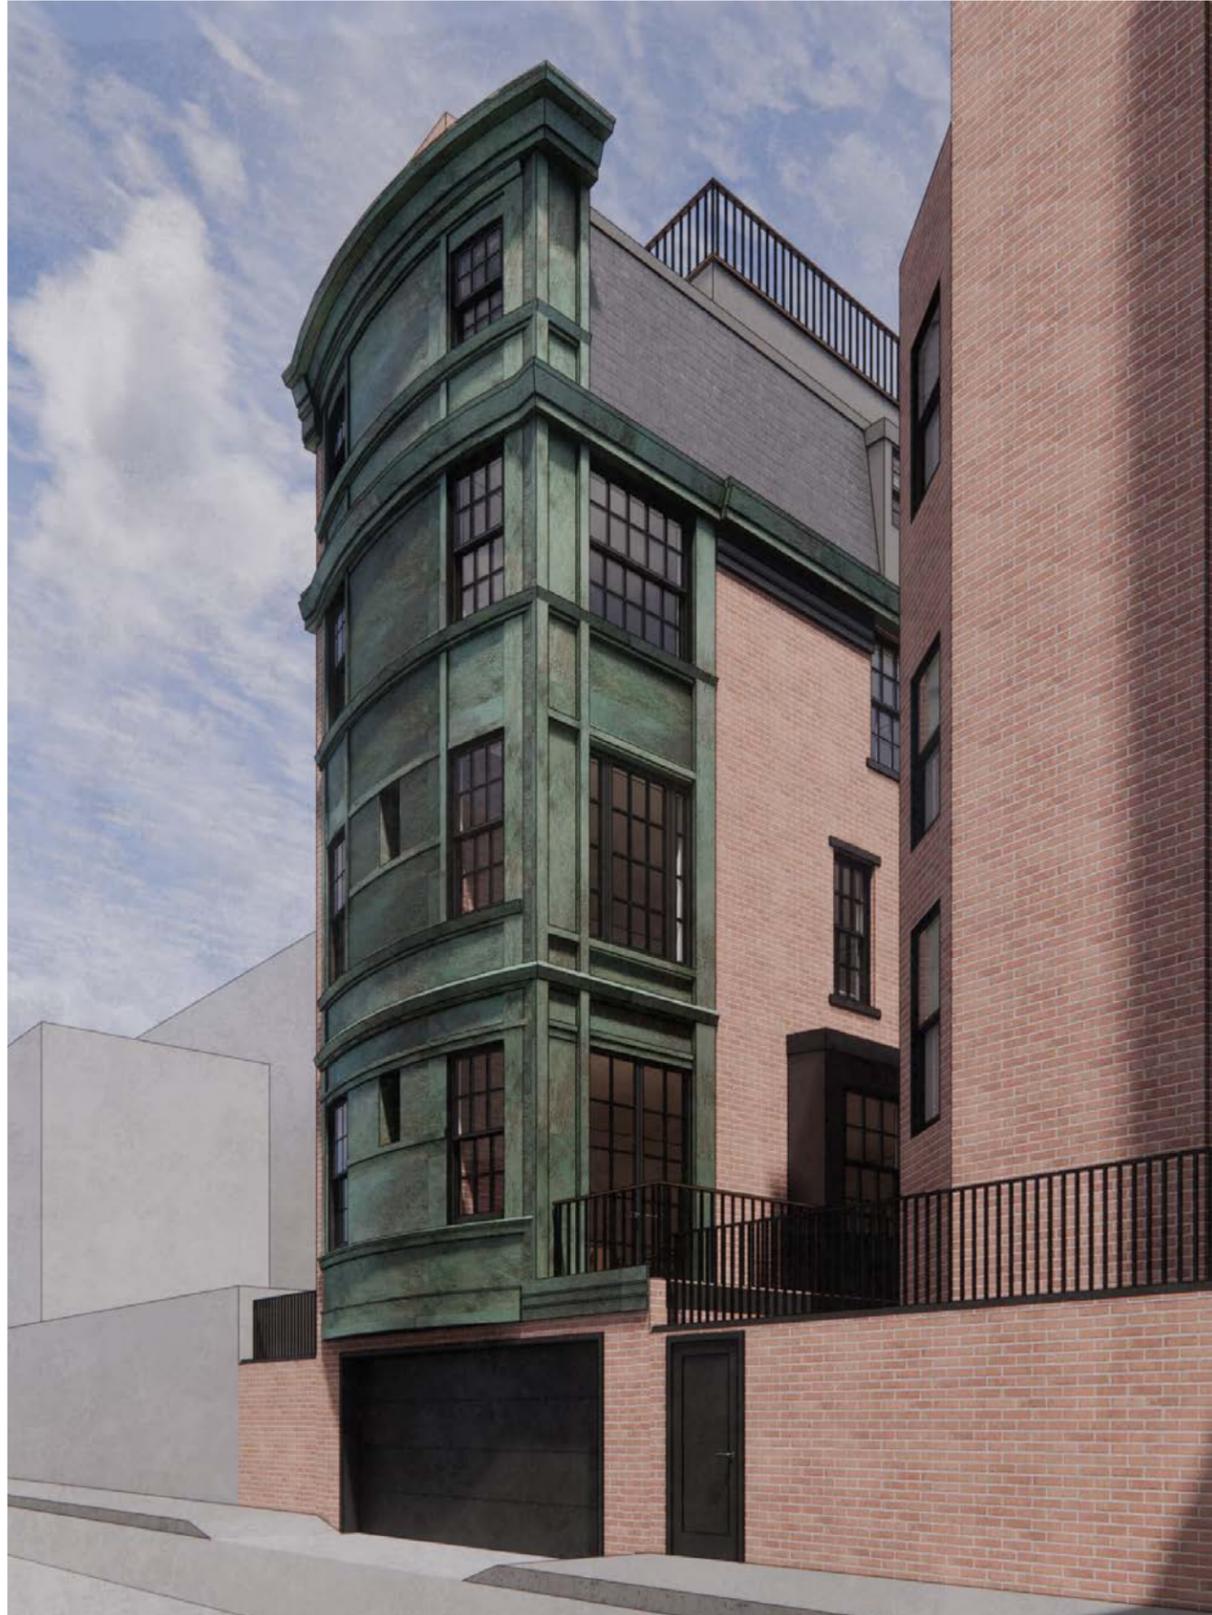
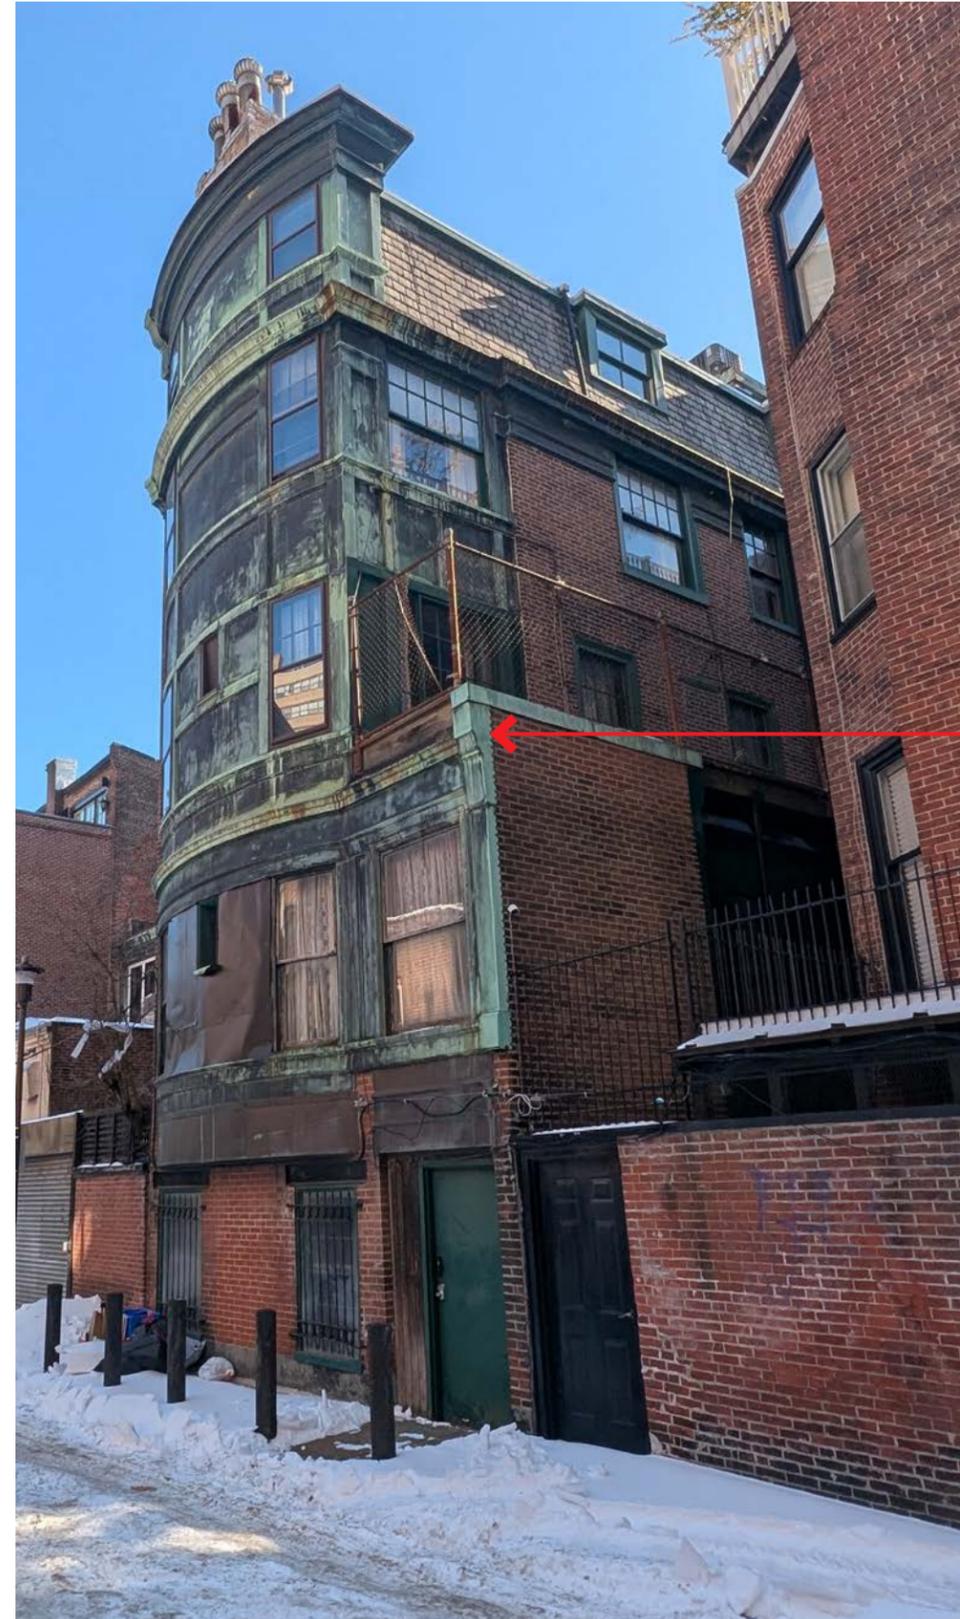
Rendering of Proposed Rear Modifications - Looking East

Existing bracket and cornice to be salvaged and reused
