**NOMINATION OF HISTORIC BUILDING, STRUCTURE, SITE, OR OBJECT
PHILADELPHIA REGISTER OF HISTORIC PLACES
PHILADELPHIA HISTORICAL COMMISSION**

Street address: 5604 N. 5th Street

Historic Name: National Bank of Olney

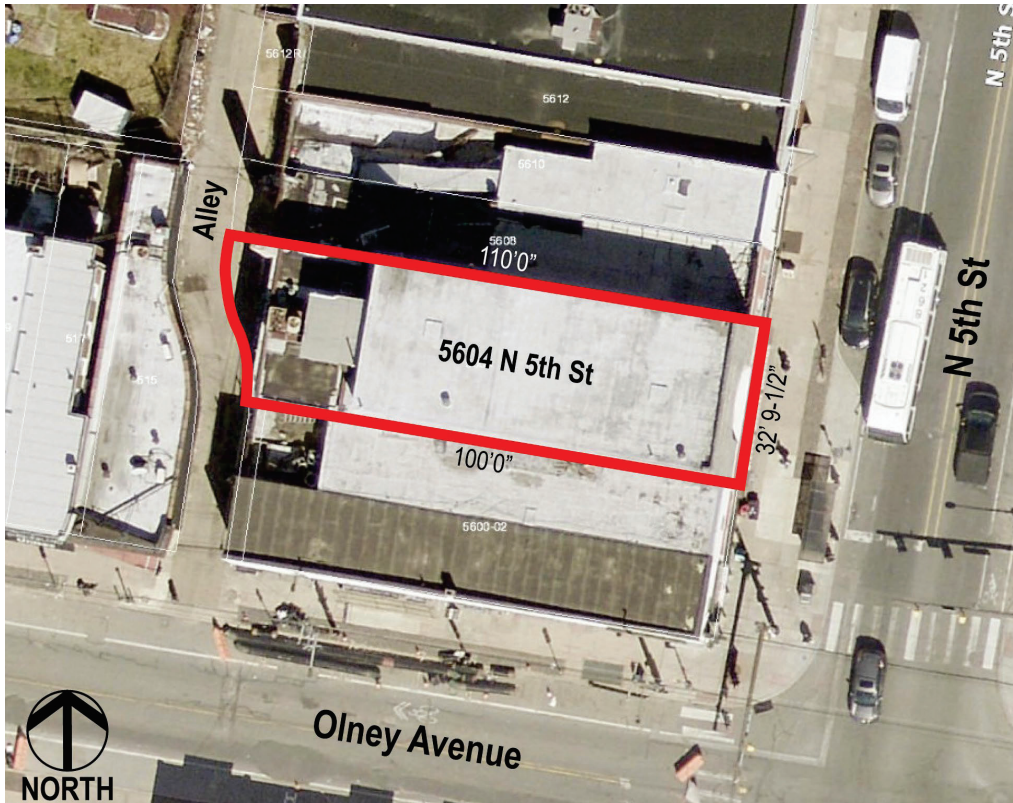
Parcel Boundary Map, 5604 N. 5th Street (imagery from atlas.phila.gov).

Beginning at a point on the westerly side of 5th Street at the distance of 32 feet 2-1/2 inches northwardly from the northerly side of Olney Avenue, thence extending from said beginning point northwardly along 5th Street the distance of 32 feet 9-1/2 inches; thence extending westwardly at a right angle to 5th Street the distance of 110 feet 0 inches to the easterly side of an alley; thence continuing southwardly, following the S-curve line along the easterly side of the alley to a point 100 feet 0 inches westwardly from the beginning point; thence continuing eastwardly at a right angle to the alley and 5th Street the distance of 100 feet 0 inches to the beginning point.

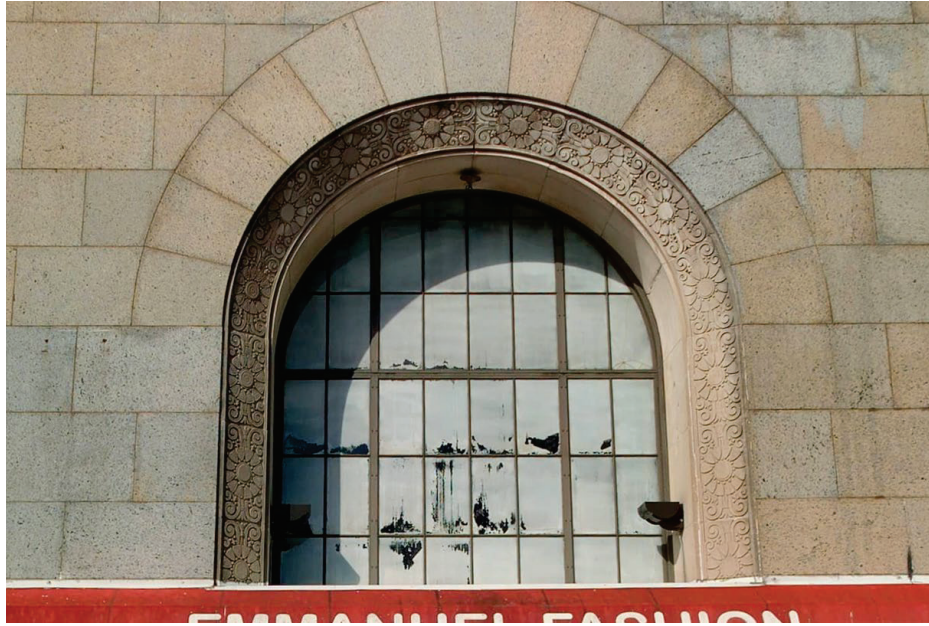
At the second story, above the awning, the central archway features an original, multi-light steel window (Figure 2). The window is recessed several feet into the building and has an ornamental cast stone surround, which features a stylized, Art Deco floral motif. The stone surround angles inward from the outer face of the exterior wall to the deep intrados directly in front of the window. As illustrated in Figure 6, the surround originally continued down both sides of the central opening to the granite water table. Although this ornamental feature is currently not visible at the

Figure 2: East elevation, close-up view of central arched window at the second story.

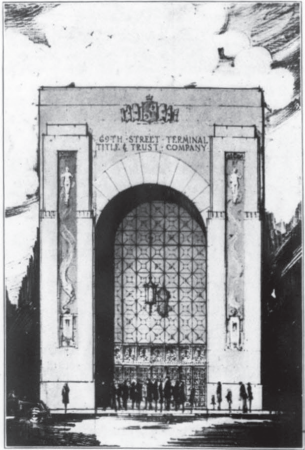
69TH STREET TERMINAL
TITLE & TRUST COMPANY

WHETHER CONSCIOUS OF IT OR NOT we are all subject to the subtle influence of beauty. Designed in rugged masses, bank buildings suggest great strength and reveal their beauty to a proud public.

A new bank building designed in modern American, fully utilitarian, certainly has an appeal with a pull that builds up deposits.

Echoing the architecture of the mighty past the bank building today of original design and majestic scale has great advertising value.

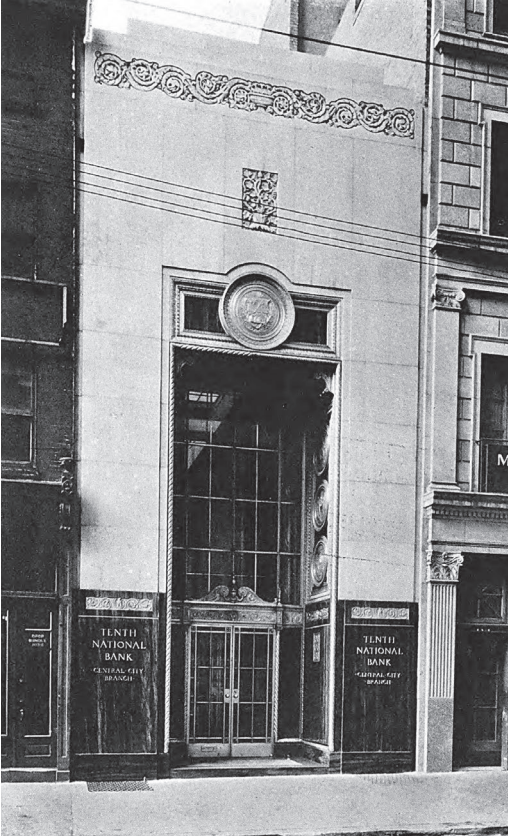
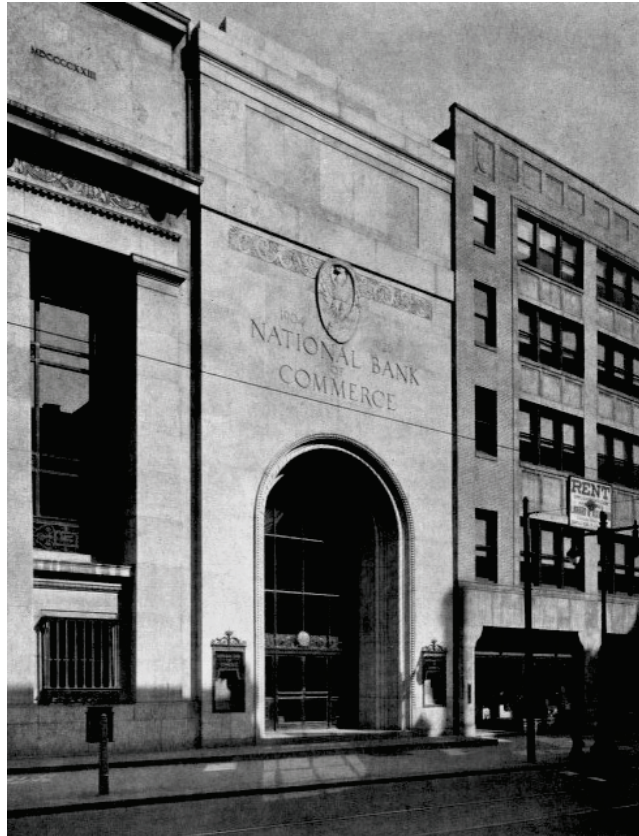
Art Deco banks by other Philadelphia designers also garnered praise from various publications. Those by Davis, Dunlap & Barney, in particular, were widely acclaimed by the architectural press. In *Architectural Forum* in June 1928, one critic was especially pleased with the firm's work on the Tenth National Bank at 116 South 15th Street (1925; demolished) and the National Bank of Commerce at 713 Chestnut Street (1926-27; demolished).¹⁶ The writer commended their simple geometric treatments and how they used large, well-proportioned openings and concentrated architectural details to relieve what were otherwise plain, unbroken wall surfaces (Figures 10 and 11).

Figure 10 (left): Tenth National Bank at 116 S. 15th Street in Philadelphia (1926-27; demolished). Image from *Architectural Forum*, June 1928.

Figure 11 (right): National Bank of Commerce at 713 Chestnut Street in Philadelphia (1926-27; demolished). Image from *Architectural Record*, July 1928.

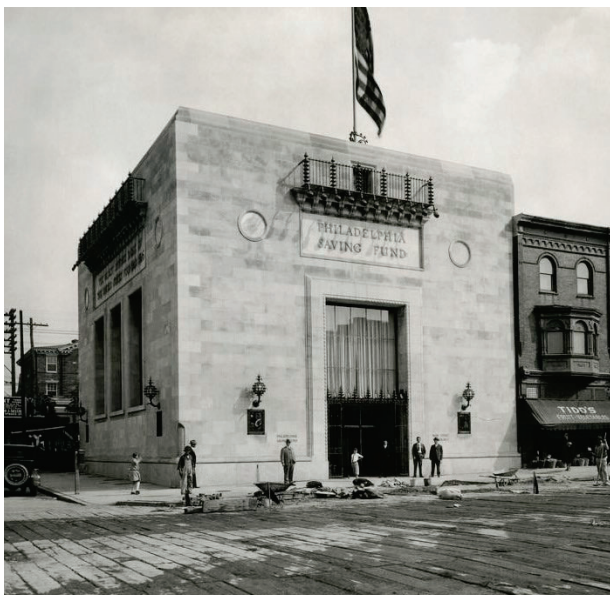
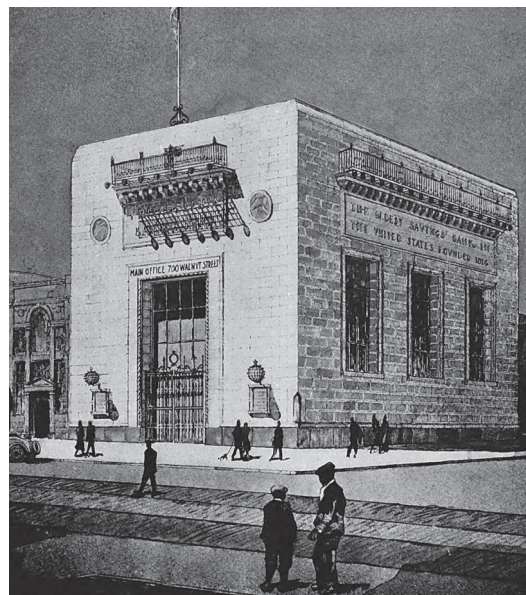
In the same issue of *Architectural Forum*, architect George Howe wrote about how he and his firm, Mellor, Meigs & Howe, employed many of the same concepts in the neighborhood branch banks they had recently completed for the Philadelphia Saving Fund Society (PSFS).¹⁷ With the Logan Branch at 4947-49 North Broad Street (1925-26; extant) and the West Philadelphia Branch at 15 S. 52nd Street (1925-26; extant), especially, Howe explained how they had achieved a friendlier, more welcoming type of bank by distilling each building down to the most basic cubic form and employing only the most deliberate moments of articulation where they were needed

to break up the smooth surfaces of the walls (Figures 12 and 13). Both PSFS branch banks are listed on the Philadelphia Register of Historic Places.¹⁸

Figure 12 (left): PSFS, Logan Branch at 4947-49 N. Broad Street in Philadelphia (1925-26; extant). Image from the Indiana Limestone Photograph Collection at Indiana University.

Figure 13 (right): PSFS, West Philadelphia Branch at 52nd and Ludlow Streets in Philadelphia (1925-26; extant). Charcoal and pencil sketch from *Architectural Forum*, June 1928.

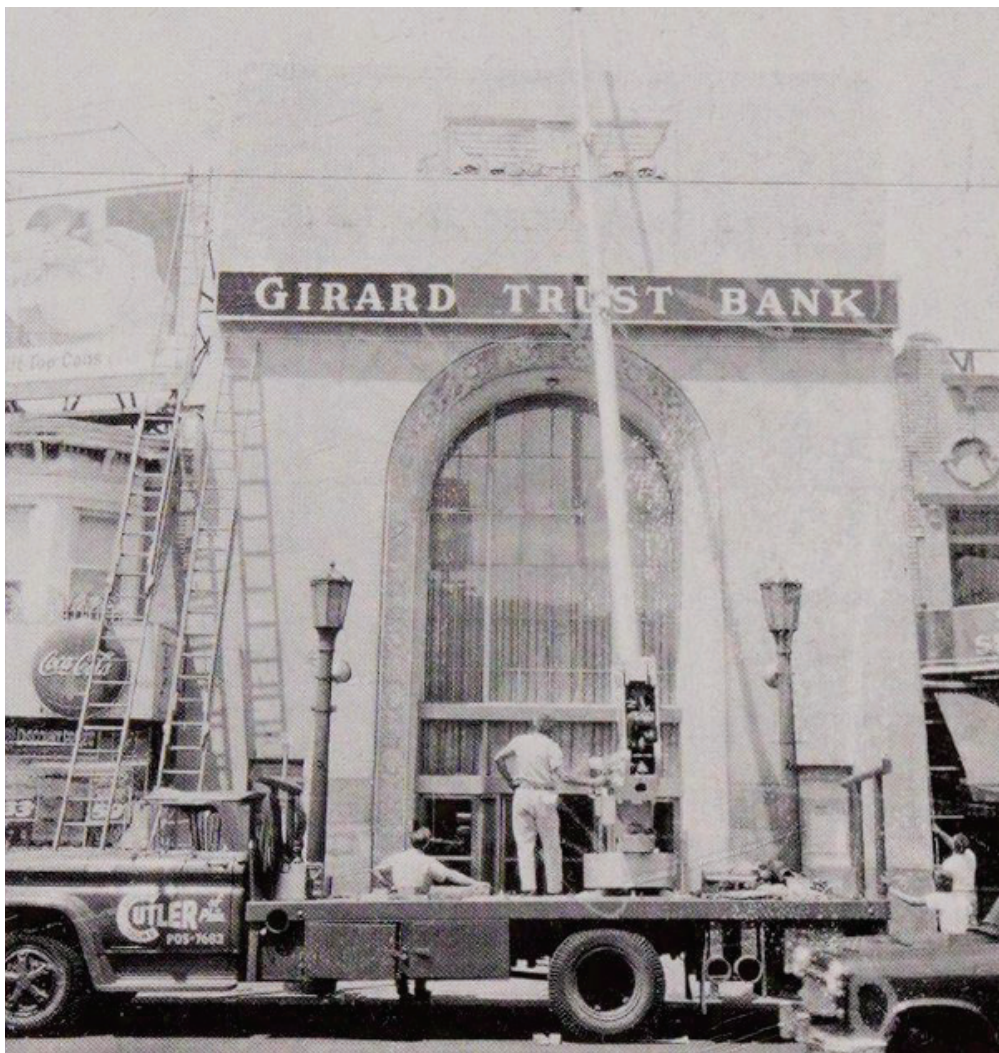
Figure 14: The former National Bank of Olney in 1965, following the building’s acquisition by the Girard Trust Company. Image from the Old York Road Historical Society.
